1.		Policy Particulars	:- THIRD PARTY CLAIM			
	Insured Veh.	SBN 6881L	Veh. Inspected	SKL 63A		
	Policy No.	Z/18/VP05/021458	Coverage (\$)	0.00		
	Claim No.	18/19/19/VP05/022388	Excess (\$)	0.00		
	Assign From	KENNY	Assign Date	17/09/2019

2.		Vehicle Partic	culars & Condition			
	Make & Model	MASERATI GRANCABRIO	c.c	4691		
	Engine No.	HIDDEN	Year of Reg.	2011		
	Chassis No.	ZAMKM45C000053232	Colour	BLACK		
	Odometer	72595	Steering	IN ORDER		
	Brakes	IN ORDER	Modification	SPORTS RIM		
	General	FAIR

ADJUSTMENT ON REPAIR COST FOR VEHICLE NO. SKL 63A

PHOTOGRAPHS FOR VEHICLE NO. SKL 63A

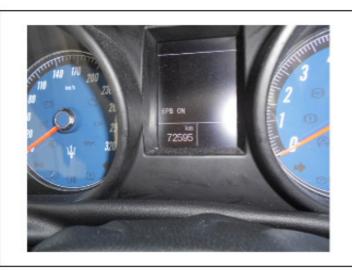
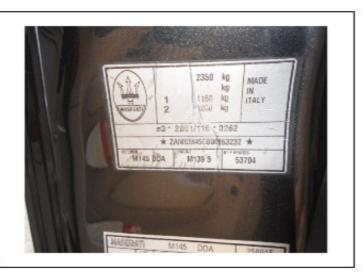
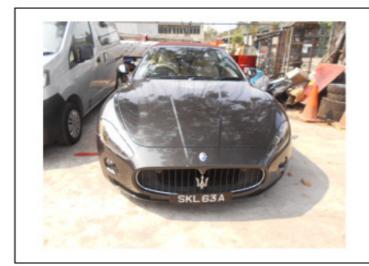
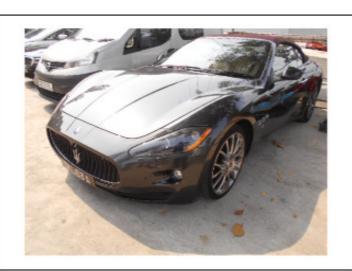
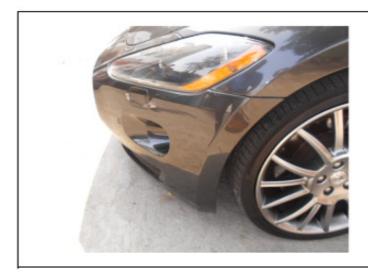
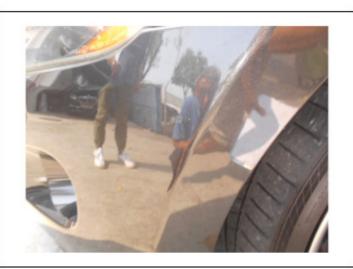
4.		Description	on of Damages			
	THE VEHICLE SU	STAINED DAMAGES AT THE N/S	FRONT PORTION.			
	DAMAGES SEE D	ETAILS.				
5.		General	Information			
	Accident Date	12/09/2019	Inspection Date	26/09/2019		
	Survey held at	TAN LIM MOTOR PTE LTD				
		51 DEFU LANE 10 SINGAPORE 539216				
5a.		Re	emarks			
	A)THE INSPECTION WAS CONDUCTED ON A"WITHOUT PREJUDICE" BASIS. B)IN ACCORDANCE TO YOUR INSTRUCTIONS, WE HAVE NOT AUTHORISED REPAIRS.					
5b.	5b. Estimate Days of Repair					
	ESTIMATED NOR	MAL PERIOD FOR REPAIR:	4 Working Days

Qty	Description of Parts	Condition	Estimate By Workshop (\$))	Our Adjusted (\$)
	REPLACEMENT OF PARTS			
1	FRONT BUMPER	TO REPAIR SEE LABOUR	5,450.00	-
1	FRONT BUMPER SIDE RETAINER LEFT	NOT NECESSARY	150.00	-
1	FRONT BUMPER SIDE LOWER GRILLE LEFT	NOT NECESSARY	520.00	-
	LESS 10% DISCOUNT		-612.00	-
			5,508.00	-
	<u>LABOUR</u>			
	TO CHECK ELECTRICAL LIGHTING CONCERNED.		100.00	60.00
	PANEL BEATING,KNOCKING AND STRAIGHTEN THE NECESSARY PORTION,REMOVE AND RENEWAL OF PARTS,ADJUST AND REALIGN THE SAME.INCLUSIVE OF THE REPAIR OF FRONT BUMPER.		1,000.00	800.00
	PUTTY AND SPRAY PAINTING OF THE AFFECTED PORTION.		1,200.00	800.00
			2,300.00	1,660.00
	GRAND TOTAL		7,808.00	1,660.00

RECOMMENDED COST OF REPAIRS		1,660.00
