DAMAGE ASSESSMENT REPORT			
NTUC INCOME INSURANCE CO-OPERATIVE LTD		Ref: CS/INC19016481/Kvd3n2	
73 BRAS BASAH ROAD		Date: 27-09-2019

1. Policy Particulars :- THIRD PARTY CLAIM			
Insured Veh.	SLB 5957D	Veh. Inspected	SKX 9109E
Policy No.		Coverage (\$)	0.00
Claim No.	MT/1062866-001	Excess (\$)	0.00
Assign From	ANNIE KOH	Assign Date	18/09/2019

### ADJUSTMENT ON REPAIR COST FOR VEHICLE NO. SKX 9109E

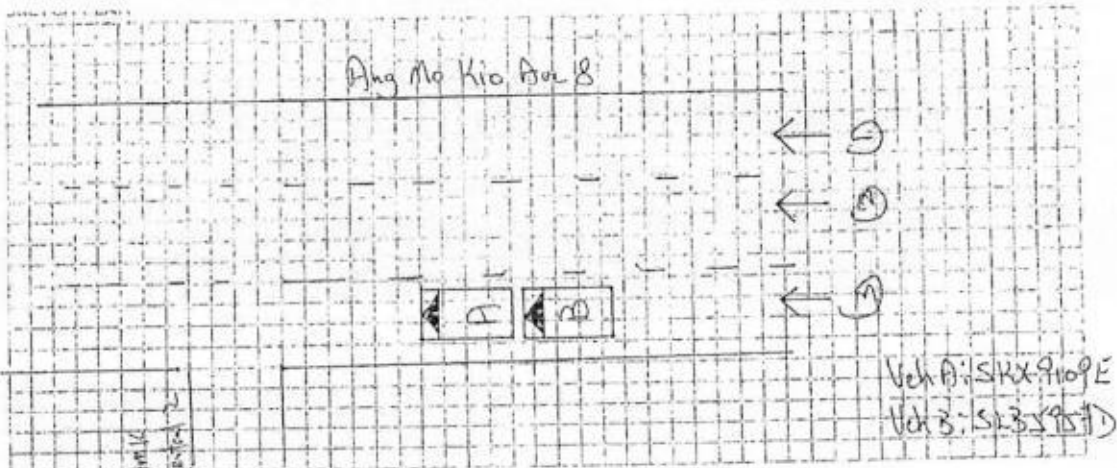
Sketch Plan #2 Pg. 1

On 16/9/2019 @ about 1700hrs, I was travelling along Ang Mo Kio Ave 8 towards Ave 5. Just before Ang Mo Kio Central 2 entrance, I stopped at a traffic light due to red light. While waiting for the lights to turn green, suddenly I felt an strong impact from the rear of my vehicle. I exited my vehicle and realised that veh B (SLB5957D) had collided into my vehicle rear portion.
