DAMAGE ASSESSMENT REPORT

Insured Veh.	SKZ 9939R	Veh. Inspected	YN 6081G
Policy No.		Coverage (\$)	0.00
Claim No.	MT/1056304-002	Excess (\$)	0.00
Assign From	ANNIE KOH	Assign Date	18/09/2019

ADJUSTMENT ON REPAIR COST FOR VEHICLE NO. YN 6081G

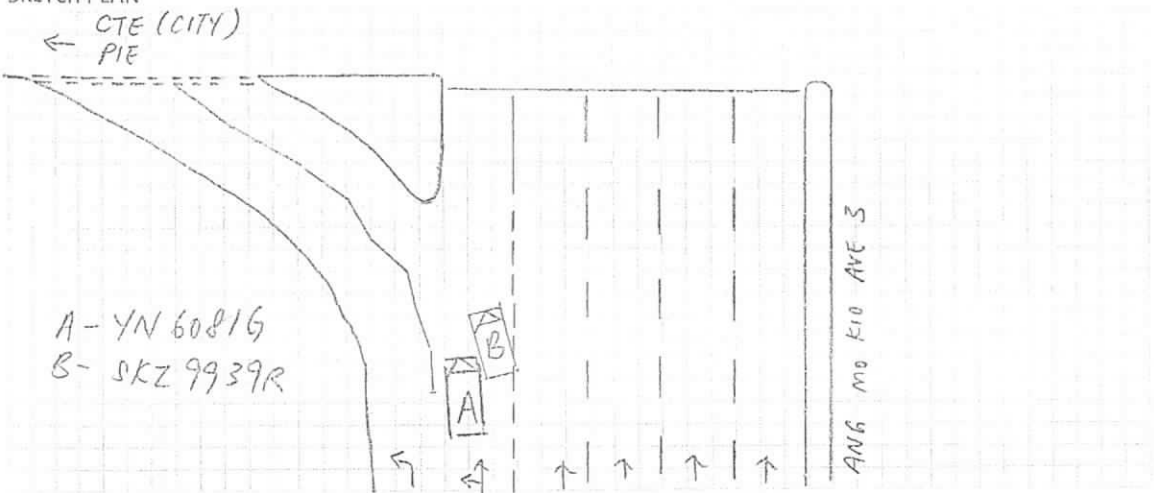
SKETCH PLAN

I Marugaya Sdharajee driving vehicle no YN6081G along Ang mo kio Ave 3 going back to office suddenly a car came behind and ~~he~~ take over me and hit front side and side sight light broke while I'm turning towards Gate bridge Rd from Ang mo kio Ave (3) that's all.
