Make: Nissan Serena 2.0GS-Hybrid s.c 1997

Des. of Damages: Frt / Rear / O/S / N/S / UIC / Rooftop or

PRE-REPAIR INSPECTION REQUEST – SJC1123M vs SJG6494M (OI) on D.O.A.: 19/09/2019

VEHICLE DAMAGE INSPECTION REPORT**Our File No:** CS/AIG19016675/FSD3S2
Date: 08/10/2019REFERENCE

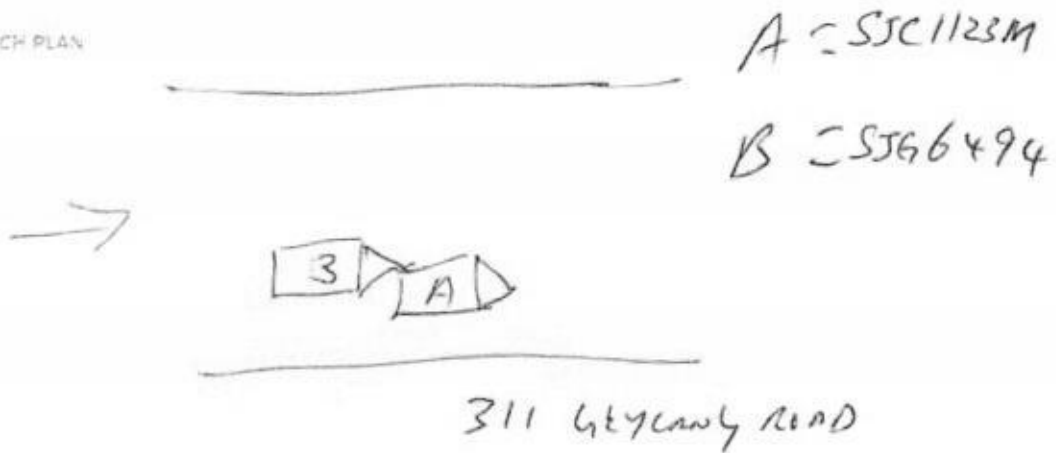
Sketch Plan #2

SKETCH PLAN

DESCRIBE CIRCUMSTANCES OF THE ACCIDENT

On 19 Sep 2019 1631hrs, I was driving along 311 Gylenny road, suddenly vehicle B hit left rear of my car.
