## LKK Auto Consultants Pte Ltd

### 1. Policy Particulars :- THIRD PARTY CLAIM

### ADJUSTMENT ON REPAIR COST FOR VEHICLE NO. SJQ 7620G

PHOTOGRAPHS FOR VEHICLE NO. SJQ 7620G

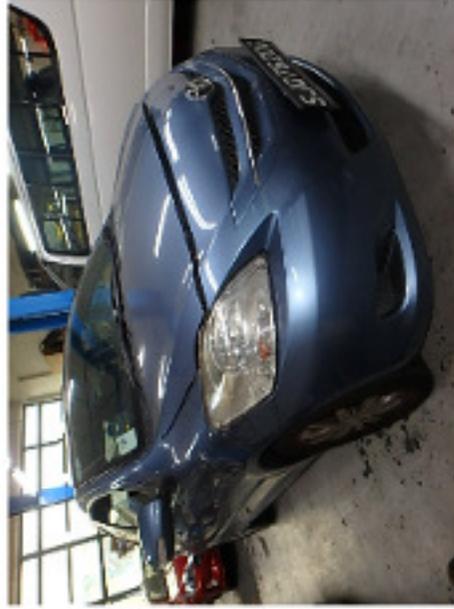
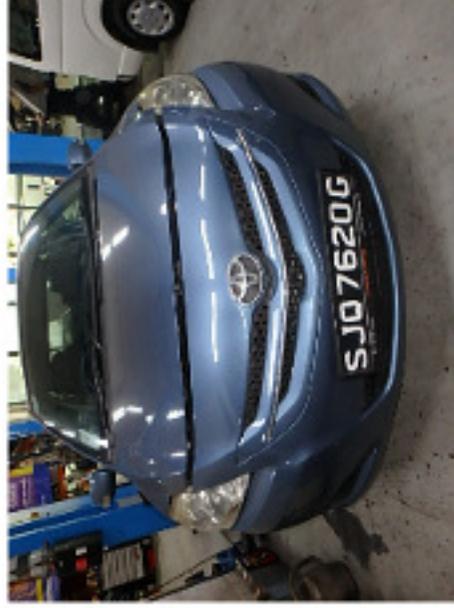
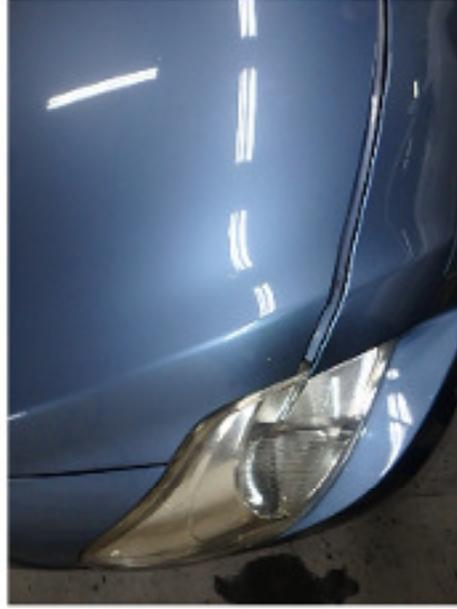
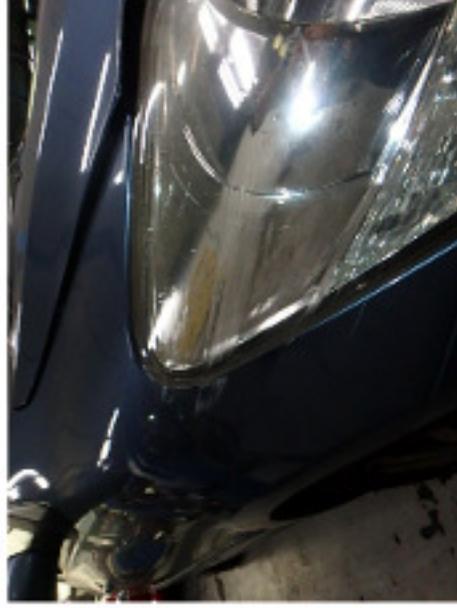
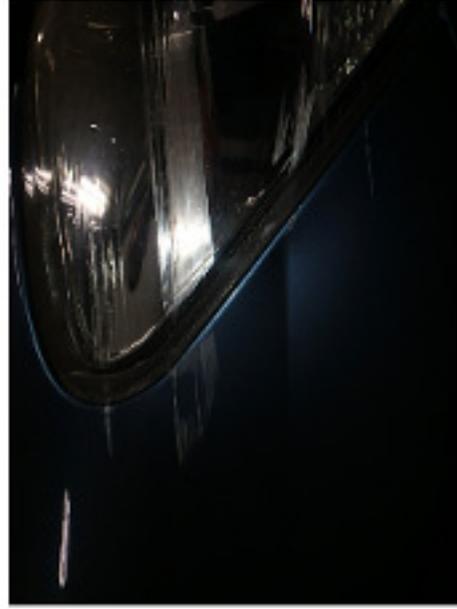
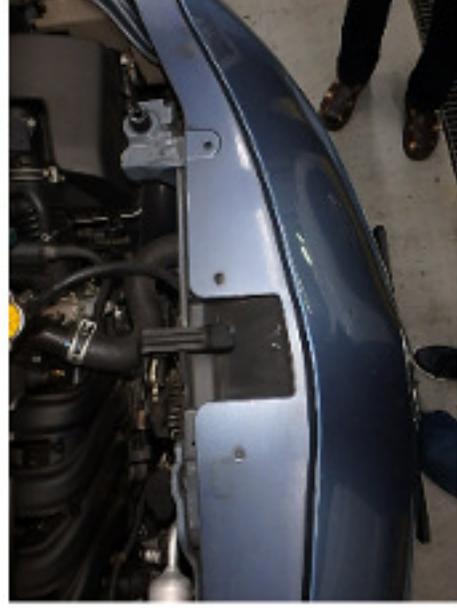
THE VEHICLE SUSTAINED DAMAGES AT THE O/S FRONT PORTION.  
DAMAGES SEE DETAILS.

Qty	Description of Parts	Condition	Estimate By Workshop (\$)	Our Adjusted (\$)
<b>REPLACEMENT OF PARTS</b>				
1	FRONT HEAD LIGHT	CUT	415.60	415.60
1	FRONT BUMPER	CRACKED	486.30	486.30
15	FRONT BUMPER CLIP @\$3.50	NECESSARY	52.50	52.50
1	FRONT BUMPER GRILLE	SERVICEABLE	85.20	-
1	FRONT FENDER	BENT	390.80	390.80
	LESS 25% DISCOUNT		-357.60	-336.30
			1,072.80	1,008.90
<b>LABOUR</b>				
	TO REMOVE AND REPLACE THE PARTS MENTIONED ABOVE ,PANEL BEAT AND REALIGN THE NECESSARY AFFECTED AREAS.		400.00	300.00
	TO APPLY PUTTY & SPRAY PAINTING ON AFFECTED AREAS.		600.00	400.00
	TO CHECK WIRING SYSTEM.		50.00	20.00
			1,050.00	720.00
<b>GRAND TOTAL</b>			<b>2,122.80</b>	<b>1,728.90</b>
<b>RECOMMENDED COST OF LUMP SUM REPAIRS (TO ITS PRE-ACCIDENT CONDITION)</b>				<b>1,050.00</b>
