PRE-REPAIR INSPECTION REQUEST – SJW1709T vs GBF6122L (OI) on D.O.A.: 26/09/2019

Vehicle No : SJW 1709 T
Make : Toyota Corolla
Year : 1992

VEHICLE DAMAGE INSPECTION REPORT

Our File No: CS/AIG19016995/KVD3N2

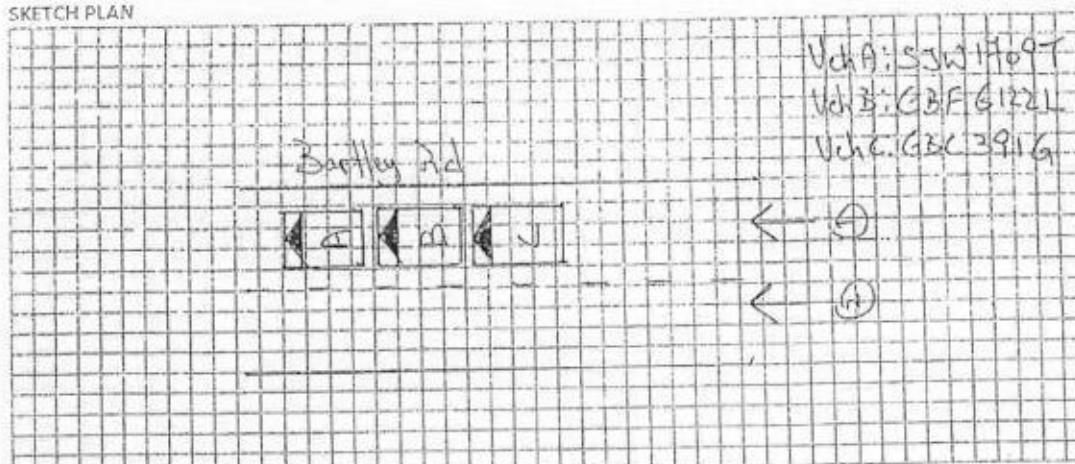
Sketch Plan #2 Pg. 1

SKETCH PLAN

On 26/9/2019 @ abt 0830hrs, I was travelling along Bartley Rd towards Tampines Ave 10. I was driving in the most right lane. Due to heavy traffic, the car in front of mine slowed down thus I followed suit and slowed down my car. Suddenly, I felt a strong impact from the rear of my vehicle. I exited my vehicle and realised it was a collision of 3 vehicles.
