# ASSIGNMENT

ACCIDENT INVOLVING SMD 4827E & SH 8944G ALONG SERVICE ROAD OF BLOCK  
 813 JELlicoe ROAD ON 13 JULY 2019 @ 0930HRS

### ADJUSTMENT ON REPAIR COST FOR VEHICLE NO. SMD 4827E

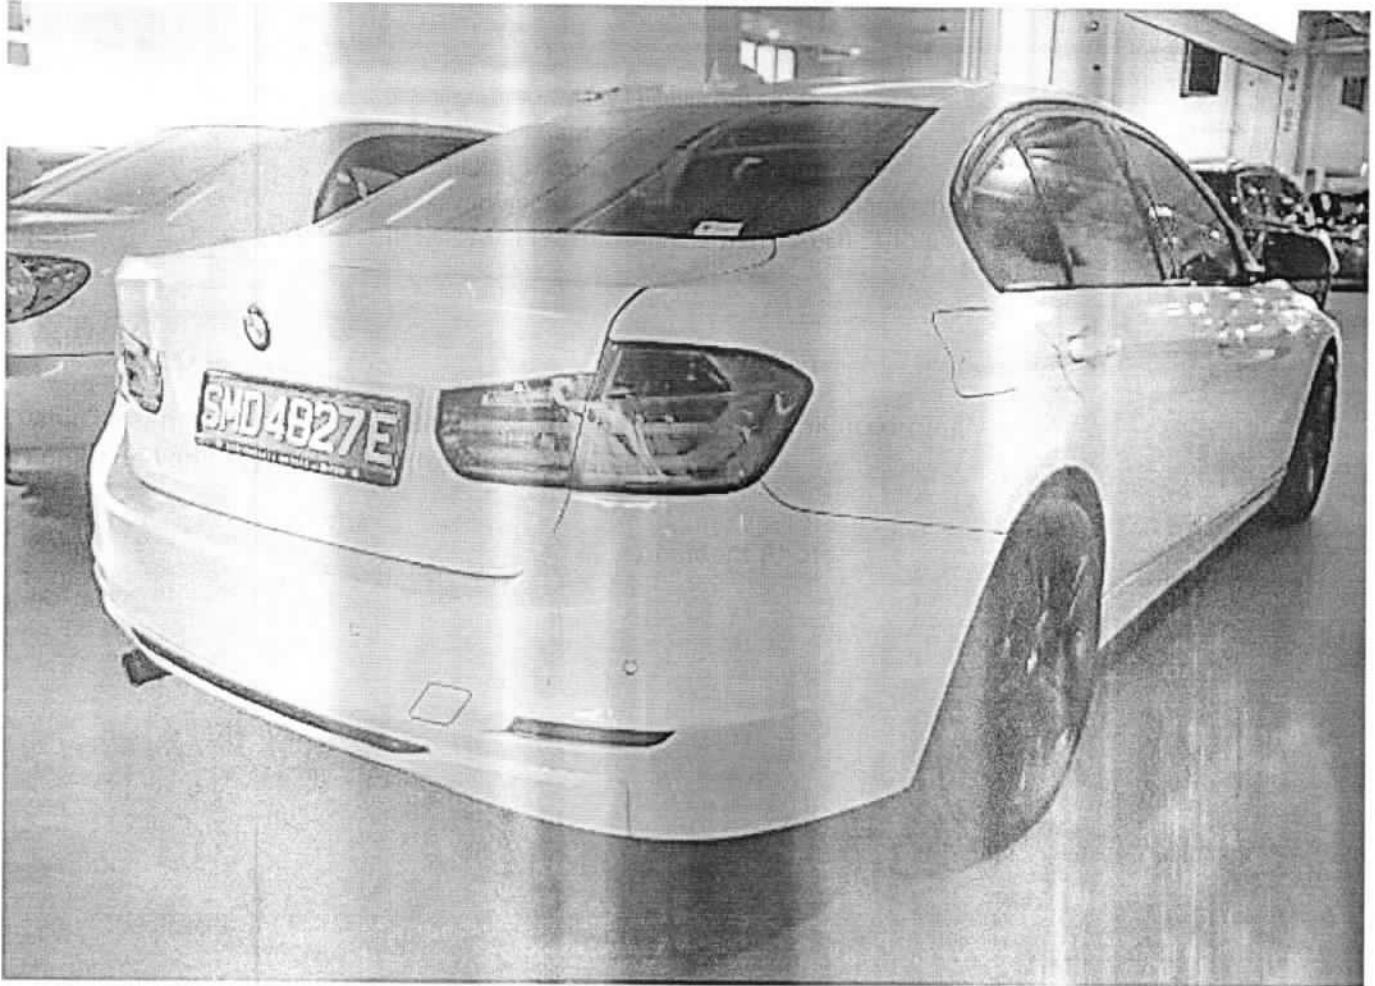
**Accident Photo**

TP vehicle seems unscathed, please adjust cost of repairs - S\$4.5K accordingly.  
LOD uploaded and rights granted to you in Merimen.

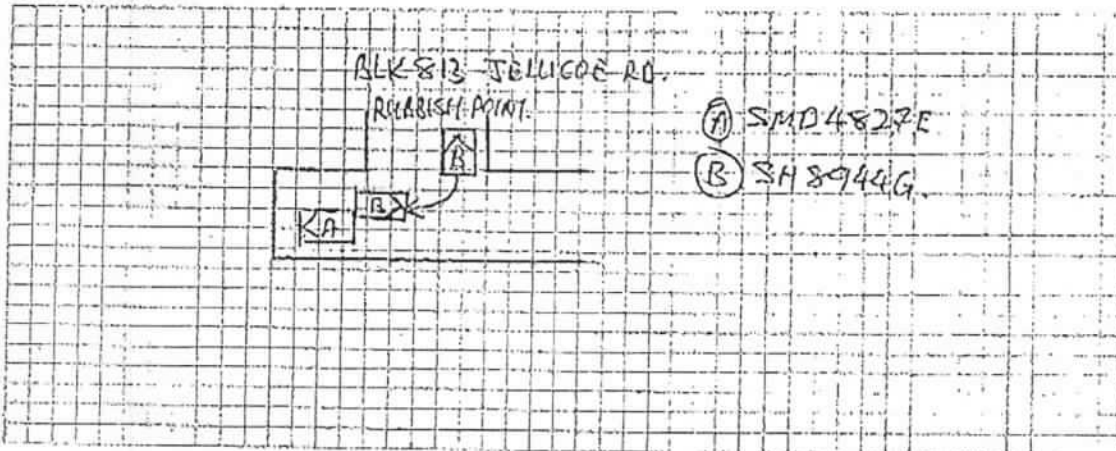
## SKETCH PLAN

MY CAR WAS PARKED STATIONARY. A TAXI SH8944G THEN  
REVERSE AND HIT INTO MY CAR REAR RH SECTION
