#### ESTIMATE REPAIR BILL FOR KIA OPTIMA REGN NO: SHB 8586 T

CS/INC19017294/K1qf3n2

# DAMAGE ASSESSMENT REPORT

# ADJUSTMENT ON REPAIR COST FOR VEHICLE NO. SHB 8586T

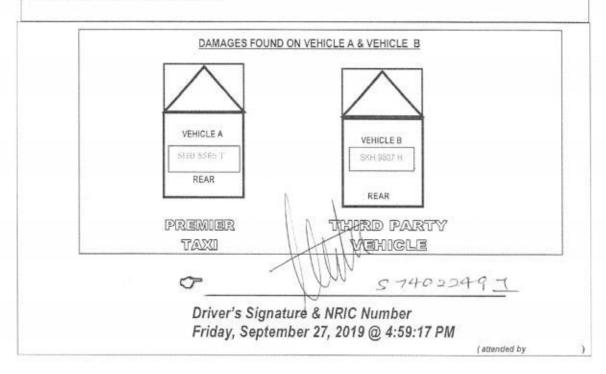
ON 27/09/2019 @ 0045HRS, I WAS DRIVING MY TAXI (SHB 8586 T) - ALONG LOYANG AVENUE SLIP ROAD WHEN I STOP TO CHECK FOR ONCOMING VEHICLES TOWARDS PASIR RIS DRIVE 3 WITH ONE PASSENGER ONBOARD.

MOMENT LATER WHILE STATIONARY, SUDDENLY I FELT AN IMPACT FROM THE REAR. VEHICLE B ( SKH 9807 H) COLLIDED ONTO MY TAXI'S REAR PORTION.

DUE TO THE IMPACT, MY TAXI DAMAGES ON THE REAR PORTION AND VEHICLE B HAVE DAMAGES ON THE FRONT PORTION.
