GOLDBELL CAR RENTAL PTE LTD
C/o 10 Hoe Chiang Road #13-03A Keppel Towers Singapore 089315
ACCIDENT INVOLVING SLC 4048D AND **SMG 9742S** AT PLAZA SINGAPURA
CARPARK ON 01.09.2019

DAMAGED VEHICLE (SLC 4048 D) INSPECTION REPORT (WITHOUT PREJUDICE)

ASSESSMENT OF REPAIRS AND SPARE PARTS COSTS FOR VEHICLE NO: SLC 4048 D

VEHICLE DAMAGE INSPECTION REPORT

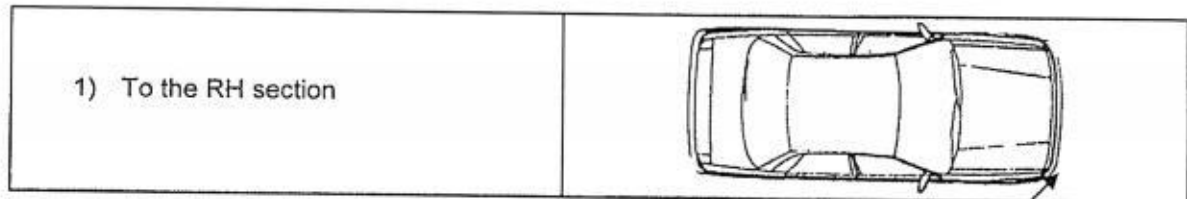
(E) Point of Impact

The impact of the collision has damaged/affected the front bumper cover, headlamp assembly and etc.

Our adjusted cost of lump sum repair is **\$1,600.00** and an estimated **3** days is required to repair the vehicle. Please refer to the Annex for a detailed account of the cost estimates.
