TP / CS / TP19017311 / kyf307

ESTIMATE TO REPAIR TOYOTA NOAH 1.8X - SMH4657H

4. Description of Damages			
THE VEHICLE SUSTAINED DAMAGES AT THE REAR PORTION. DAMAGES SEE DETAILS.			
5. General Information			
Accident Date	28/09/2019	Inspection Date	01/10/2019
Survey held at	HUI YANG MOTOR PTE LTD BLOCK 176 SIN MING DRIVE #04-02 SIN MING AUTOCARE SINGAPORE 575721		
5a. Remarks

ADJUSTMENT ON REPAIR COST FOR VEHICLE NO. SMH 4657H

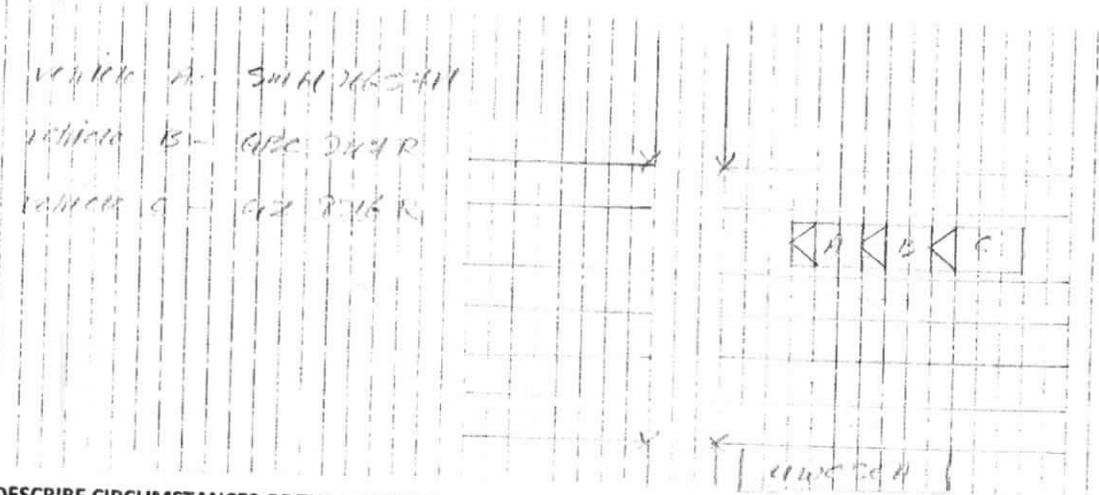
SKETCH PLAN

on 28/09/2019 @ about 18:20hrs, I vehicle A SMH 265711 was travelling along Tompkins Ave to take Bartley Rd east to drop off my passengers. while waiting @ the cross junction of Tompkins Ave to Ave 5 & Tompkins and Ave 3 for the traffic light to turn green.

Suddenly, I felt a very huge impact from the rear & look into the rear view mirror then realise that vehicle B GBC 247R had collided onto my vehicle.

After I get off from vehicle to check on the damage then to realise that vehicle C GZ 926R had hit into vehicle B which lead to a chain collision.
