Estimate To Repair SH3031Z - Toyota **PRIUS TAXI**
Chassis No : JTDKN36U201822198

ACCIDENT BETWEEN SH 3031Z(TP) & GY 9645R (AIG) ON 28/09/2019

VEHICLE DAMAGE INSPECTION REPORT

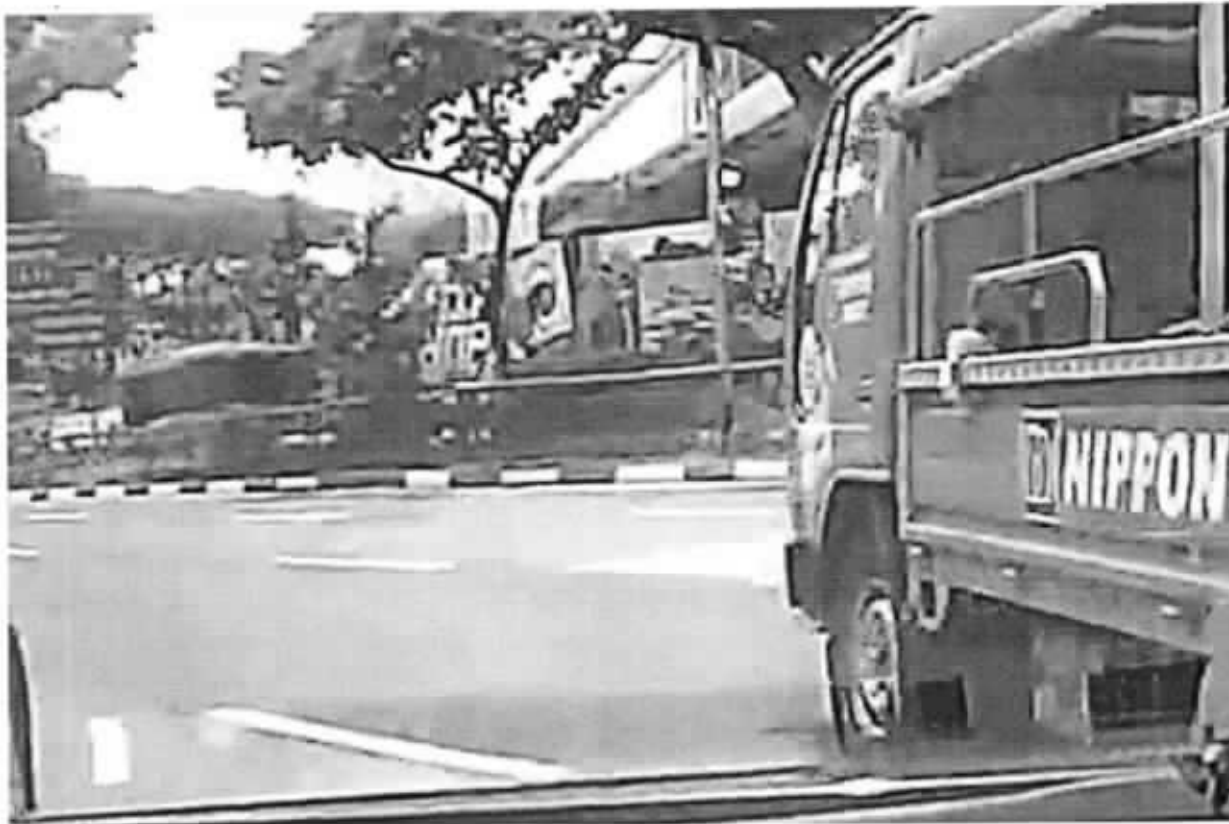
Can request longer video footage from TP, e.g. few seconds prior accident?

Wish to confirm on the road, as you can see the land marking, was inconclusive.

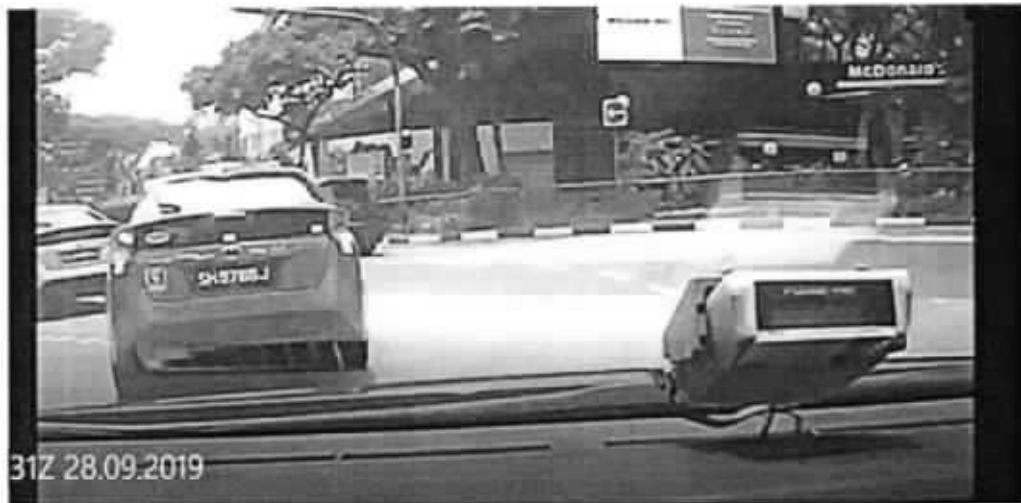
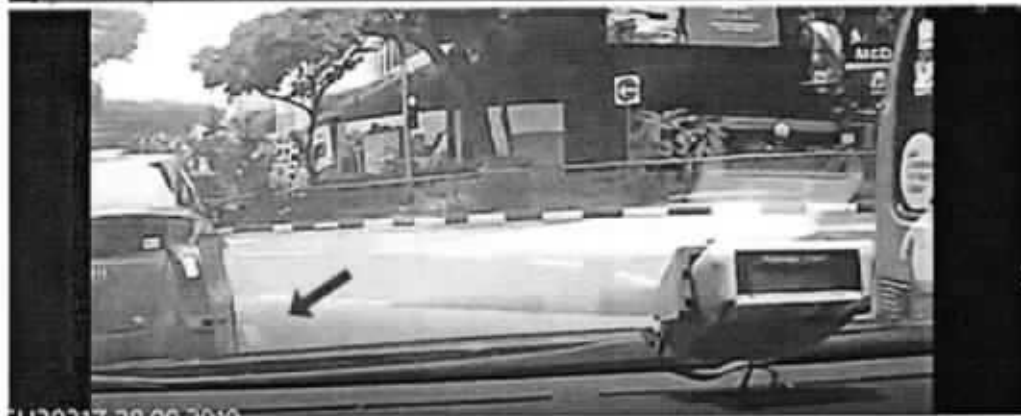
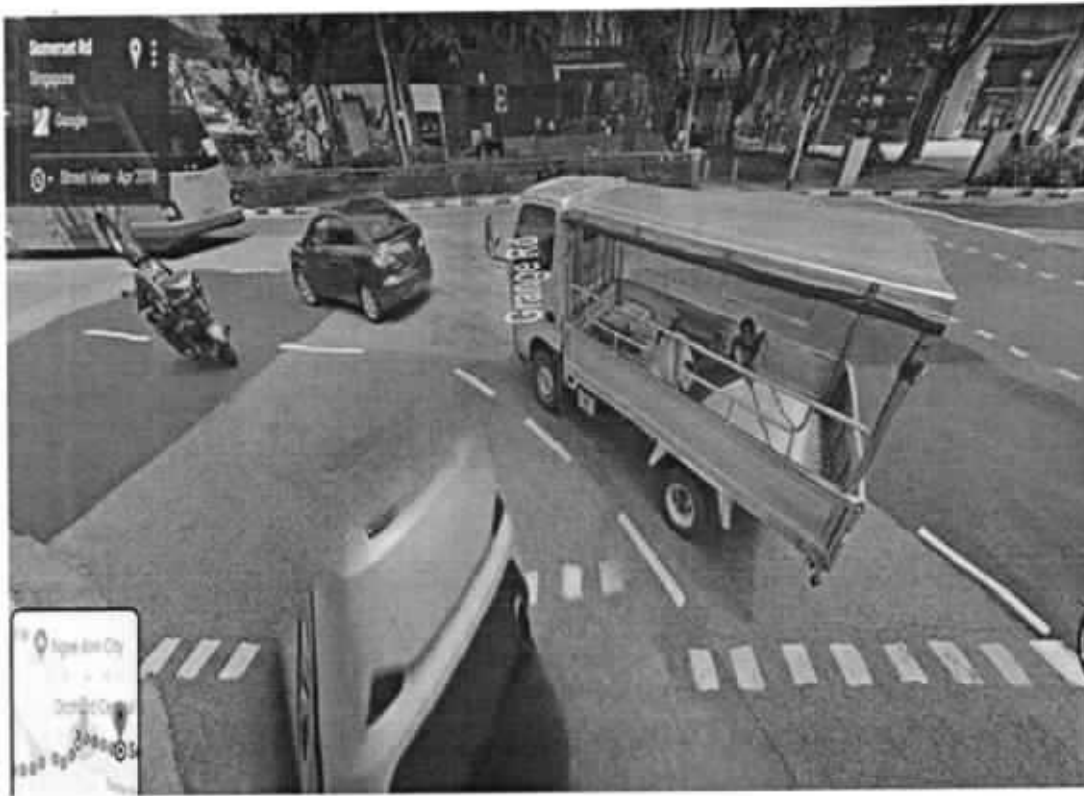
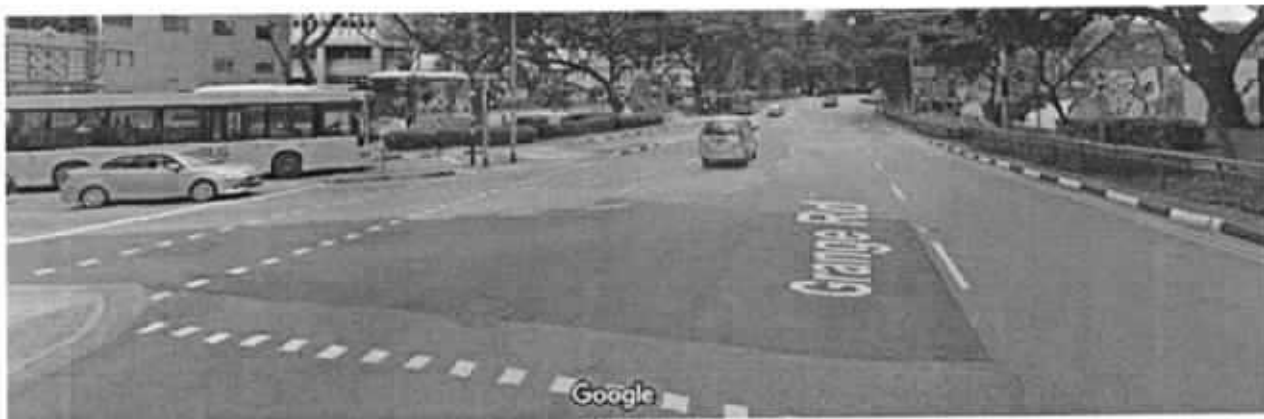
However, based on the video footage provided by third party, we noted that third party was changing lanes and had encroached into our Insured's path whom was travelling in his own lane.

We append below the screenshots taken from the accident video to show the lane marking and also google map screenshots on the lanes for your easy reference:

As such, we suggest to reject Third party's claim for changing lanes without proper lookout and encroaching into our Insured's lane.
