NEW OD CLAIM - FBK6195A

ASSESSMENT FOR REPAIR: HONDA CB400SF MANUAL - FBK6195A

VEHICLE DAMAGE INSPECTION REPORT

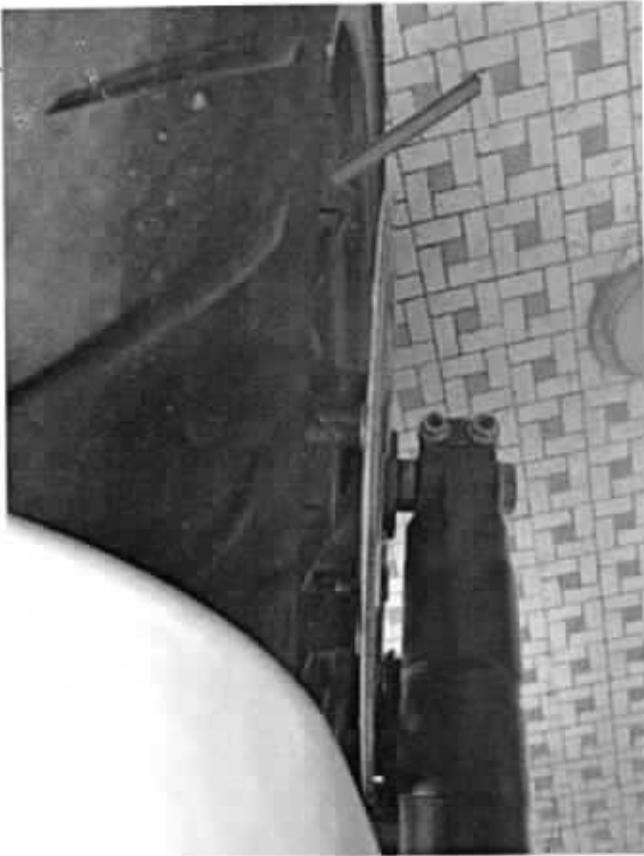
1. The left front wheel was hit by the car while reversing. During operational test the front left disc was grinding against the left front brake caliper, which caused the left front brake disc warped. Refer to Refer to the arrow in the photo below.

- 1) The left front wheel was hit by the car while reversing. During operational test the front left disc was grinding against the left front brake caliper, which caused the left front brake disc warped. *Refer photo 47, 48*
- 2) The impact from the fall caused the bike to be misaligned. The left fork ~~which~~ does not warrant a replacement. Labour was provided. *How*
- 3) The impact hit the front wheel rim, the white mark is not a scratch mark, the rim was grazed hence stated as repair. *Refer to photo 47-48*. The impact onto the bike was at the left side of the front wheel as there were no impact damage observed on the left side of the bike

1) The left front wheel was hit by the car while reversing. During operational test the front left disc was grinding against the left front brake caliper, which ~~was~~ the left front brake disc is warped. *caused*

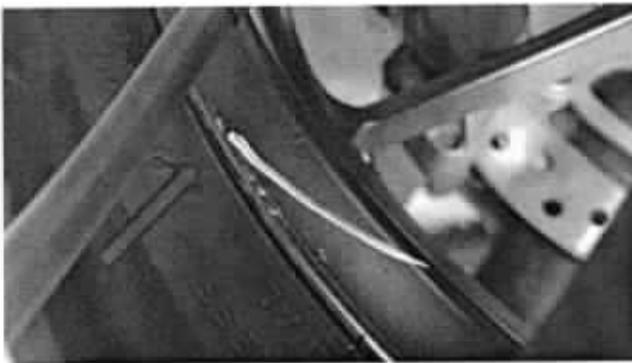
2. The impact from the fall caused the bike to be misaligned. However the left fork does not warrant a replacement. Labour was provided.
3. The impact hit the front wheel rim, the white mark is not a scratch mark, the rim was grazed hence stated as repair. Refer to the arrow in the photo below.

- Left fork does not warrant a replacement
- Rim was grazed hence stated as repair

2) The impact from the fall caused the bike to be misaligned. The left fork ~~was not possibly bent~~ *which does not*

3) The bumper hit the front wheel ^{rim} the white mark is not a scratch mark. *the rim was grazed here stated as repair.*
