Vehicle No	: FBM958U	Accident Date	: 02/10/2019
Make	: YAMAHA SNIPER	Policy No.	: 1900115577
Assignment Date	: 07/10/2019	Excess	: S\$300.00
Date of Inspection	: 07/10/2019	Est. Duration of Repair	: 2.00
Inspection At	: BIKE PRODUCTION (HQ) NO 610 SERANGOON ROAD SINGAPORE 218216

ASSESSMENT FOR REPAIR: YAMAHA SNIPER T150 - FBM958U

VEHICLE DAMAGE INSPECTION REPORT

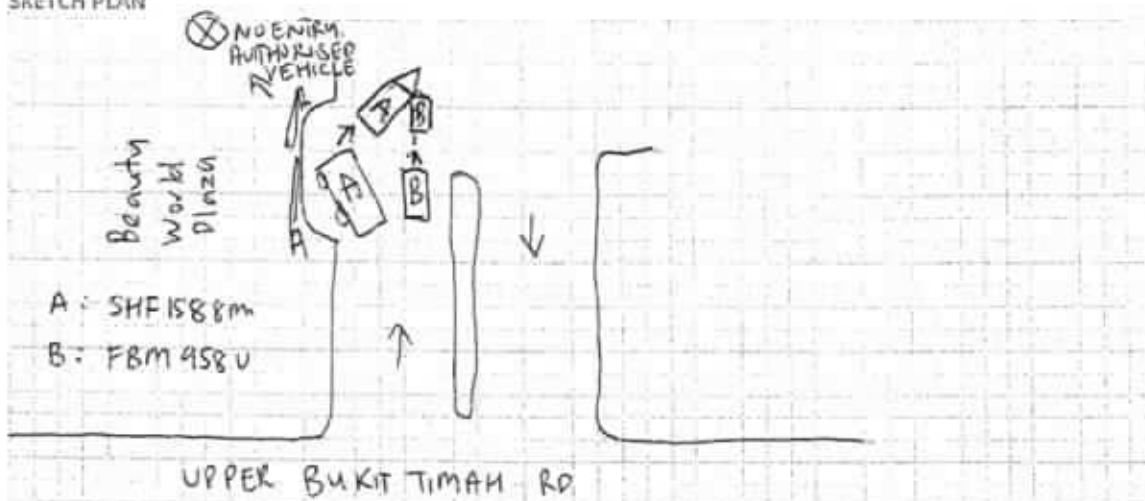
SKETCH PLAN

On 02/10/2019 at about 2050hrs I was riding along the road in front on Beauty world plaza. suddenly a Green Taxi Reg: SHF1588M came of from the divider between the straight road and Beauty world plaza and his front right bumper collided onto the side of my motorcycle, as the impact is too big, I fell off my motorcycle. My motorcycle suffered serious damage and I was conveyed by the ambulance to Ng Teng Fong General Hospital. I was given 5 days of medical leave. Traffic Police was at scene.
I wish to state that I am riding at a very slow speed at about 30km/h at that point of time before the accident.
