Report Reference : TP / 19002-09/AY / 2019  
Date of Report : 23 Sep 2019

## THIRD PARTY SURVEY ACCIDENT HAPPENED ON 31 Aug 2019

**1. Policy Particulars :- THIRD PARTY CLAIM**

### ADJUSTMENT ON REPAIR COST FOR VEHICLE NO. SKZ 4065U

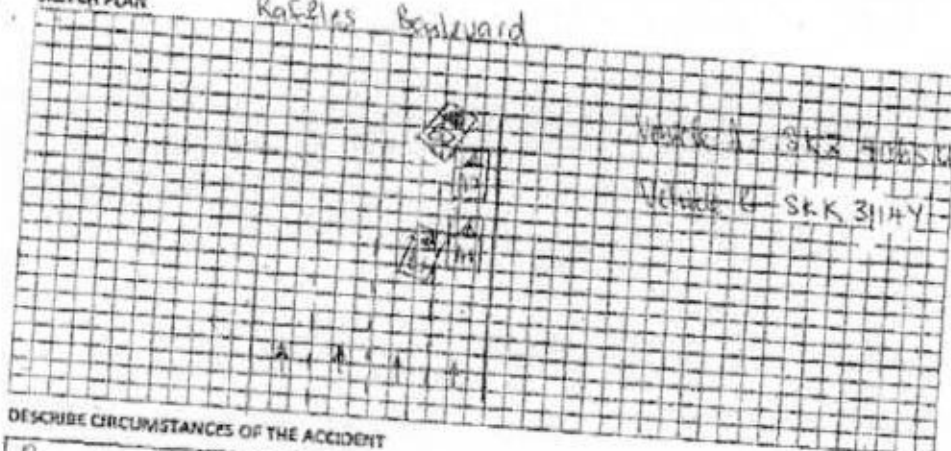
Sketch Plan #2 Pg. 1

On the stated date and time, at the stated venue my vehicle 'A' SKZ 40654 was travelling straight on my rightful lane on the extreme right lane. Suddenly vehicle 'B' SKK 31147 travelling on my left cut onto my lane and hit onto my front left portion, then he moved forward his rear right portion hit onto my front left portion again. Total double impact on my front left portion of my vehicle.
