VEHICLE DAMAGE INSPECTION REPORT

Our File No: CS/TMI19017680/K1YD3S2
Date: 31/10/2019

Claimant Vehicle No: SHA2207H

Reg No: **SHA2207H**
Make & Model: TOYOTA PRIUS HYBRID, 1.8 (A)
Reg. Date: 13/12/2018 (Man. Year: 2018)
Colour: Blue
Engine Capacity: 1798 cc
Market Value/New Car Price: N/A
Sum Insured (\$\$): **Market Value/New Car Price**

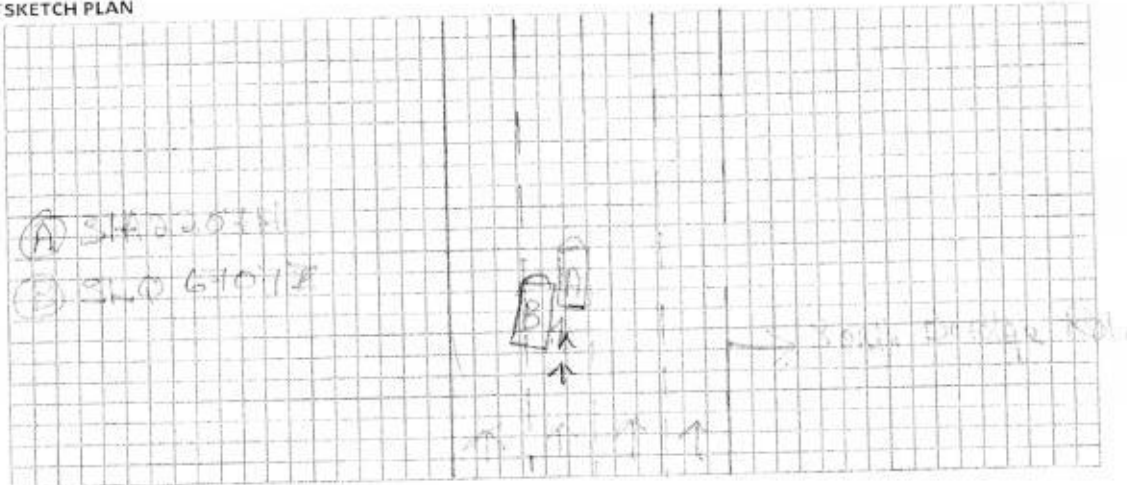
SKETCH PLAN

On 5/10/2019 at about 2030 hrs, I vehicle A was driving my taxi along South bridge road toward Neil Rd. while I was in my lane going straight, vehicle B on my left come into my lane, but I can't avoid him then I going straight brush against vehicle B
