REF: CS / C7219017760 / Hsf36 Special Instruction: etc

To Inspect Vehicle No: SMG 5503 S Insured: PC 643P

Dear Sir / Madam,  
PRE-REPAIR INSPECTION FOR SMG5503S  
ACCIDENT INVOLVING PC643P AND SMG5503S ON 02.10.2019.

## VEHICLE DAMAGE INSPECTION REPORT

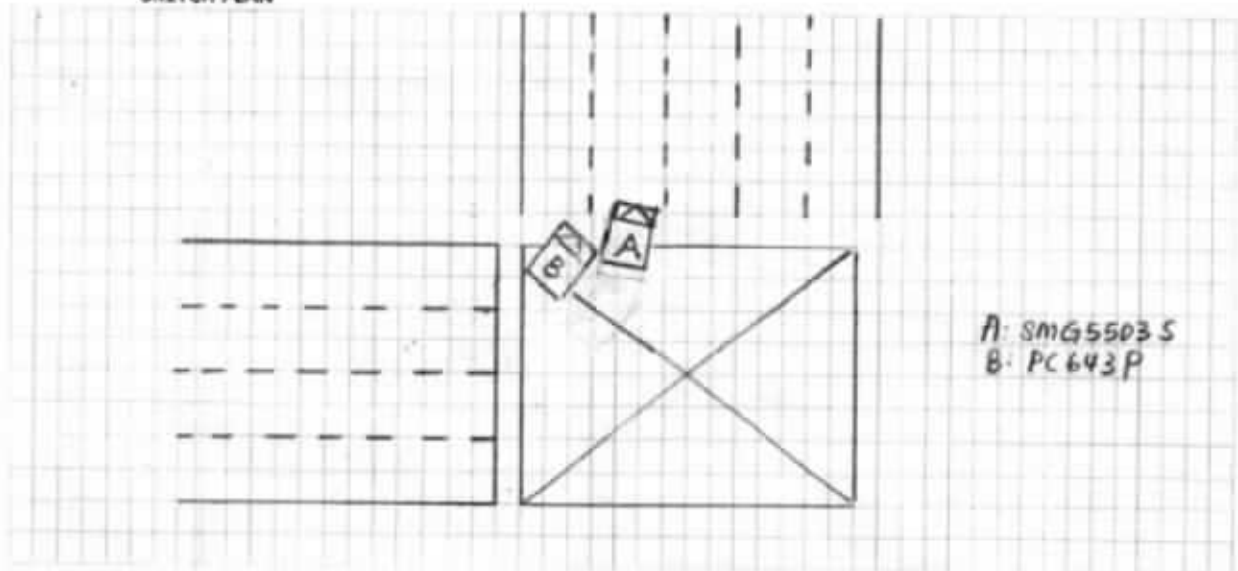
## SKETCH PLAN

I was travelling along Cecil Street turning to Cross Street passing by vehicle B which was beside me. When turning, I kept it on my lane. Out of sudden, I felt an impact from my left. Vehicle B which was turning misjudged and collided onto my vehicle.
