Preliminary Advice

Insured Vehicle No	: SKR8981R	Accident Date	: 02/10/2019
TP Vehicle No	: YP2977M	Assignment Date	: 09/10/2019
Make	: MITSUBISHI CANTER	Est. Duration of Repair	: 2.00
Date of Inspection	: 14/10/2019		
Inspection At	: MOVA AUTOMOTIVE PTE LTD (BUKIT MERAH) BLK 1008, #01-04/06/08/94, BUKIT MERAH LANE 3 SINGAPORE 159722

VEHICLE DAMAGE INSPECTION REPORT

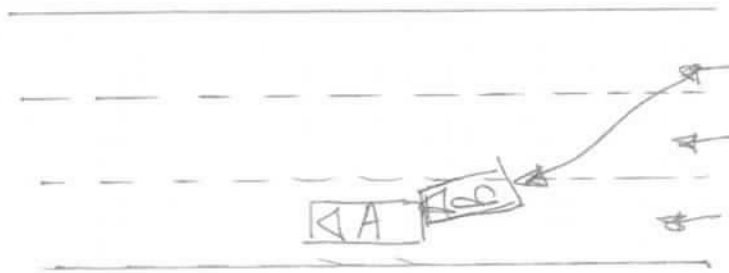
Sketch Plan Pg. 2

Along ECP towards Changi (3.5 to 4km)

A= YP2977M

B= SKR 8981R

I was travelling straight on the extreme left lane of a 3-lanes road, along ECP going towards Changi. When suddenly I felt a great impact from behind. When I alighted, I discovered that Ven B had rear ended my vehicle. Nobody was reported with injuries at the accident scene. That's all.
