OD/FP Re-inspection / Evaluation

To inspect Vehicle No: SLQ 137H Insured: SLL 3570 X

6-vehicle chain collision on 03.10.18

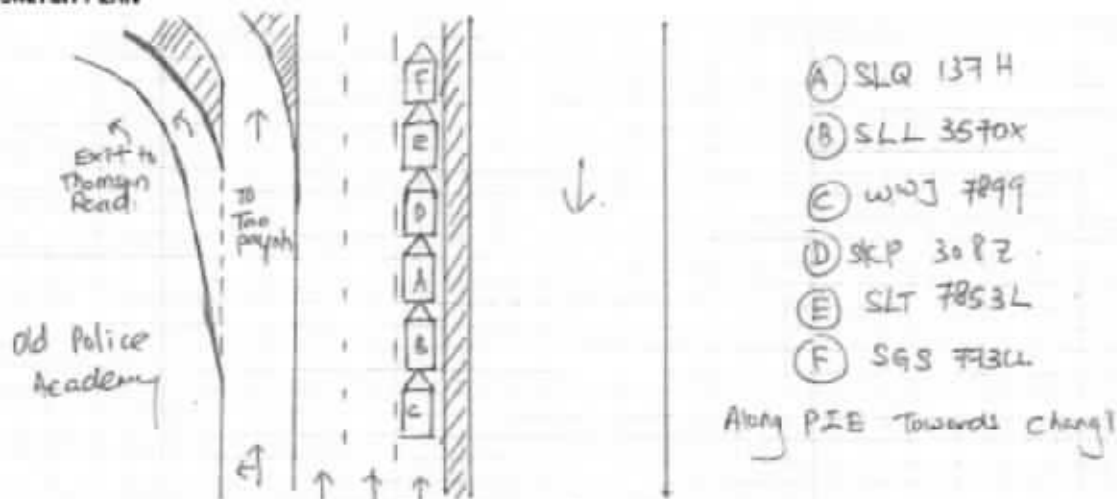
Sketch Plan #2

On 03 Oct 2018 @ about 1630hrs, I was driving my car (SLQ 137 H) along PIE Towards Changi (Near Exit to Thomson Road, Tanjong Pagar, Old Police Academy). In extreme right lane, vehicle in front of me has stopped, so I slow down & stop in time too. Suddenly I felt an impact from behind, due to the huge impact, my car being pushed forward and collided onto rear portion of vehicle in front of me. soon the next impact from behind and collided onto rear portion of my car again. I then came out to inspect my car & I realized that I was involving 6 cars chain collision accident. My mobile phone was spoiled after the impact from this accident so I borrow a mobile phone from vehicle D (SKP 3082)'s driver to contact my son and try to capture some accident scene photos. However, I was fainted after that and conveyed to Tan Tock Seng Hospital by ambulance. I was discharge from hospital on dated 05-10-2018 and was given 17 days MC. I hereto lodge this report to claim against vehicle B (SLL 3570X)'s Insurance for my accident damages, belonging damages, medical expenses & injury. Herewith attached my mobile phone's damaged photos, hospital discharge summary & MC for insurance claim purpose.

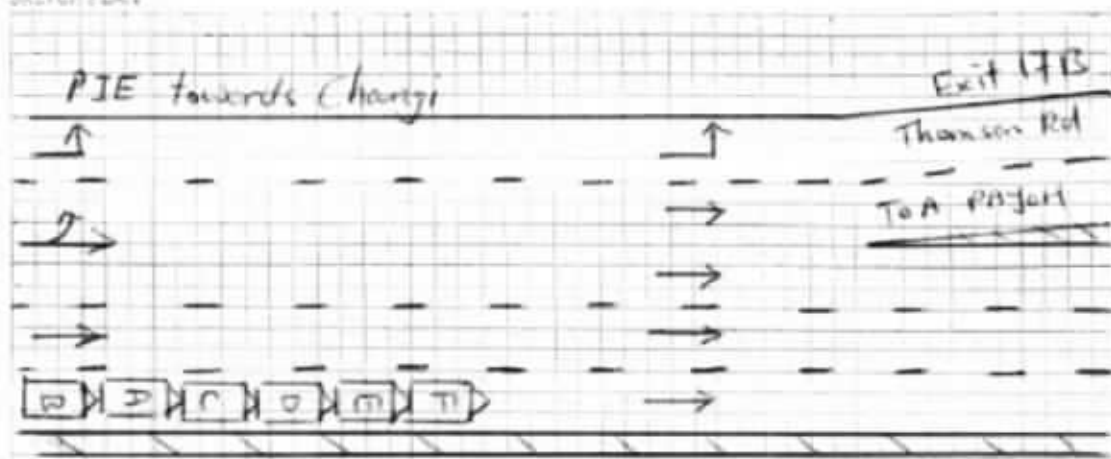
Accident Sketch Plan

- (A) SLL 3570X
- (B) WWJ 7899
- (C) SLQ 137H
- (D) SKP 308Z
- (E) Unknown
- (F) SGS 773U
