Preliminary Advice

Vehicle No	: SKN9549X	Accident Date	: 03/10/2019
Make	: VOLVO S60	Policy No.	: DMPCSN3034951804
Assignment Date	: 10/10/2019	Excess	: S\$0.00
Date of Inspection	: 10/10/2019	Est. Duration of Repair	: 9.00
Inspection At	: SNG AH TEE MOTOR & PANEL SERVICE PTE LTD (PIONEER) BLK 3 PIONEER ROAD NORTH, #01-18 SINGAPORE 628457

VEHICLE DAMAGE INSPECTION REPORT

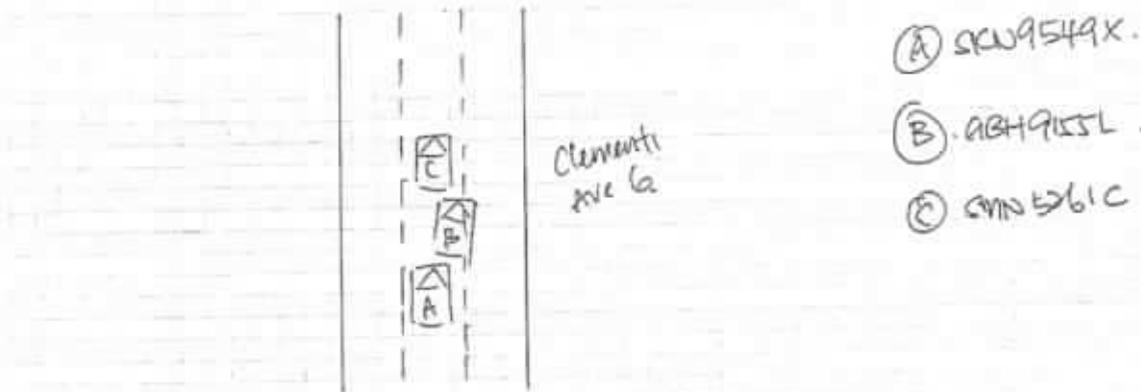
SKETCH PLAN

ON 03/10/2019 AT AROUND 0730HRS, I WAS TRAVELLING ALONG CLEMENTI AVE 6. WHILE DRIVING ALONG THE ROAD THE TRAFFIC IS HEAVY AND I ON MY LANE STRAIGHT AND VEHICLE B WAS IN FRONT ME AND FILTER TO RIGHT LANE, BUT HE MAKE A HARD JAMMED BRAKE WHEN HE HAD ALREADY MOVE OUT TO THE RIGHT AND BY THE TIME I APPLY MY BRAKE ITS ALREADY TOO LATE AND CAUSED ME HIT ONTO HIS REAR LEFT PORTION. AFTER THE ACCIDENT I WENT DOWN TO CHECK AND FOUND THAT IT ALSO INVOLVED WITH VEHICLE C.

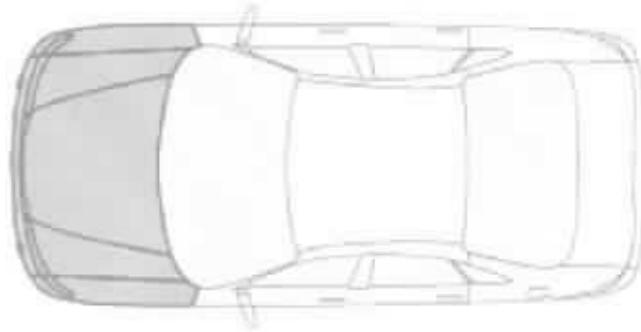
Damage Areas

All
Underbody
