TP Claims against NTUC Income: Follow-Through Survey

NTUC INCOME INSURANCE CO-OPERATIVE LTD Ref: NS/INC19018104/K1sf3n2			
73 BRAS BASAH ROAD #05-01 NTUC TRADE UNION HOUSESINGAPORE 189556		Date: 18-10-2019	 
		Code: INC4

1. Policy Particulars :- THIRD PARTY CLAIM			
Insured Veh.	GBE 3280M	Veh. Inspected	SHD 7193P
Policy No.	5075077936-03	Coverage (\$)	0.00
Claim No.	MT/1067289-001	Excess (\$)	0.00
Assign From		Assign Date	14/10/2019

ADJUSTMENT ON REPAIR COST FOR VEHICLE NO. SHD 7193P

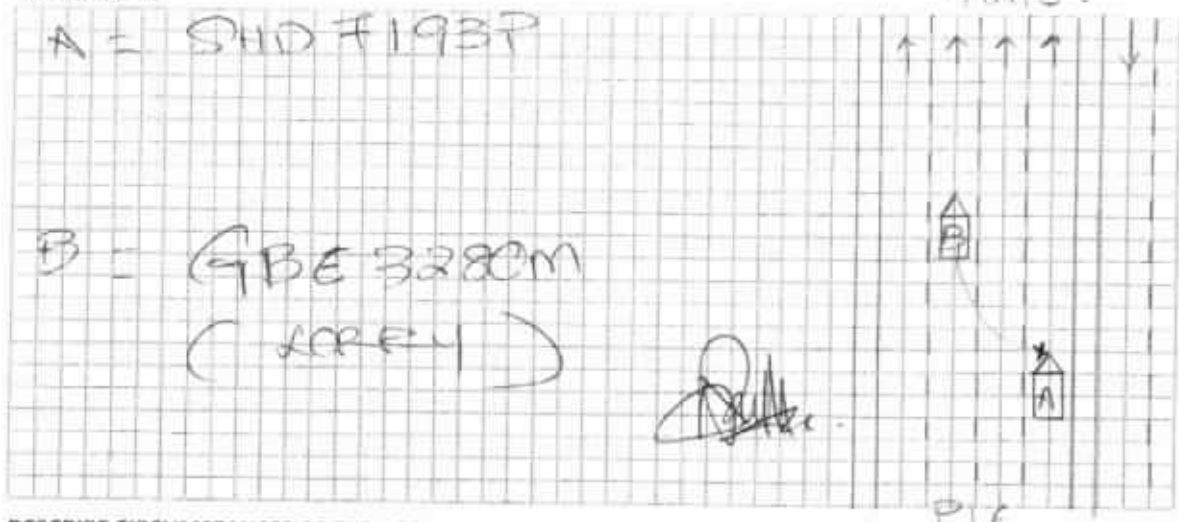
SKETCH PLAN

ON 12/10/19 AT ABOUT 20:20, I WERE DRIVING ON
 P/E TOWARDS TUNE. A METAL OBJECT FELL FROM
 A LORRY (GBE 3280M) AND HIT INFRONT OF MY
 TAXI CAUSING DAMAGE TO MY FRONT TAXI BOTH
 OF US STOP AND CHANGE PARTICULARS. THE LORRY
 DRIVER ADMIT OBJECT CAME FROM HIS LORRY.
