1.		Policy Particulars :	- THIRD PARTY CLAIM			
	Insured Veh.	SLR 9478J	Veh. Inspected	SLJ 1879E		
	Policy No.	DMHCSN3069821902	Coverage (\$)	0.00		
	Claim No.	SNM19D204876/8	Excess (\$)	0.00		
	Assign From		Assign Date	11/10/2019

ADJUSTMENT ON REPAIR COST FOR VEHICLE NO. SLJ 1879E

PHOTOGRAPHS FOR VEHICLE NO. SLJ 1879E

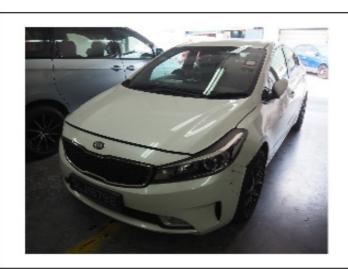
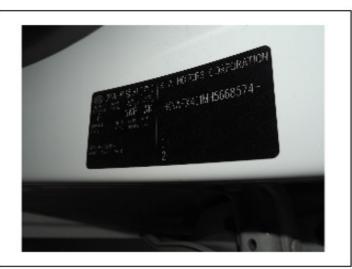
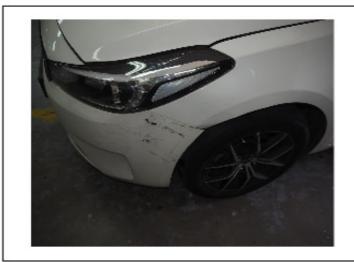
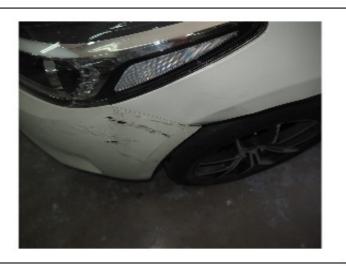
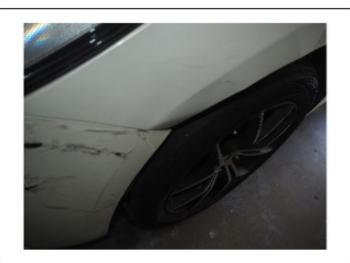
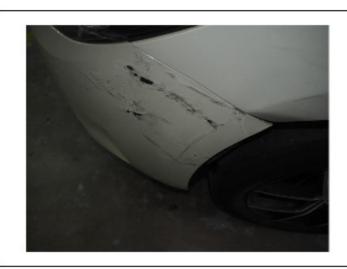
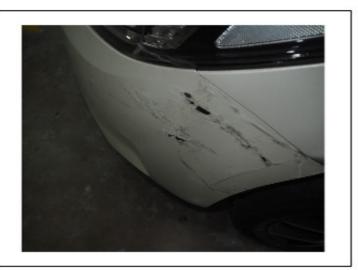
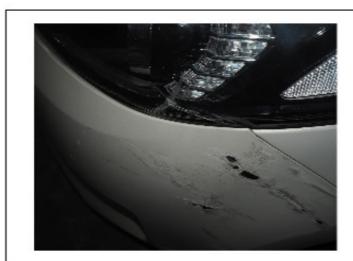
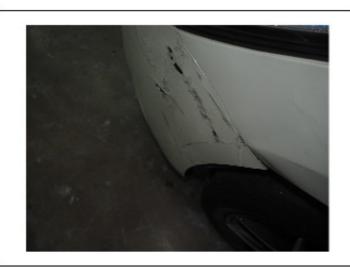
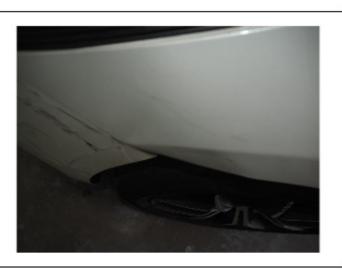
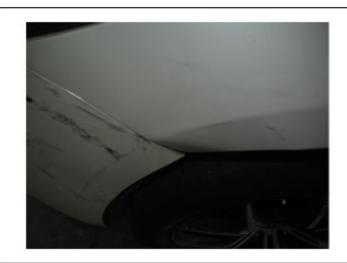
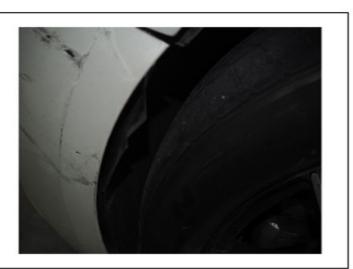
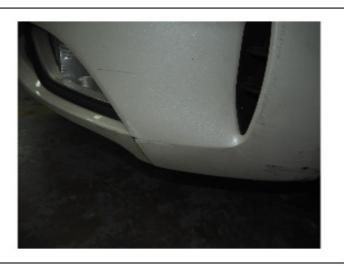
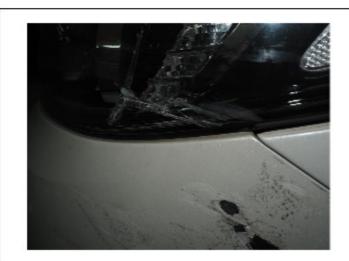
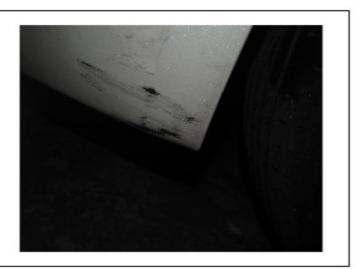
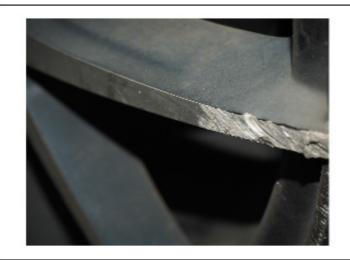
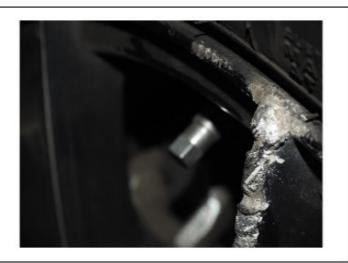
4.		Description	on of Damages			
	THE VEHICLE SU	STAINED DAMAGES AT THE FRO	ONT N/S PORTION.			
	DAMAGES SEE D	ETAILS.				
5.		General	Information			
	Accident Date	09/10/2019	Inspection Date	11/10/2019		
	Survey held at	HUA MENG SPRAY PAINTING \	WORKSHOP			
		1 KAKI BUKIT AVE 6 #01-61 AUTOBAY SINGAPORE 417883				
5a.			emarks			
	A)THE INSPECTION WAS CONDUCTED ON A"WITHOUT PREJUDICE" BASIS. B)IN ACCORDANCE TO YOUR INSTRUCTIONS, WE HAVE NOT AUTHORISED REPAIRS.					
5b.	Estimate Days of Repair					
	ESTIMATED NORI	MAL PERIOD FOR REPAIR:	5 Working Days			
			1

Qty	Description of Parts	Condition	Estimate By Workshop (\$))	Our Adjusted (\$)
	REPLACEMENT OF PARTS			
1	FRONT BUMPER	DEFORMED	702.90	702.90
2	FRONT BUMPER SIDE HOLDER @\$42.40	N/S DAMAGED	84.80	42.40
1	FRONT BUMPER REINFORCEMENT	NOT NECESSARY	545.60	-
1	FRONT BUMPER LH LOWER SIDE GARNISH	DEFORMED	47.10	47.10
1	FRONT BUMPER LH FOD LAMP	CRACKED	266.00	266.00
1	FRONT BUMPER LH FOD LAMP GARNISH	CRACKED	32.80	32.80
1	FRONT BUMPER LOWER CENTRE GRILLE	NOT NECESSARY	134.00	-
1	FRONT BUMPER SPONGE	CRACKED	134.20	134.20
2	FRONT BUMPER BRACKET @\$80.10	NOT NECESSARY	160.20	-
1	FRONT GRILLE	NOT NECESSARY	393.80	-
1	SET FRONT GRILLE CLIPS	NOT NECESSARY	66.00	-
1	FRONT LH HEADLAMP	CUT	1,766.40	1,766.40
1	FRONT LH FENDER	BUCKLED	400.20	400.20
1	FRONT LH FENDER INNER SHIELD	DEFORMED	108.50	108.50
1	SET FRONT LH FENDER INNER SHIELD CLIPS	NECESSARY	66.00	30.00
1	FRONT LH KNUCKLE ARM	BENT	374.00	374.00
1	FRONT LH KNUCKLE ARM BEARING	NECESSARY	132.00	132.00

1	FRONT LH LOWER ARM	BENT	405.20	405.20
1	FRONT LH DRIVE SHAFT	NOT NECESSARY	990.00	-
1	FRONT LH SHOCK ABSORBER	BENT	308.00	308.00
1	FRONT LH LINKAGE	NOT NECESSARY	86.40	-
1	STEERING RACK	NOT NECESSARY	1,012.00	-
1	HEADLAMP LOWER BRACKET	CRACKED	68.50	68.50
	LESS 10% DISCOUNT		-828.46	-481.82
			7,456.14	4,336.38
	SPECIAL NETT ITEMS			
1	FRONT LH SPORT RIM (SN)	CUT	800.00	550.00
1	FRONT LH TYRE (SN)	NOT NECESSARY	300.00	-
			1,100.00	550.00
	I	1

Qty	Description of Parts	Condition	Estimate By Workshop (\$))	Our Adjusted (\$)
	LABOUR			
	TO CHECK WHEEL ALIGNMENT.		100.00	80.00
	REMOVE & REINSTALL FRONT LH SUSPENSION .		400.00	220.00
	REMOVE,REPLACE & REPAIR CONSISTENT TO THE ACCIDENT .		1,300.00	600.00
	RESPRAY PAINTING.		1,000.00	400.00
	TUFF KOTE.		100.00	50.00
			2,900.00	1,350.00
	GRAND TOTAL		11,456.14	6,236.38
