## **PAPER SURVEY OF SGH4000Z**

## AUTOMOBILE ASSESSMENT REPORT

ASSESSMENT OF VEHICLE NO. SGH 4000 Z  
DATE OF LOSS: 15-Dec-2018

## ADJUSTMENT ON REPAIR COST FOR VEHICLE NO. SGH 4000Z

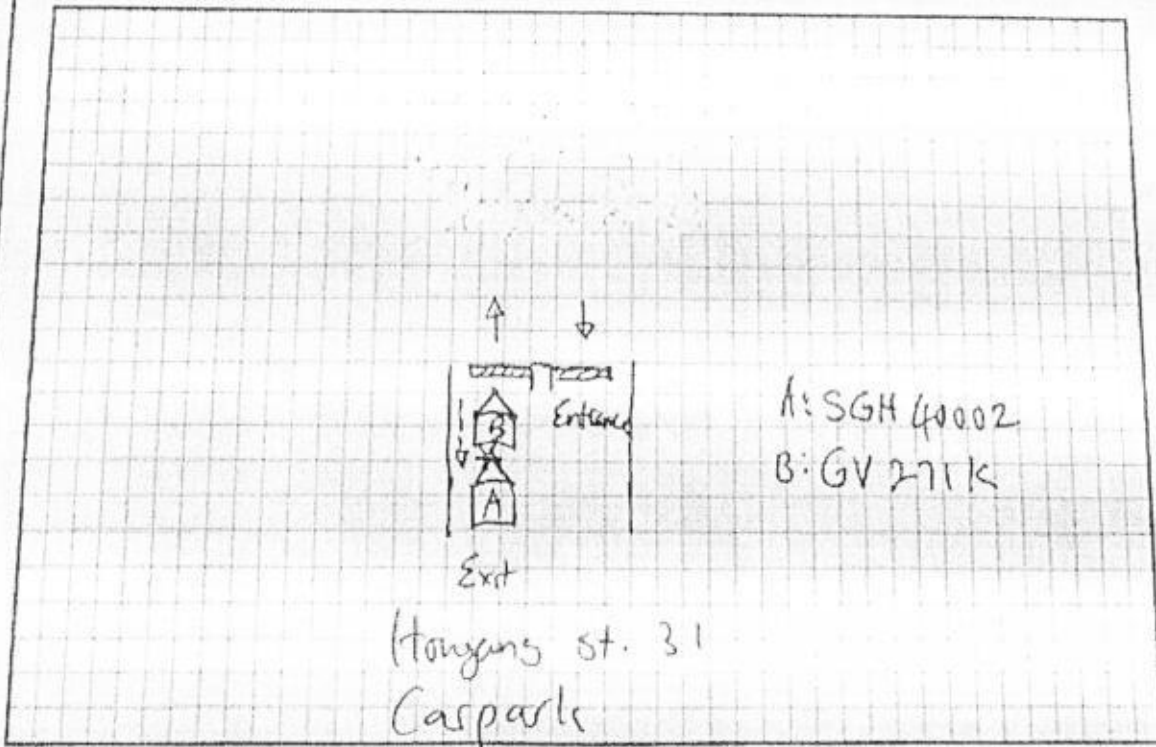
### Sketch Plan

Carpark exit, was queuing behind a van to exit the carpark. Suddenly this van started to reversed and when I saw,I honked to warn the driver. The van continued reversing and as a result bumped directly onto my vehicle front portion. Refer to the video footage.

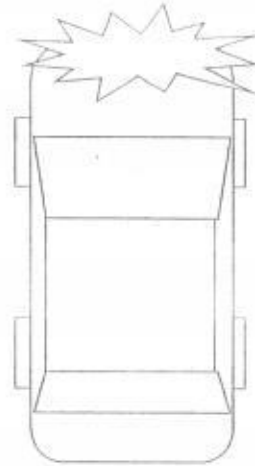
At the time of the inspection, the vehicle sustained damages to the FRONT portion.

Pursuant to your instruction, we have **NOT AUTHORISED** repair.
