## Accident Sketch Plan

## VEHICLE INSPECTION REPORT

Report No. : PAS/TP/0750918

Vehicle Registration No.	: GBG8385B	Engine Capacity (cc)	: 2953cc
Make & Model	: Nissan Cabstar	Mileage (km)	: 11653km
Date of Registration	: 07/11/2017	Chassis / Frame No.	: JN1SC2F24Z0860326
Colour	: Met. Silver	Engine No.	: ZD30026500N

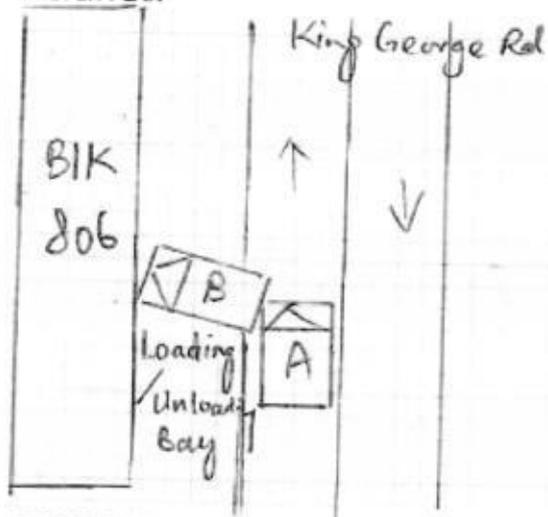
SKETCH PLAN

When I was driving along King George Rd, accidentally hit the rear portion of a parked vehicle: GBG 8385 B (the loading/unloading bay beside BLK 806).

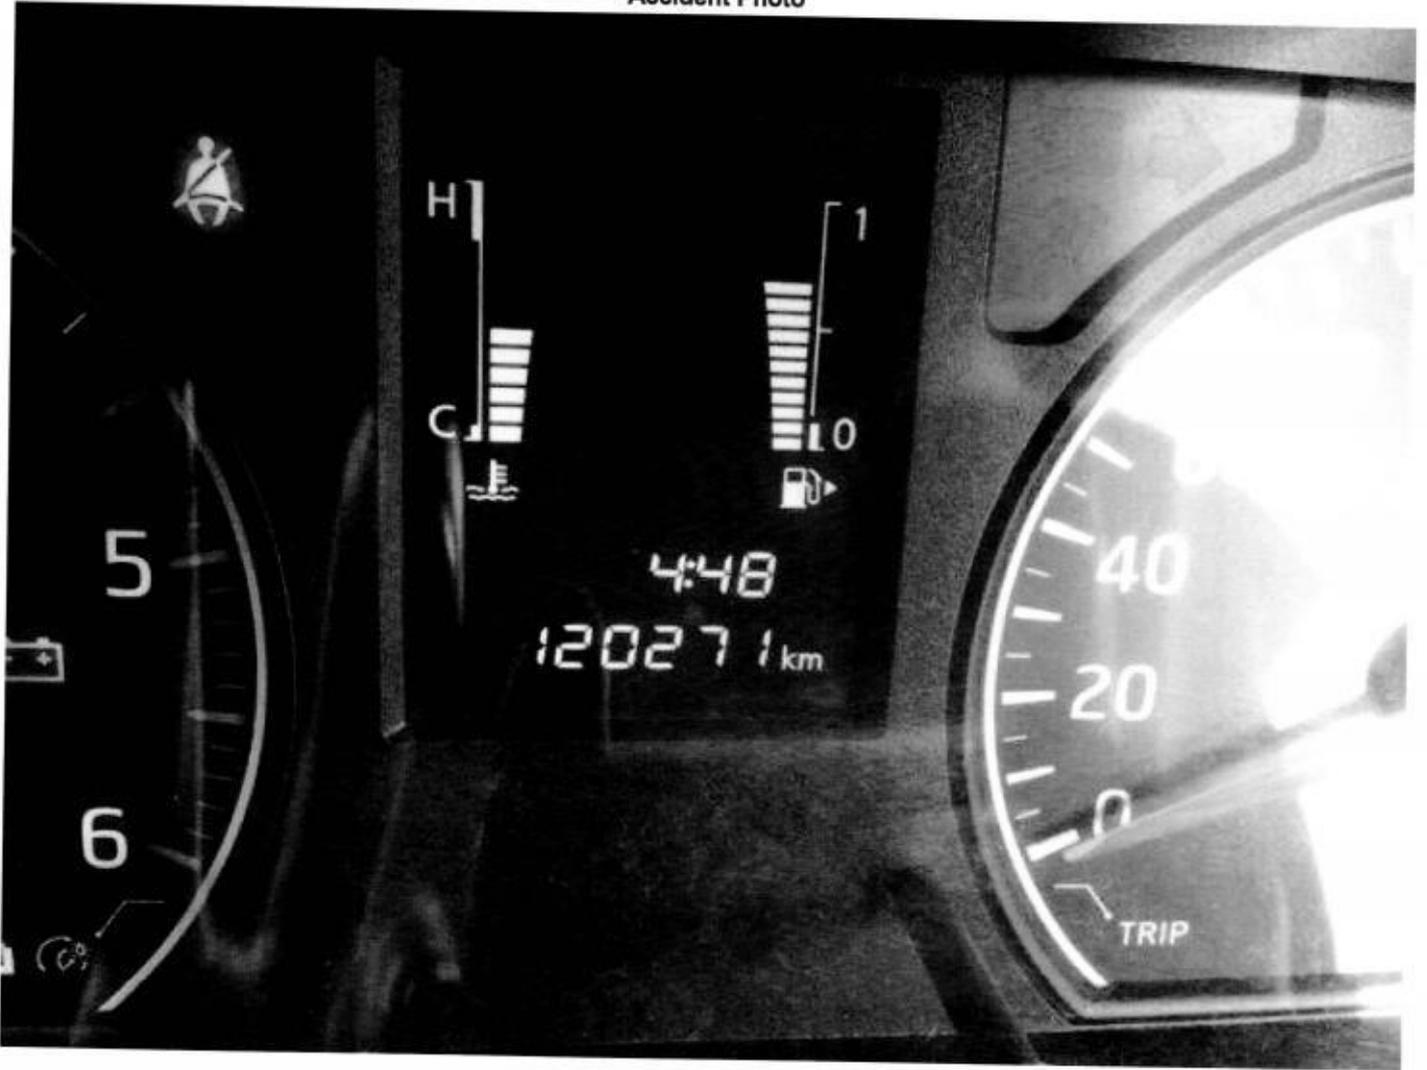
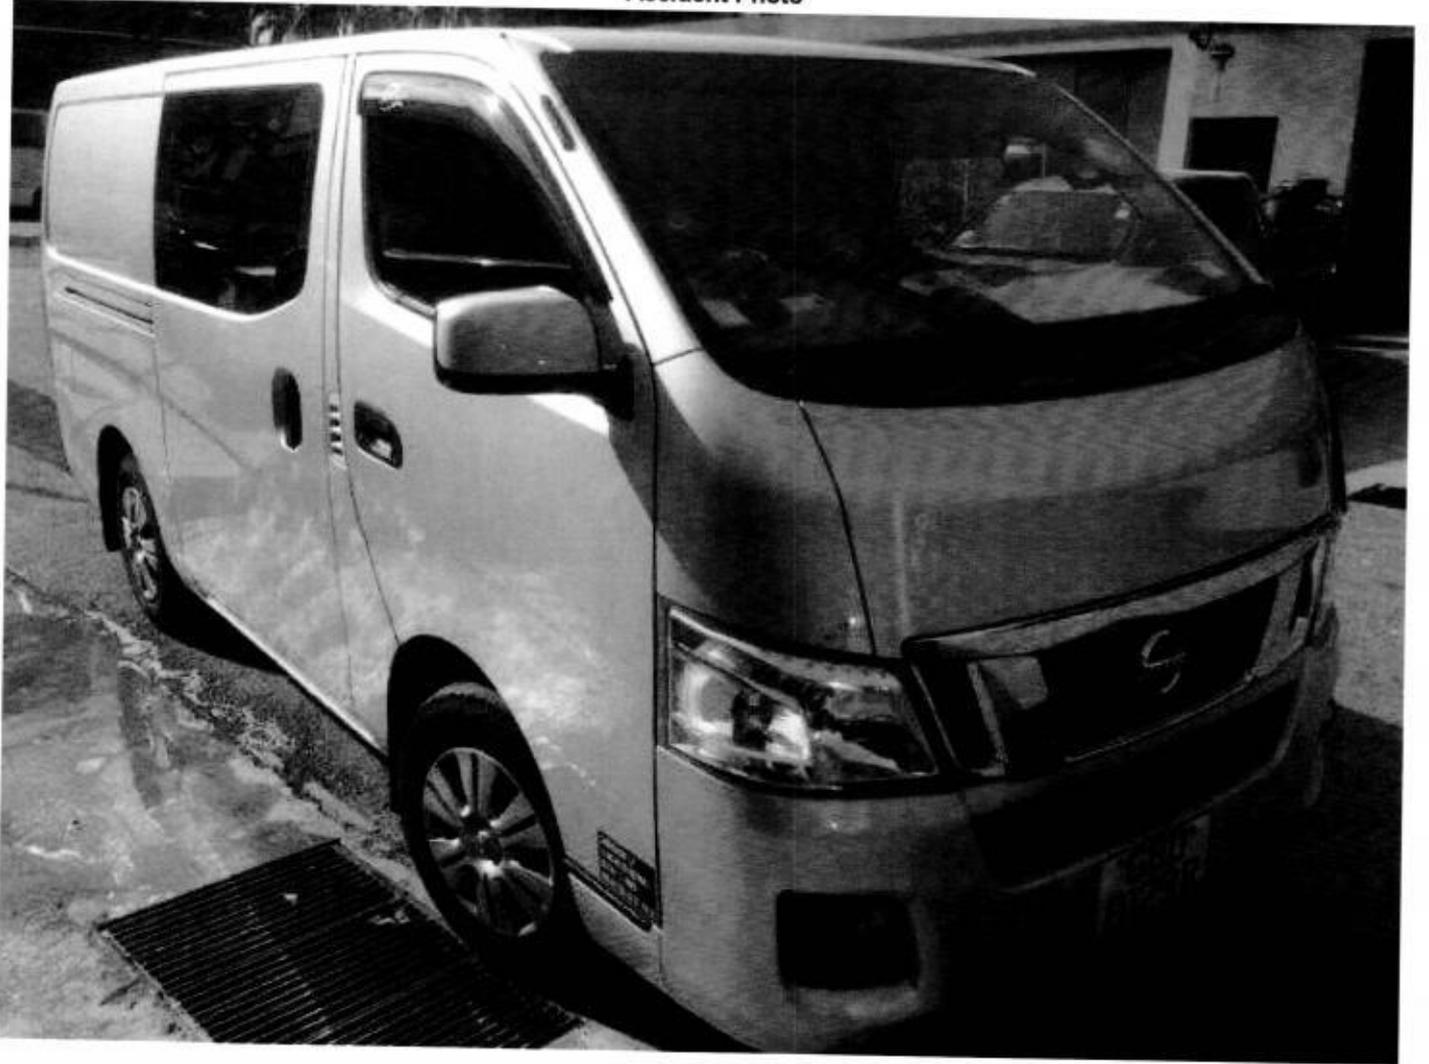
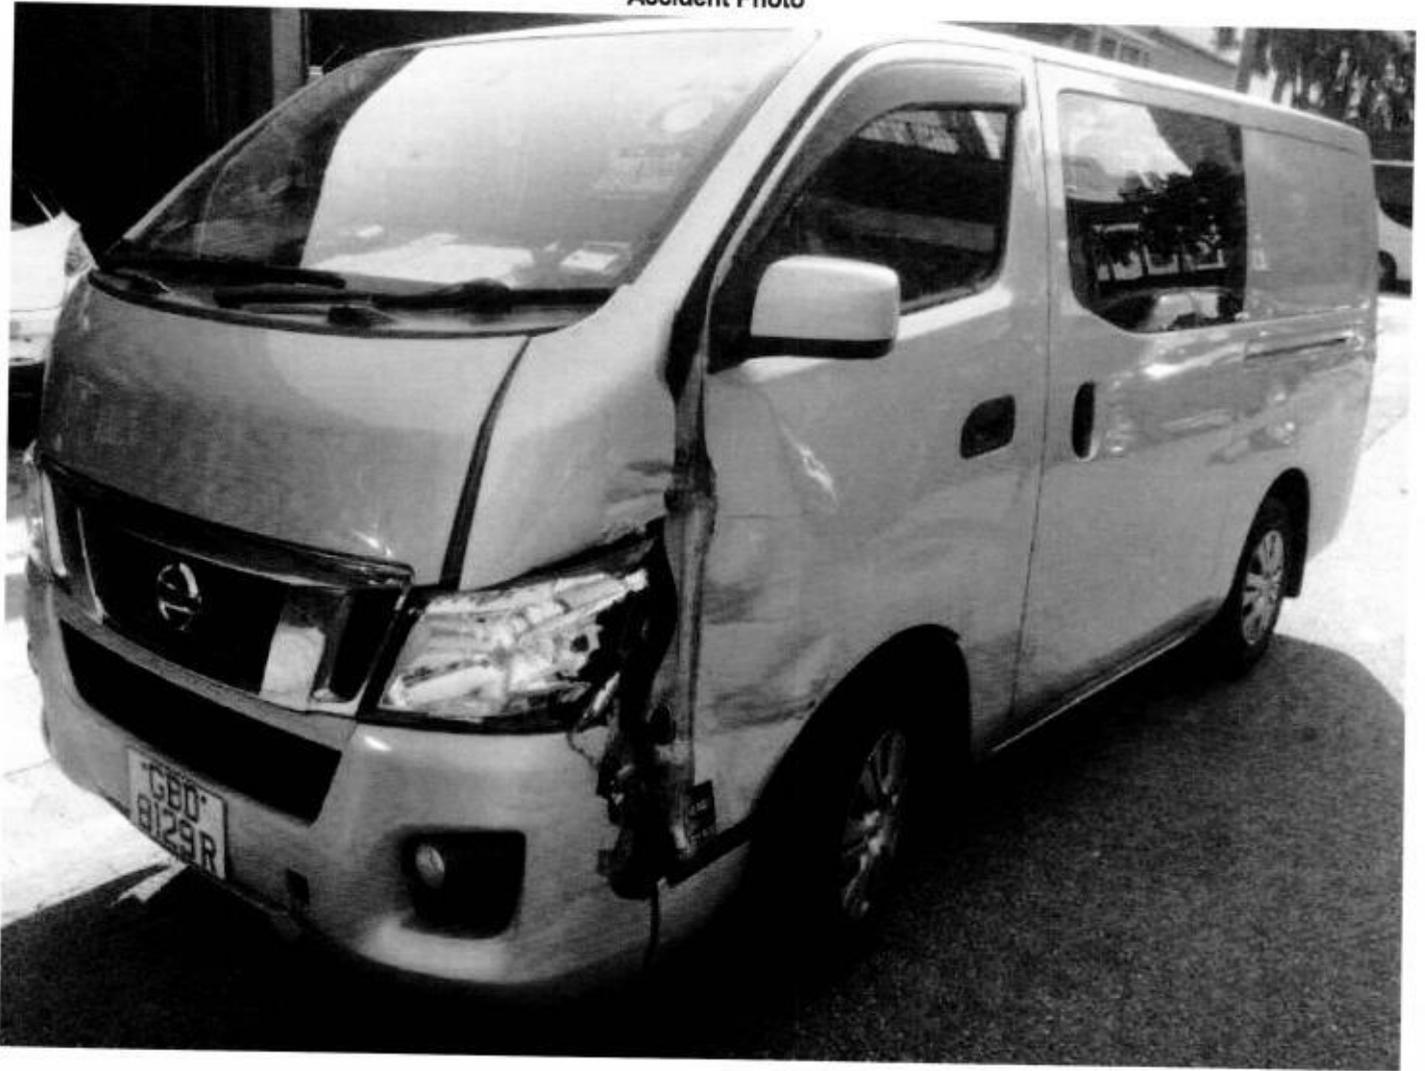
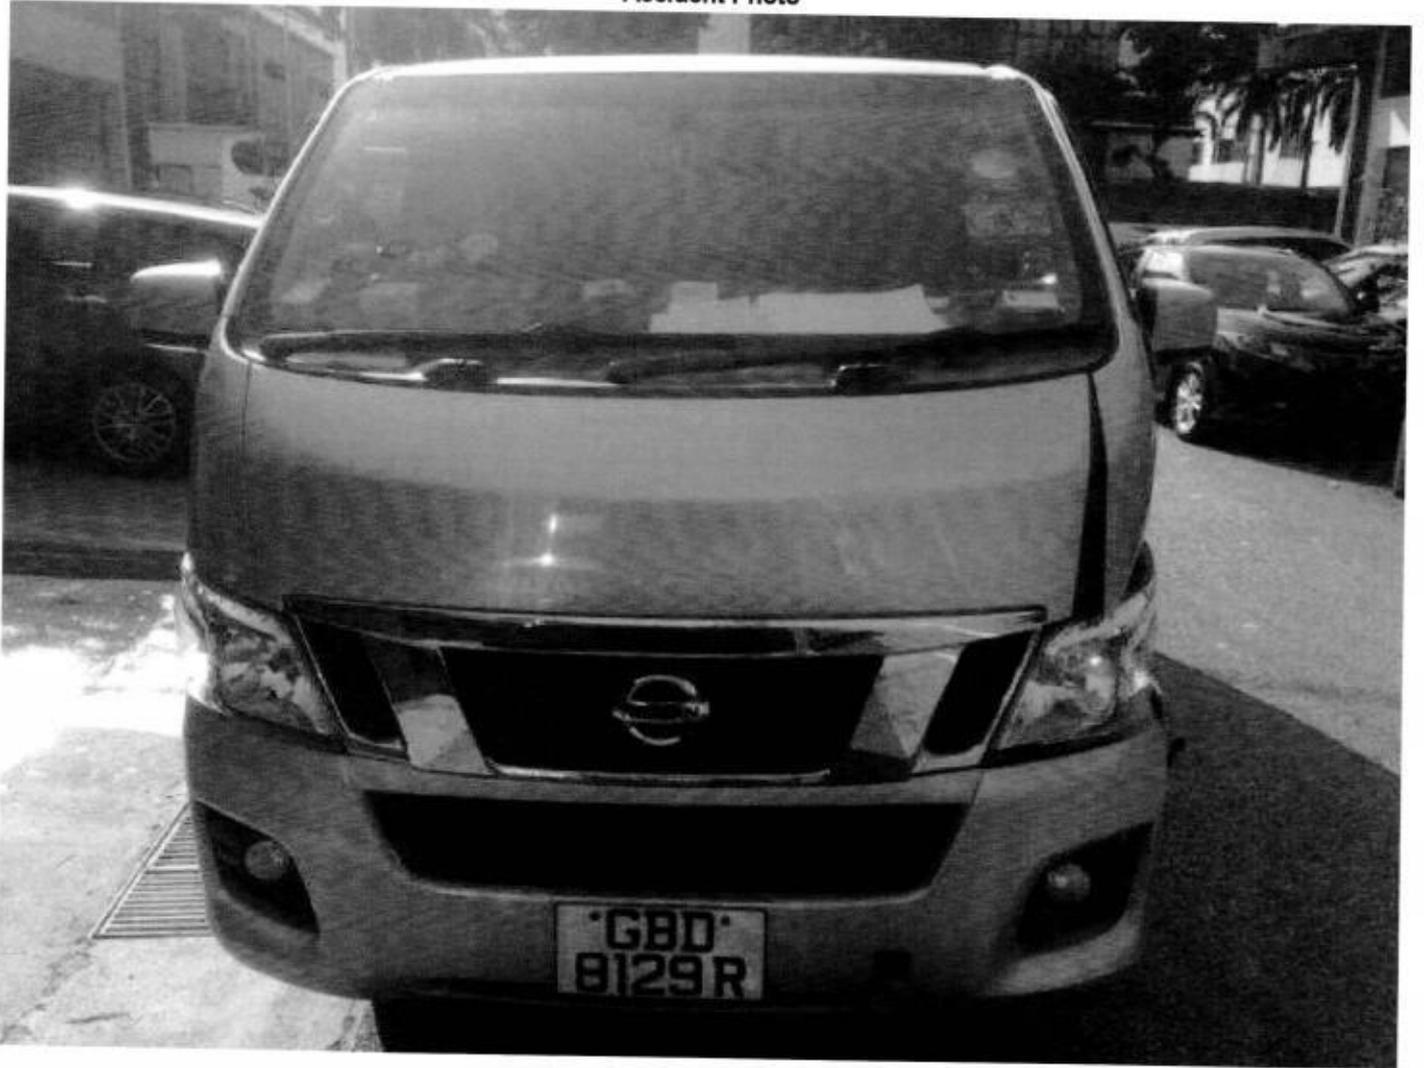
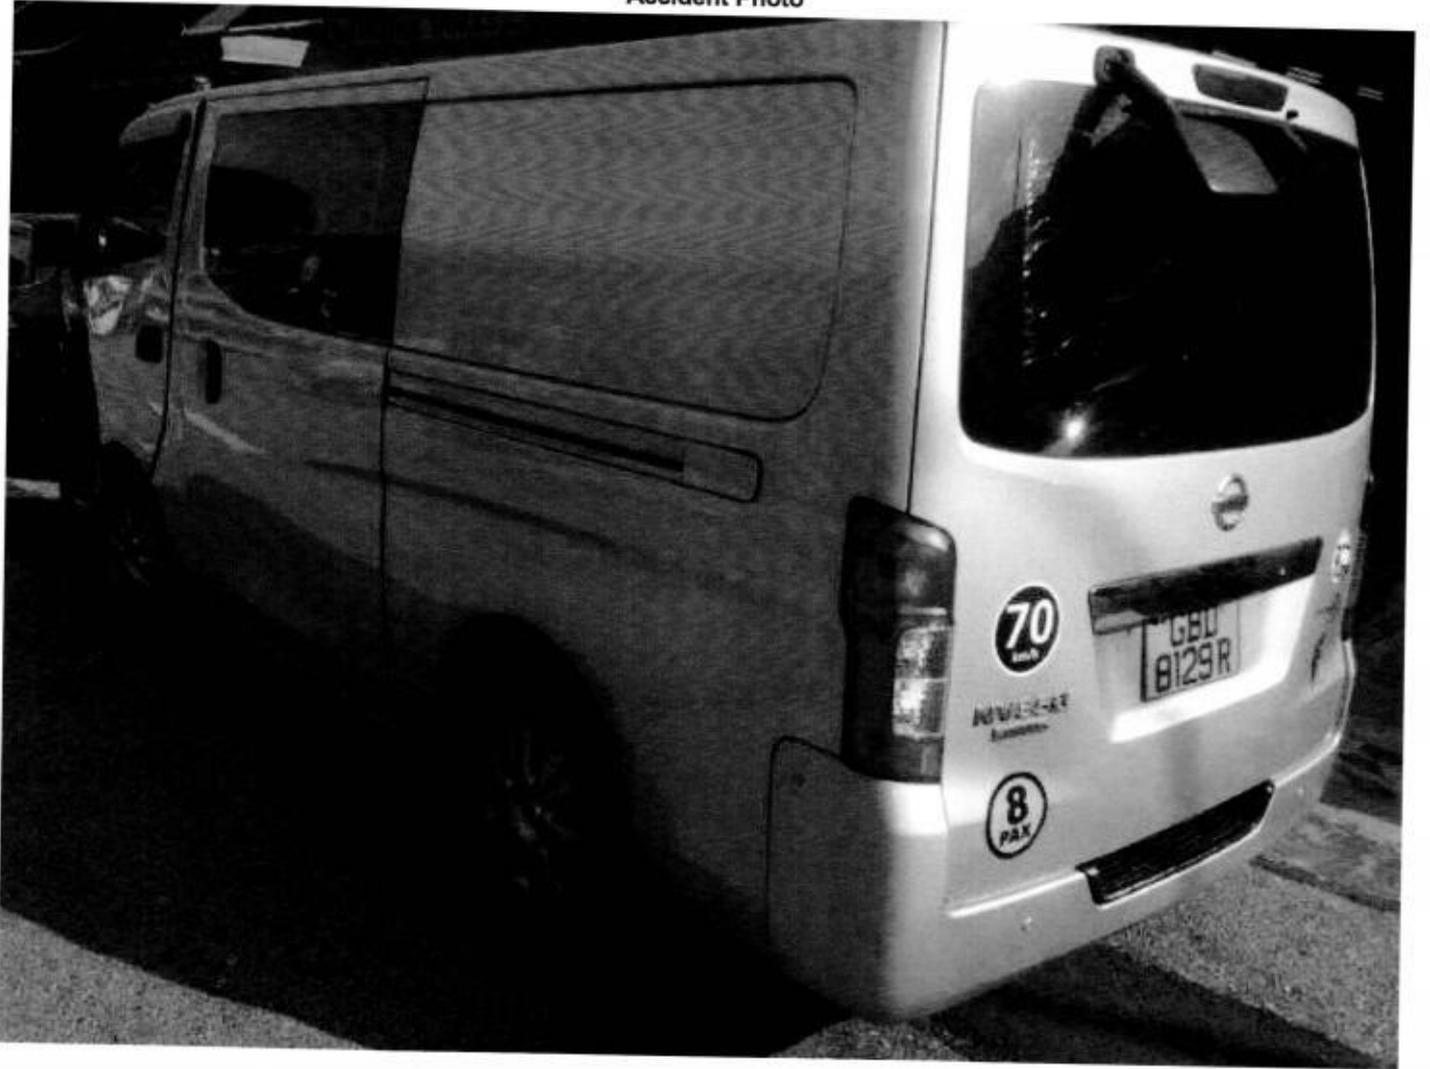
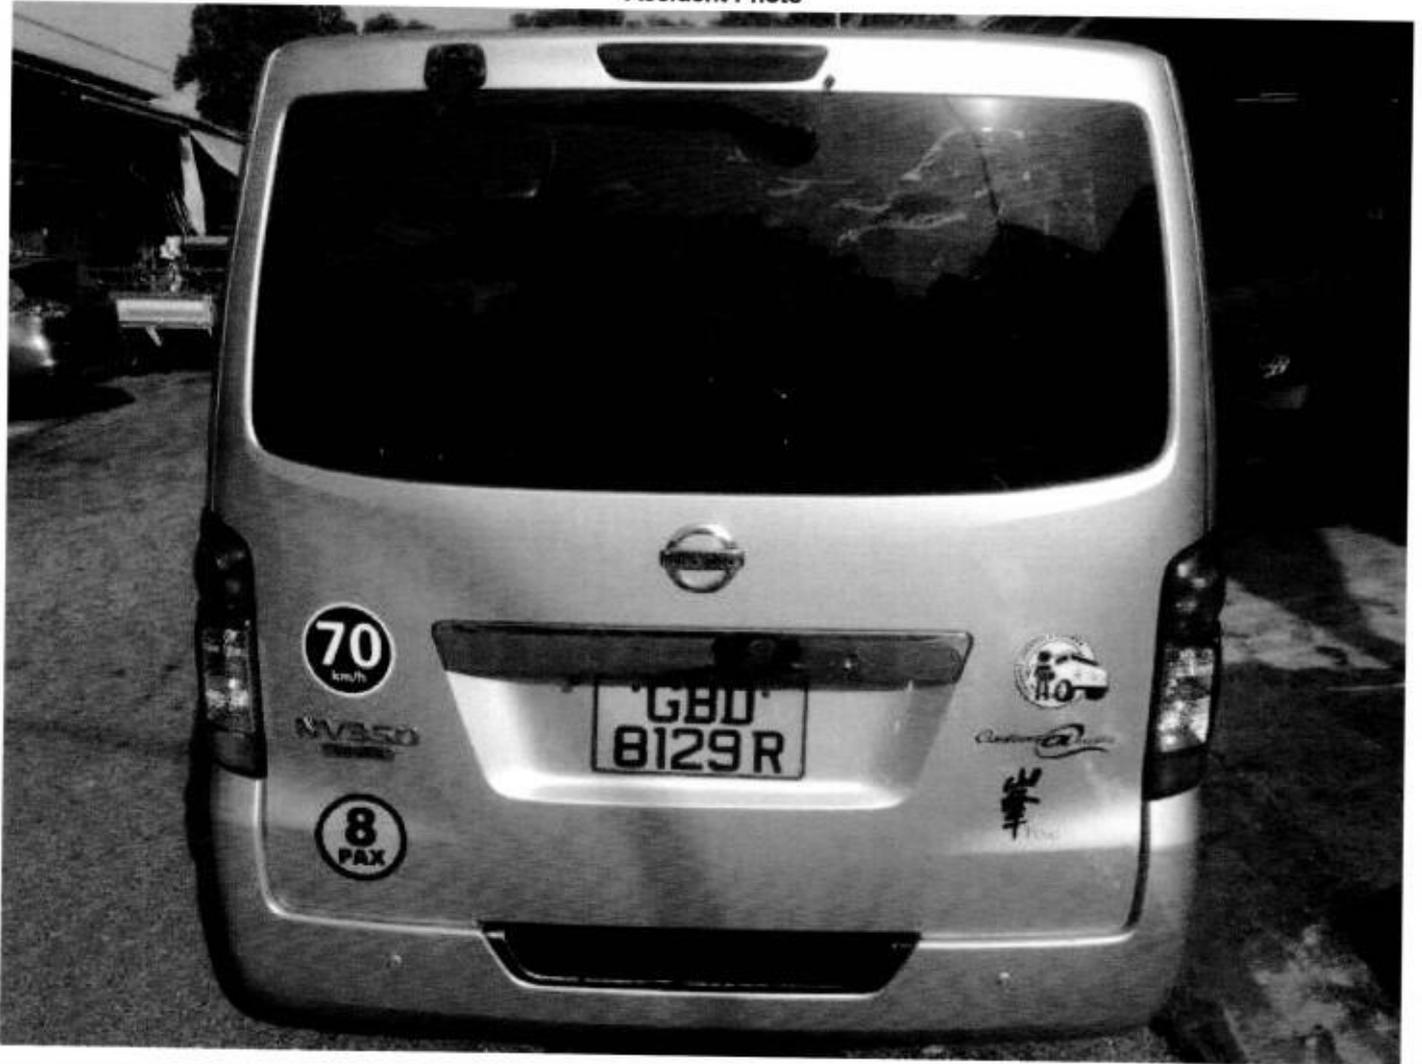
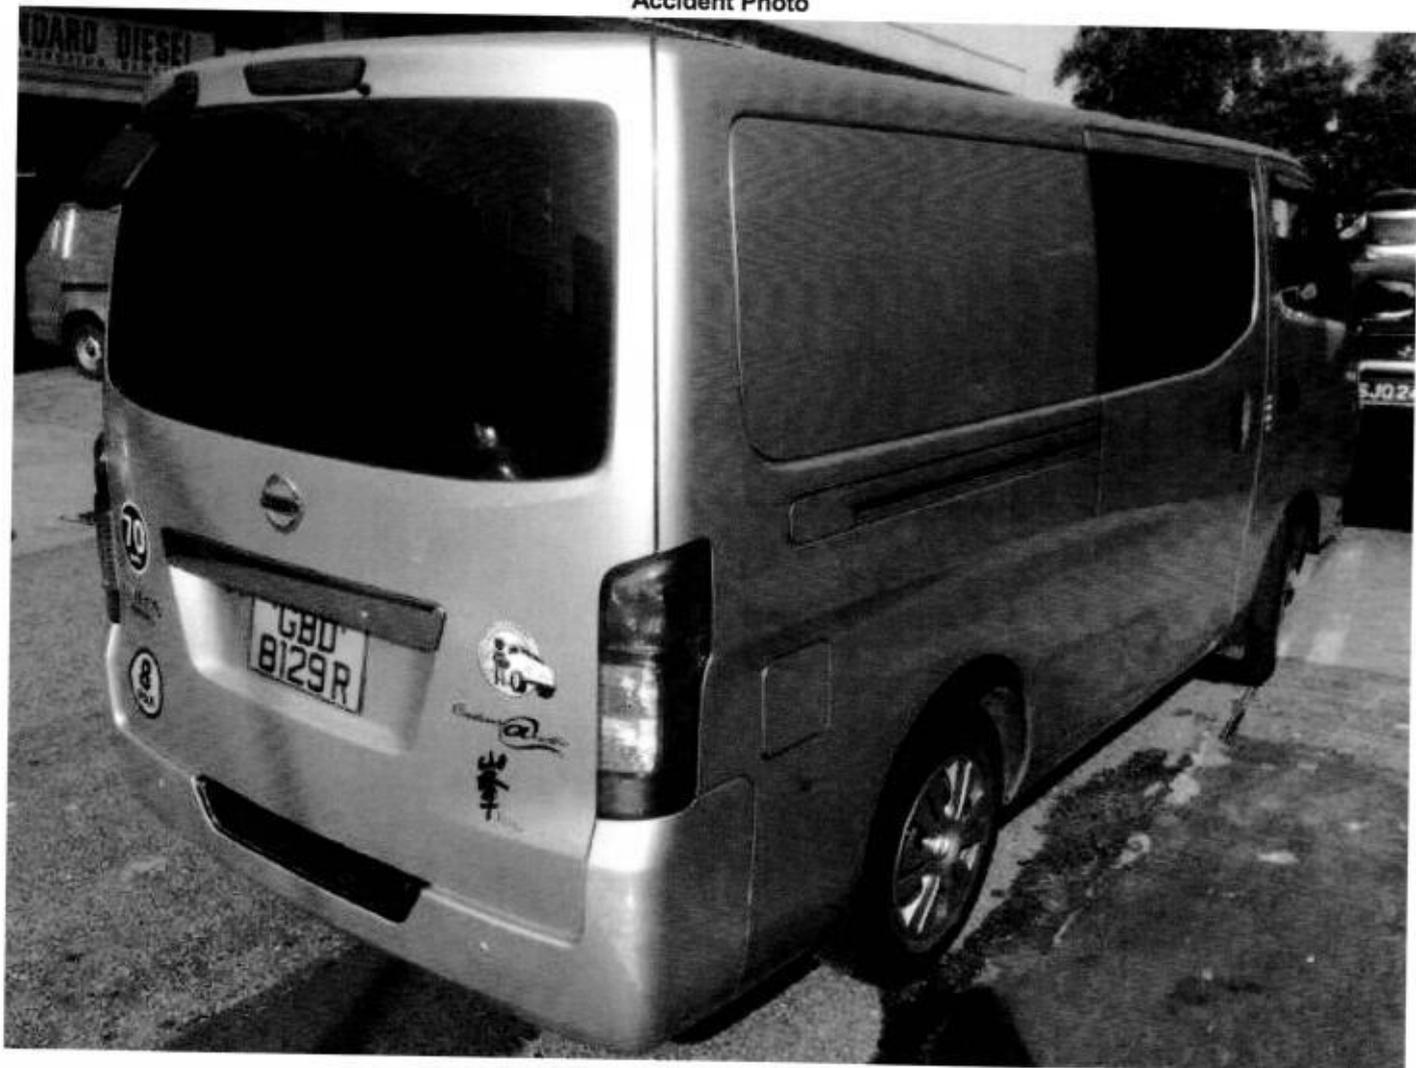
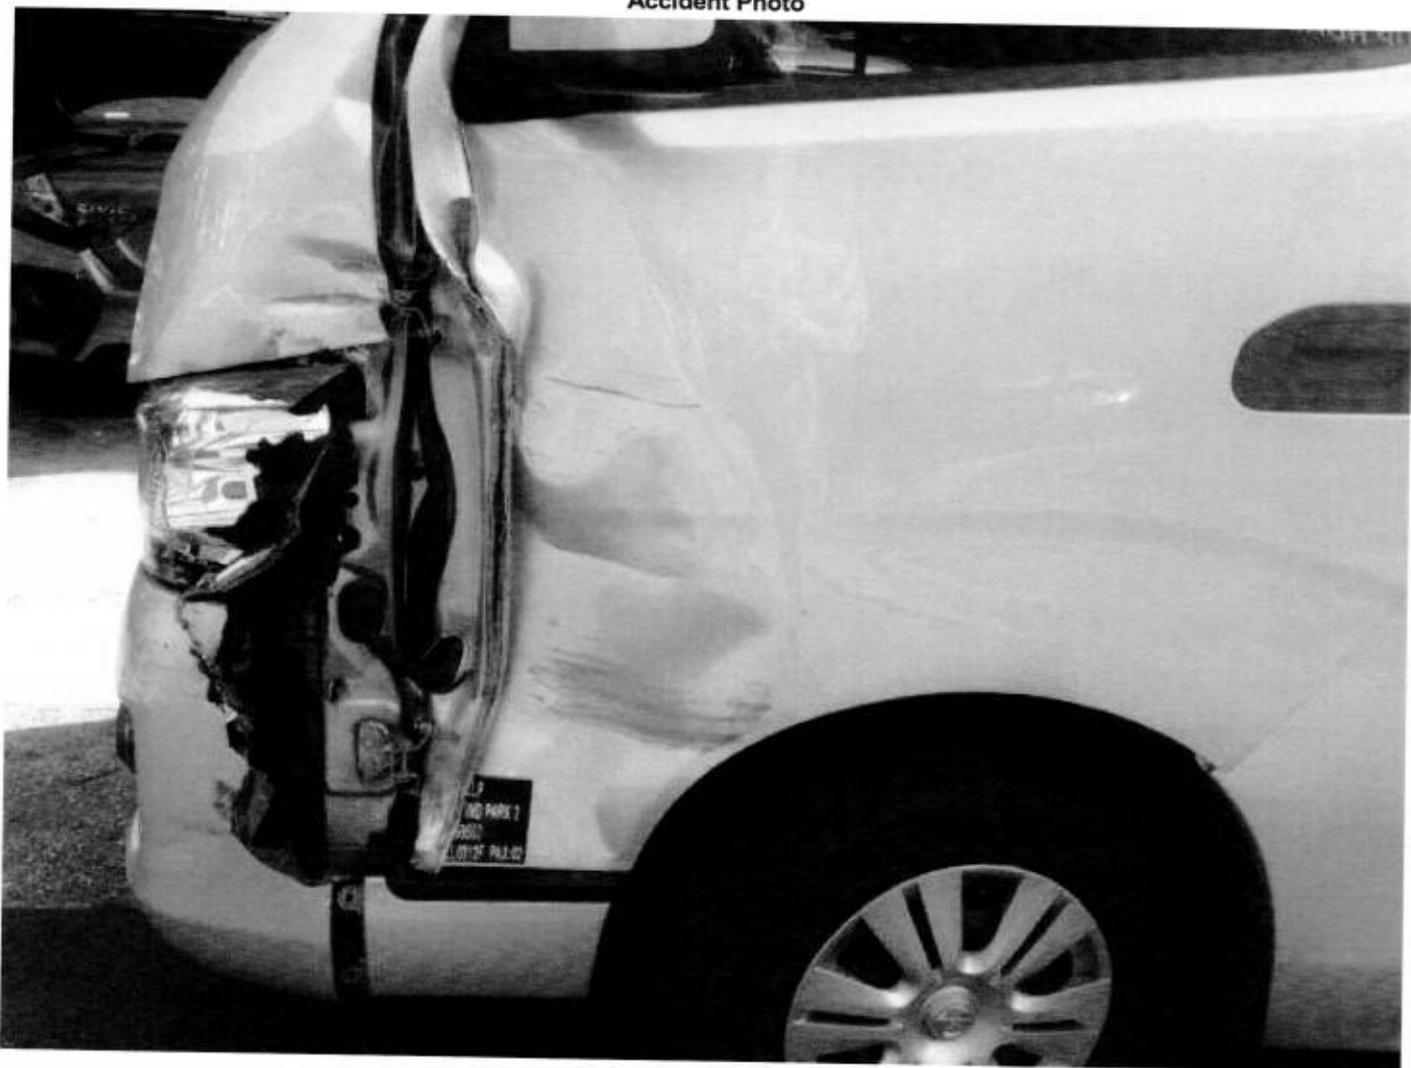
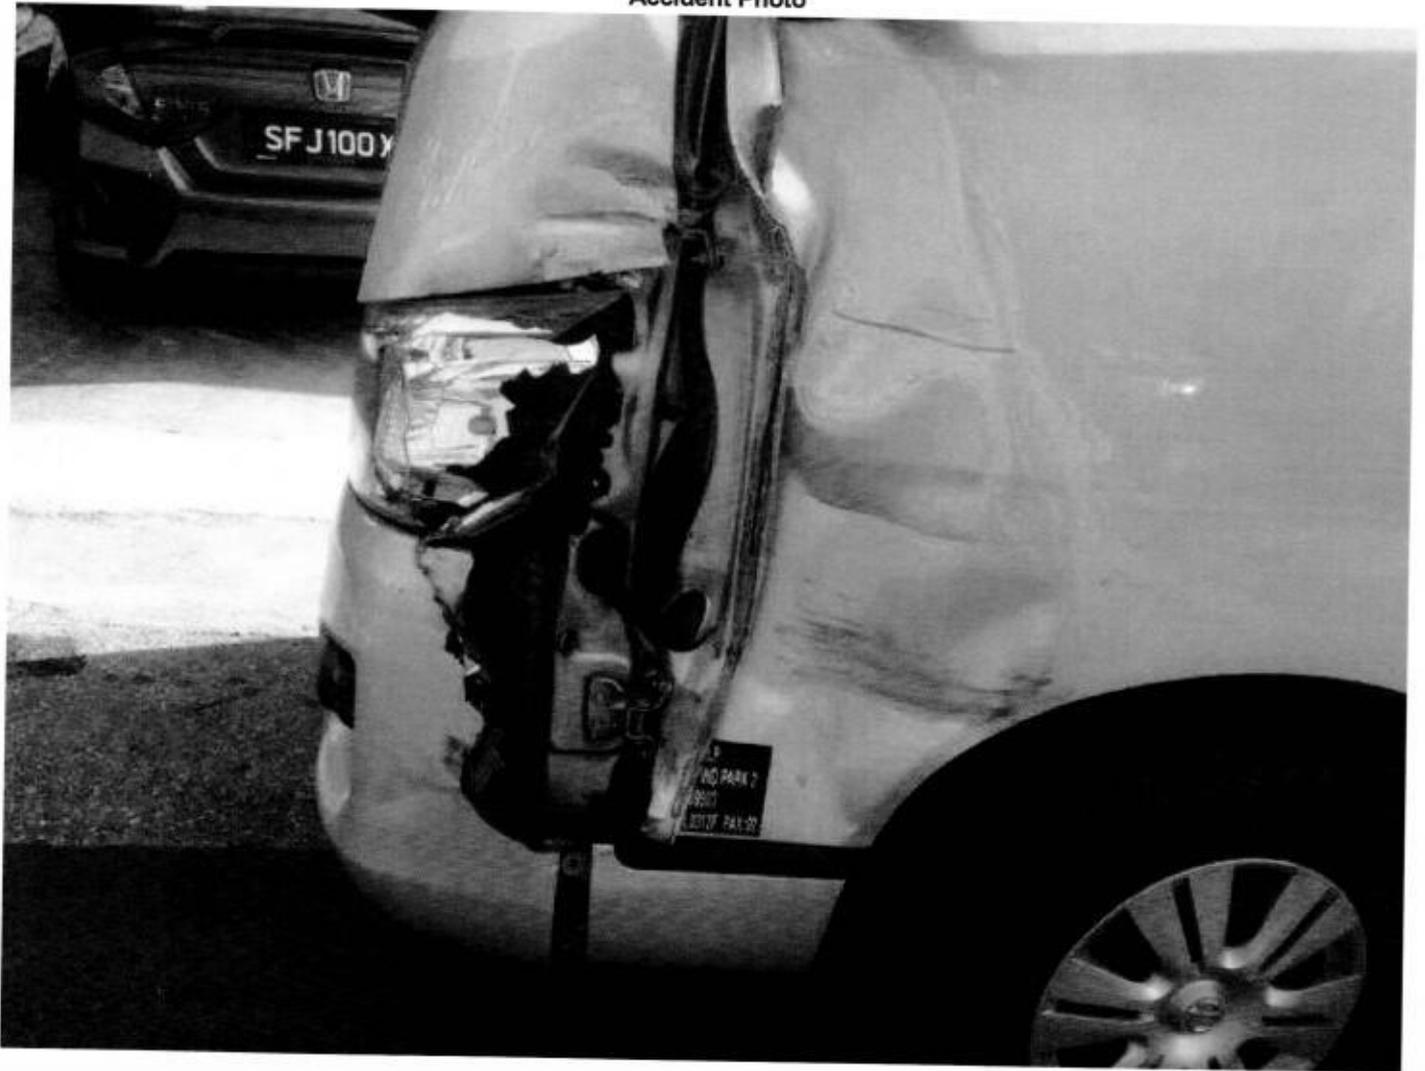
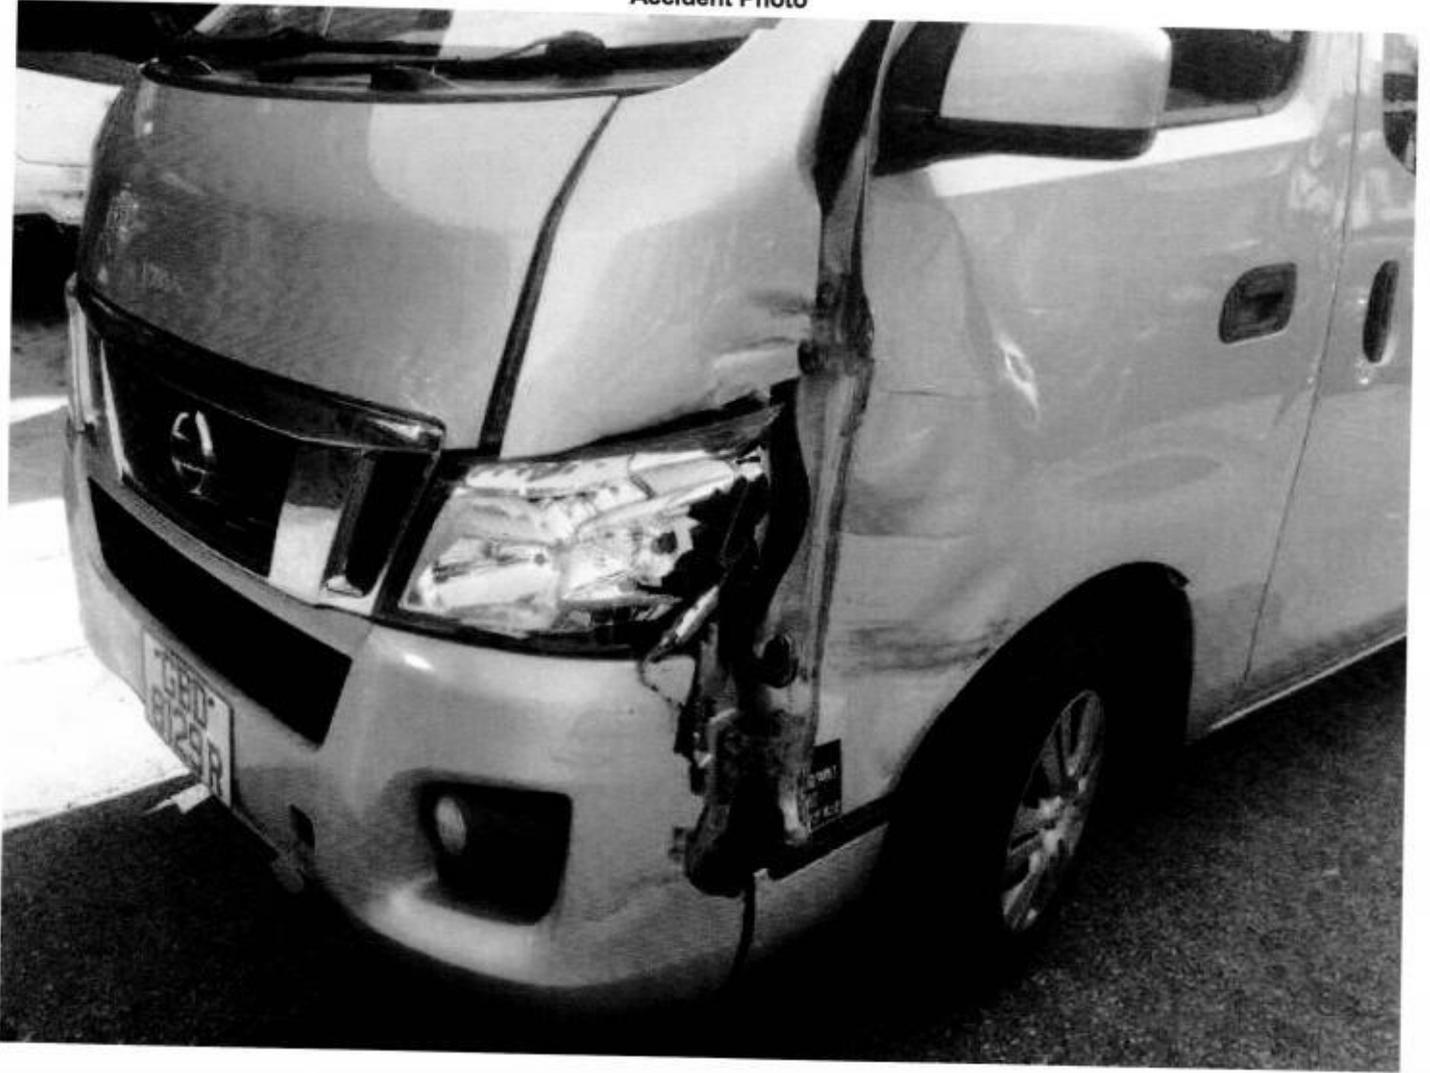
Accident Photo

At the front and rear RH portions.

The front panel, front bumper, RHR door pillar, headlamps, front grille, rear tailgate, RHR sidegate, rear deck end panel, RH taillamp, etc.

Our adjusted amount for the cost of repairs is SGD \$9,803.61.

The repairer has agreed to undertake the repairs at a lump sum of SGD \$7,840.00.
