Insured Vehicle No	: SLN4802K	Accident Date	: 17/10/2019
TP Vehicle No	: SKA8937J	Assignment Date	: 18/10/2019
Make	:	Est. Duration of Repair	: 6.00
Date of Inspection	: 18/10/2019		
Inspection At	: ZOOM AUTOWERKS PTE LTD (HQ) 130 BEDOK RESERVOIR ROAD, EUNOS SPRING, #08-1339 SINGAPORE 470130

The vehicle sustained impact / damages o/s.front portion and parts claimed are consistent to the accident.

VEHICLE DAMAGE INSPECTION REPORT

Our File No: CS/SMO19018424/UUF3N2

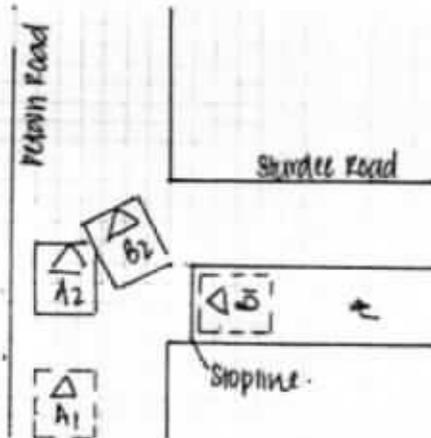
SKETCH PLAN

Vehicle A: SKA 8937J

Vehicle B: SLN4802K

on the stated date & time, I, vehicle A;
SKA 8937J, was travelling straight along the stated venue.
Suddenly, vehicle B, SLN4802K, came out of Sturdee Road
and collided onto my vehicle's front right portion.
