## SINGAPORE ACCIDENT STATEMENT

### VEHICLE DAMAGE INSPECTION REPORT

## ADJUSTMENT ON REPAIR COST FOR VEHICLE NO. PC 5085S

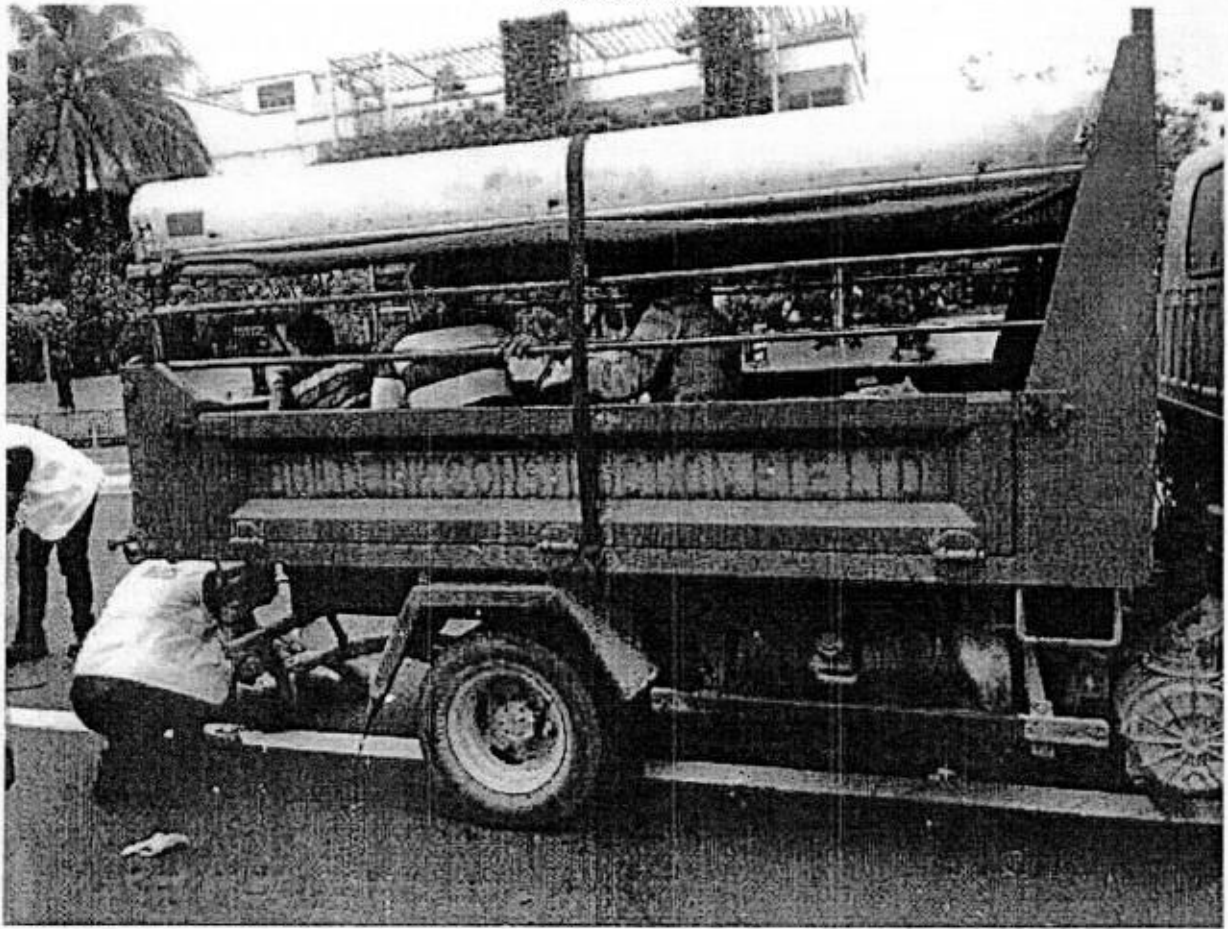
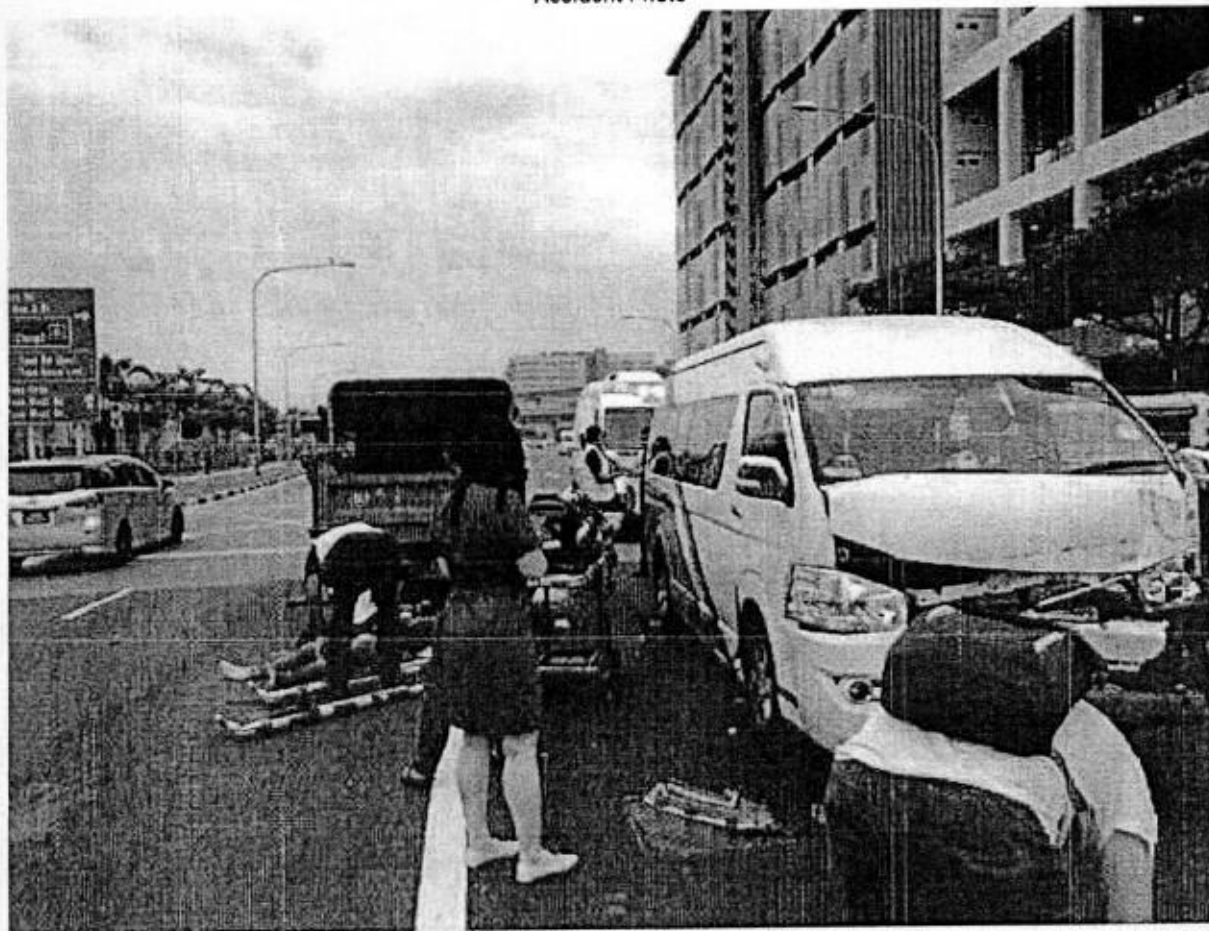
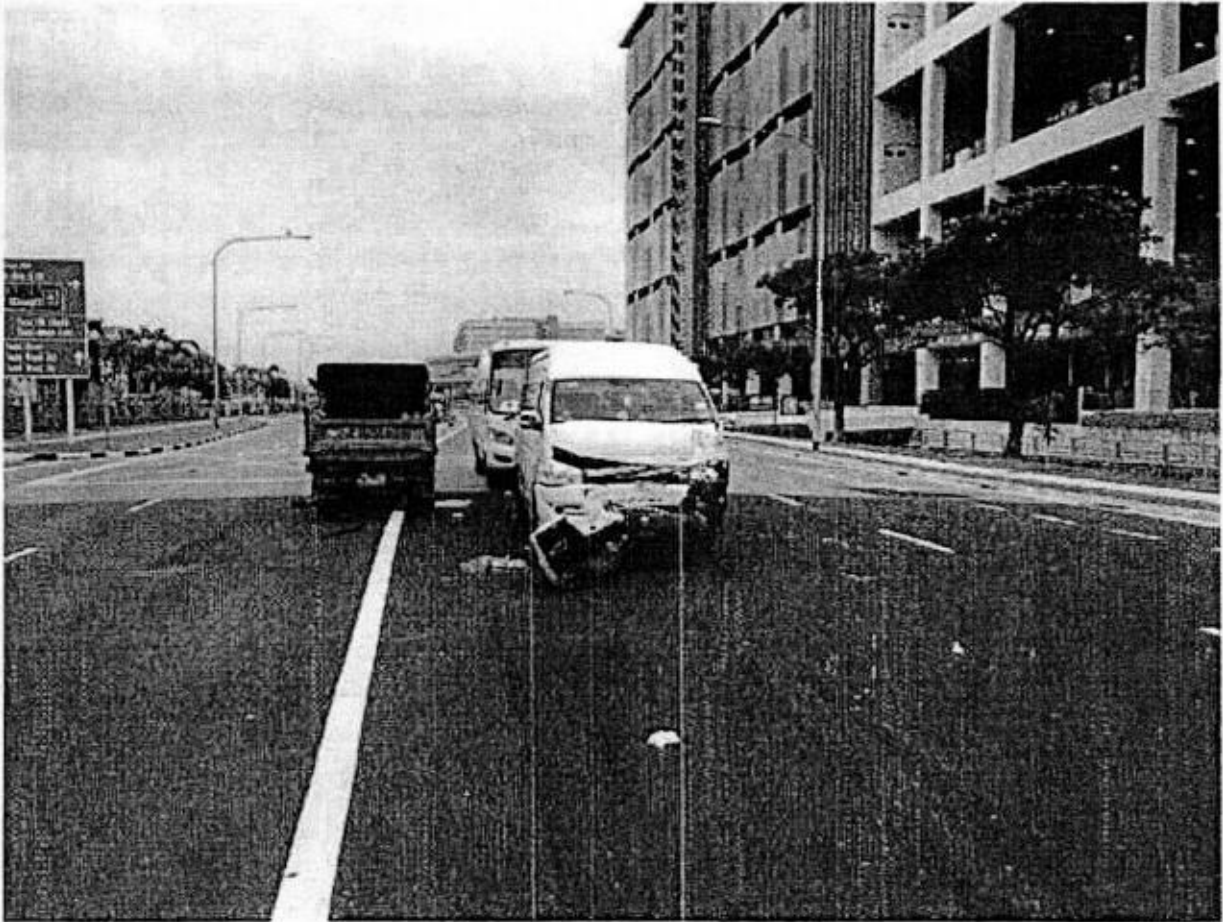
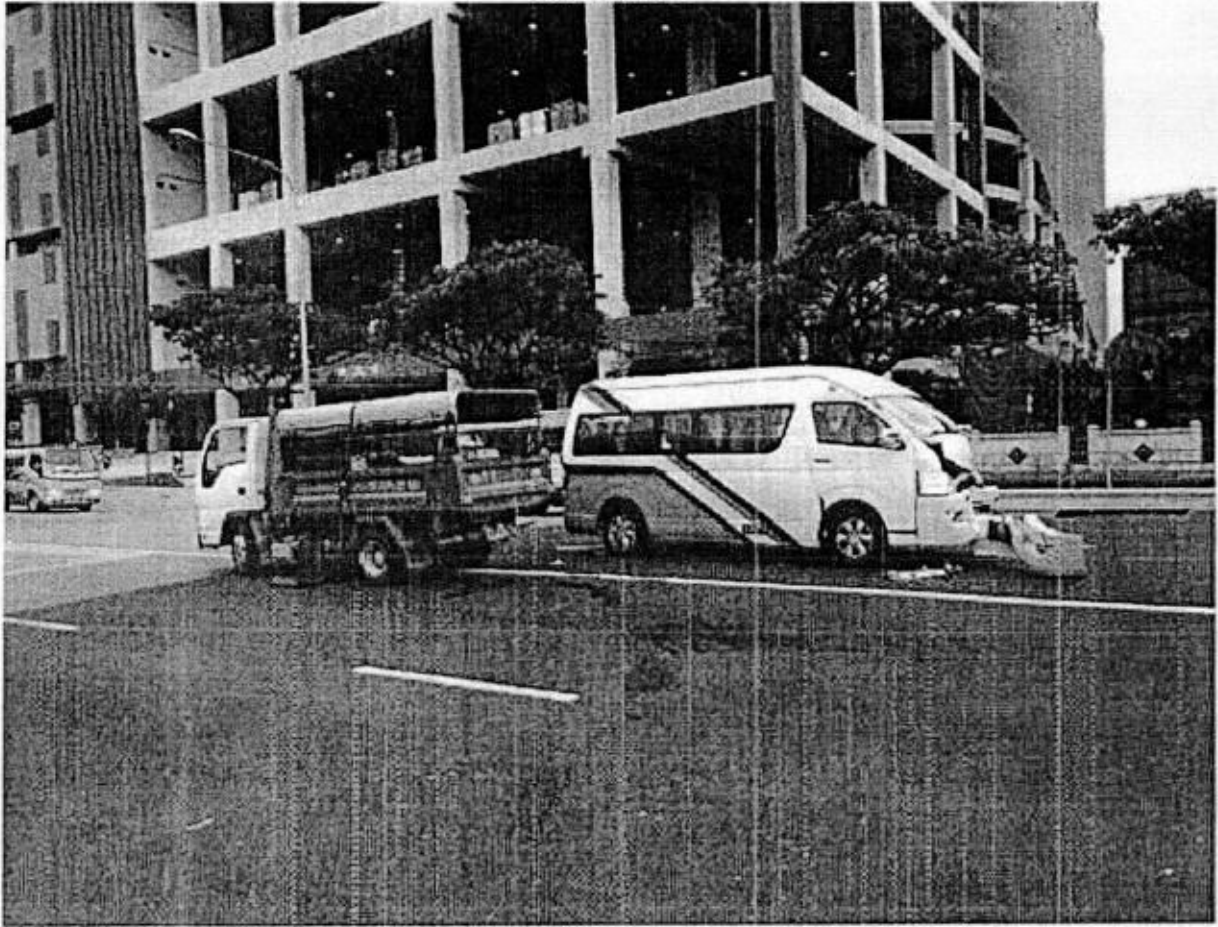
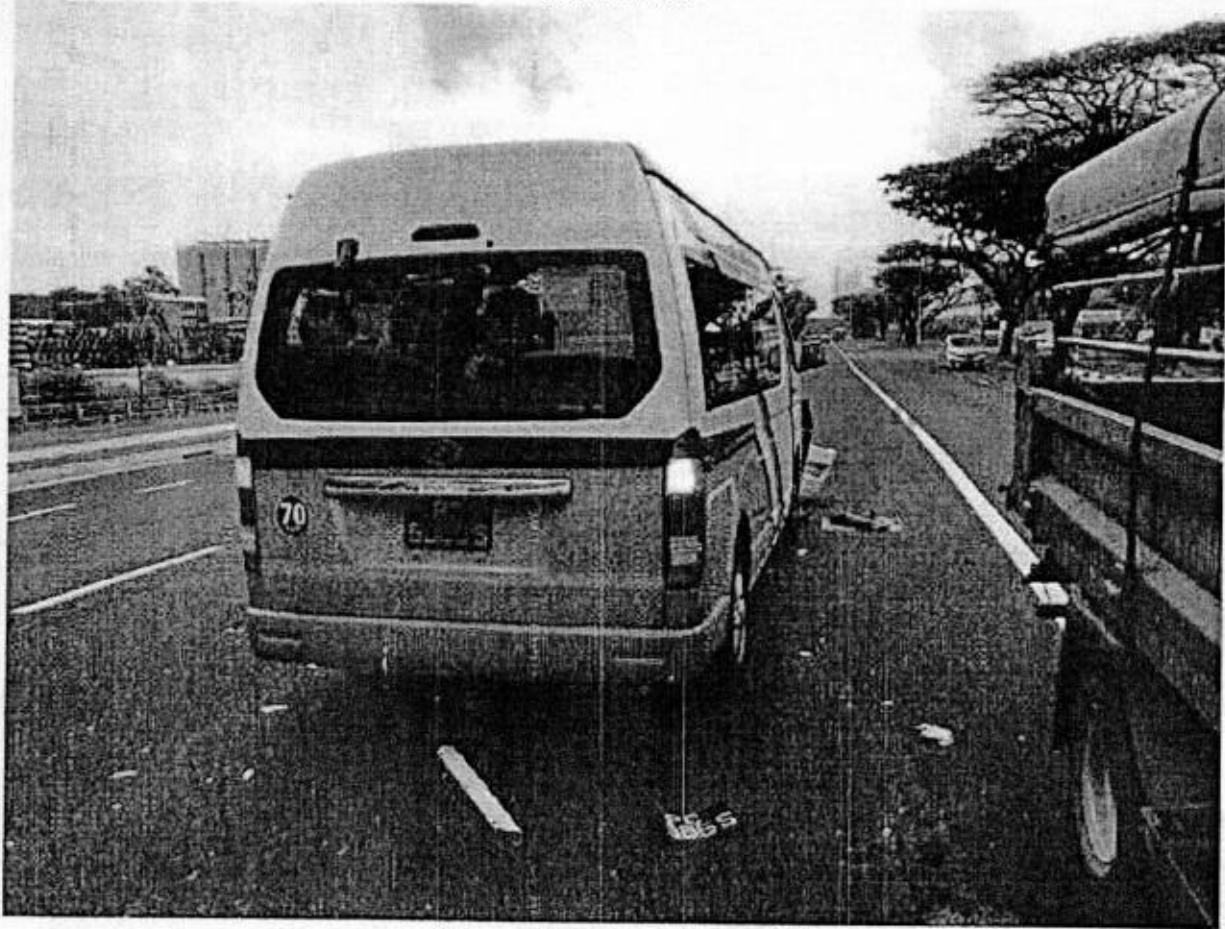
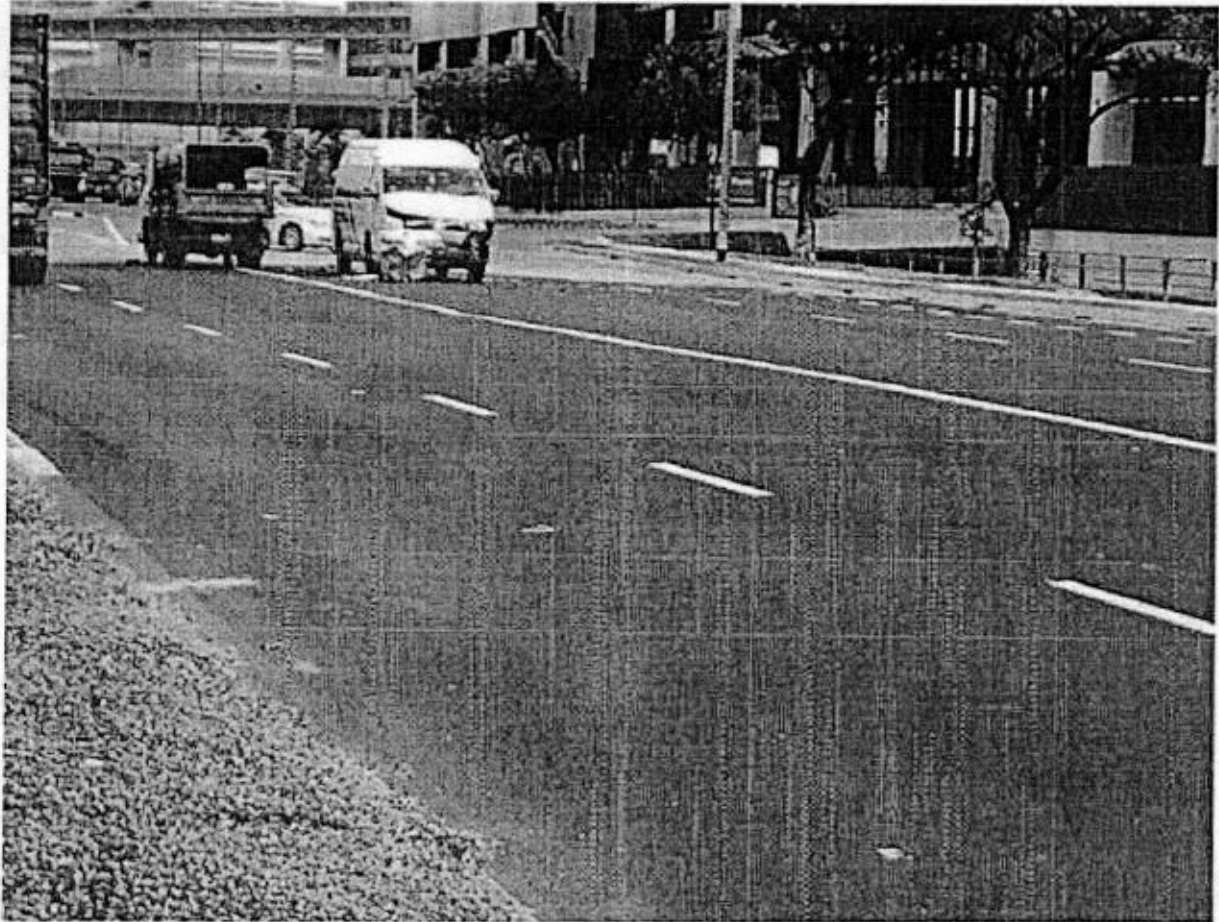
Accident Photo

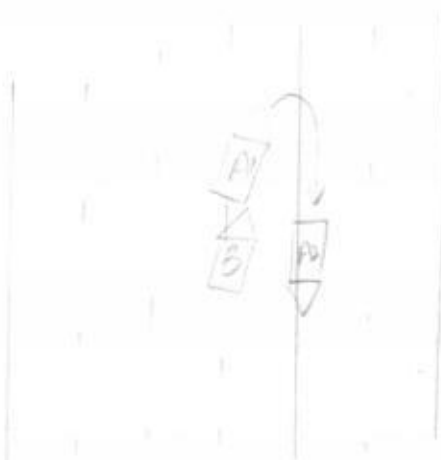
SKETCH PLAN

I was changing to right most lane after turned on my signal lamp. Suddenly CAR B collided into my rear left portion and caused my vehicle moving forward to opposite direction of the road.

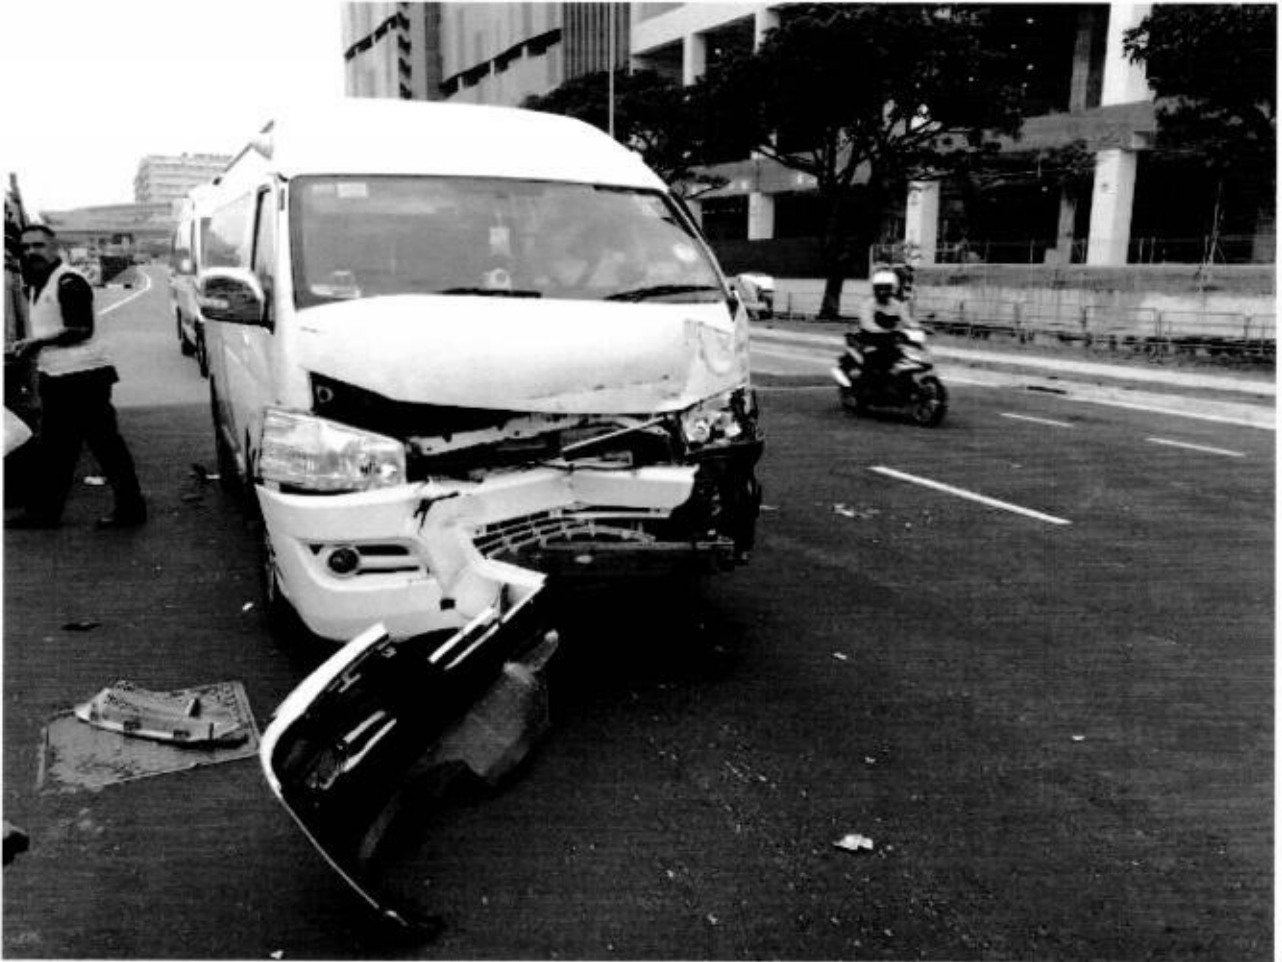
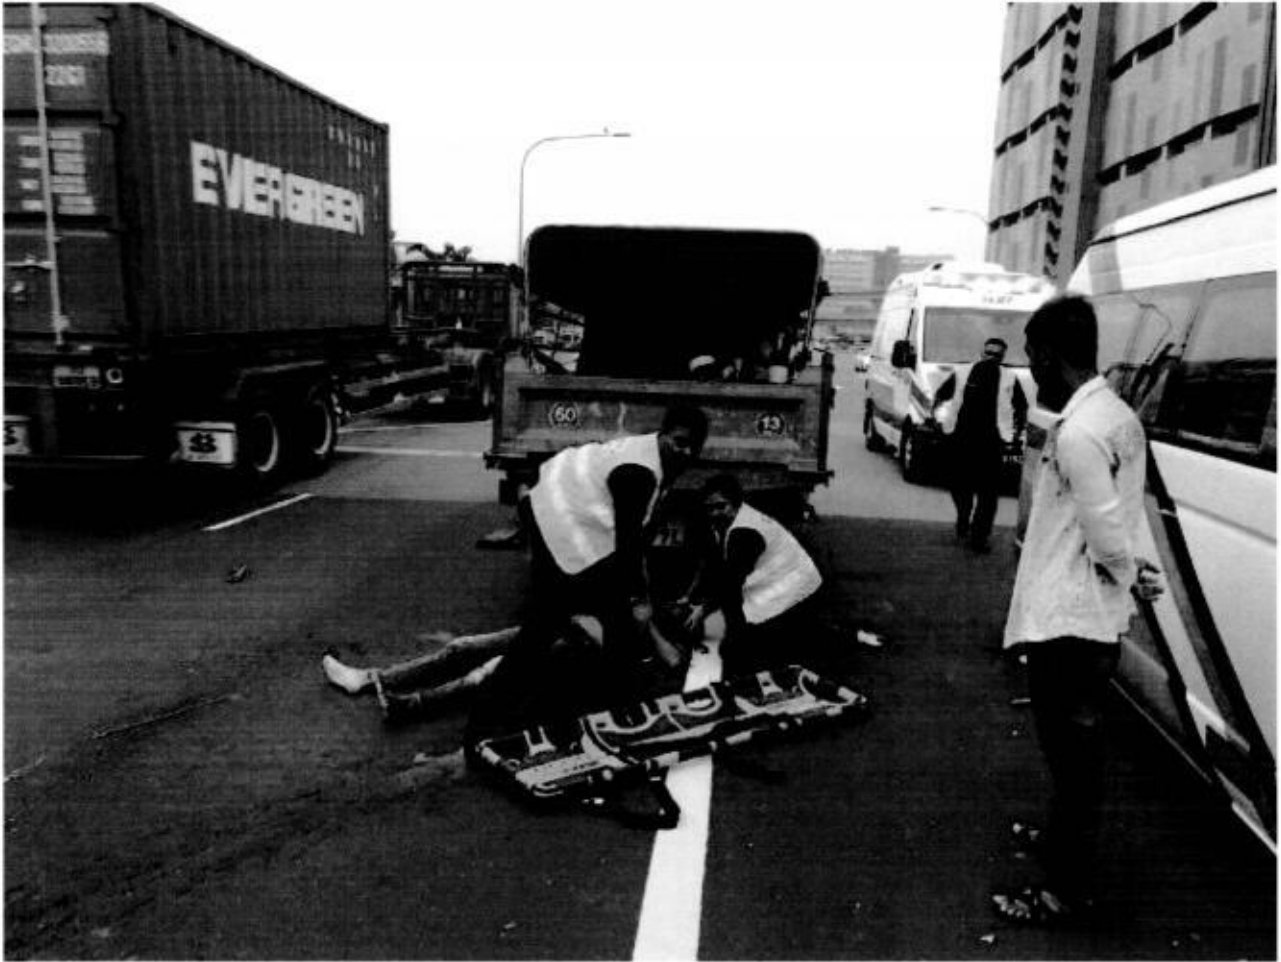
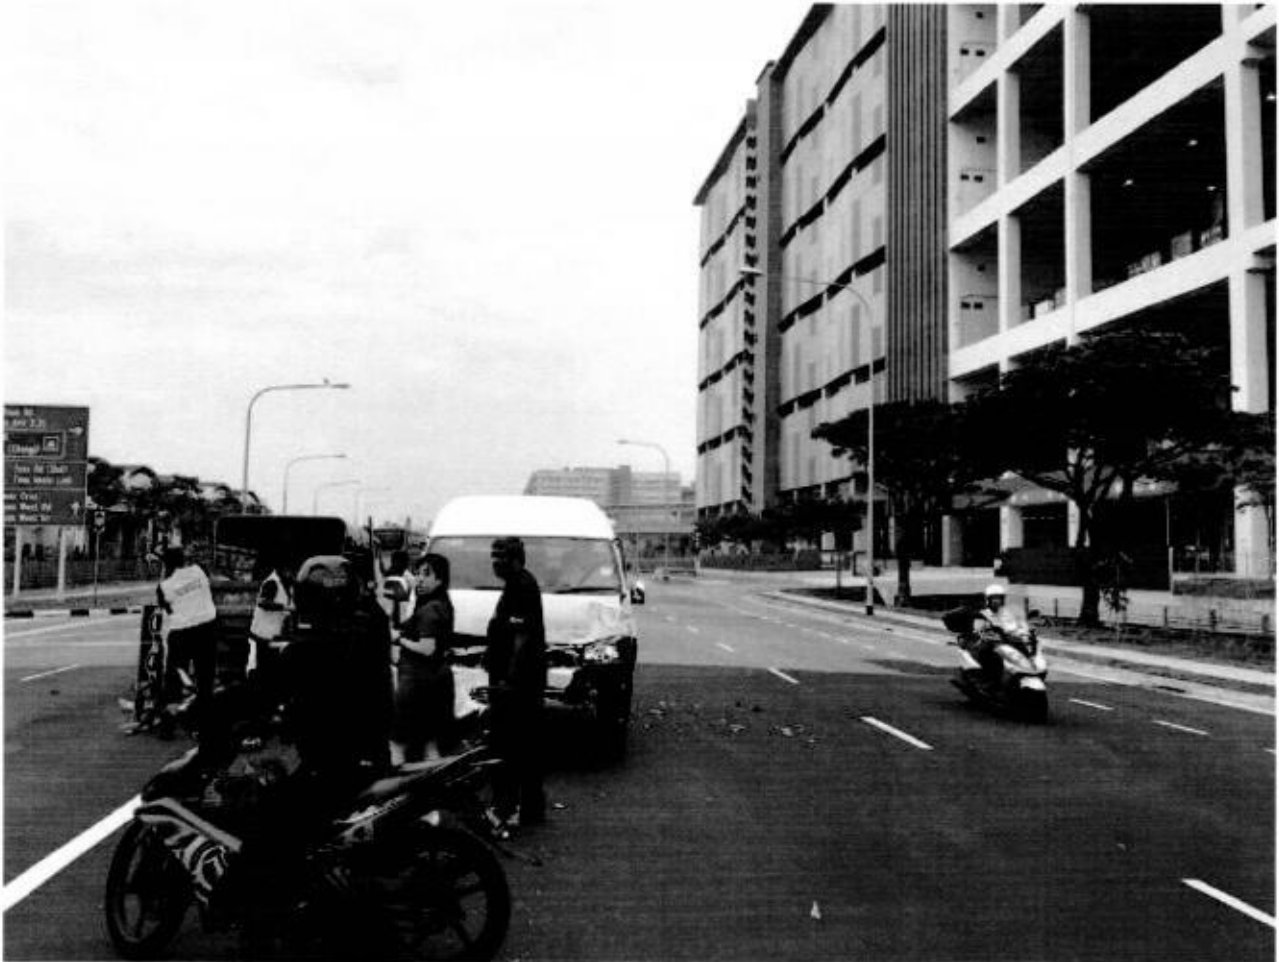
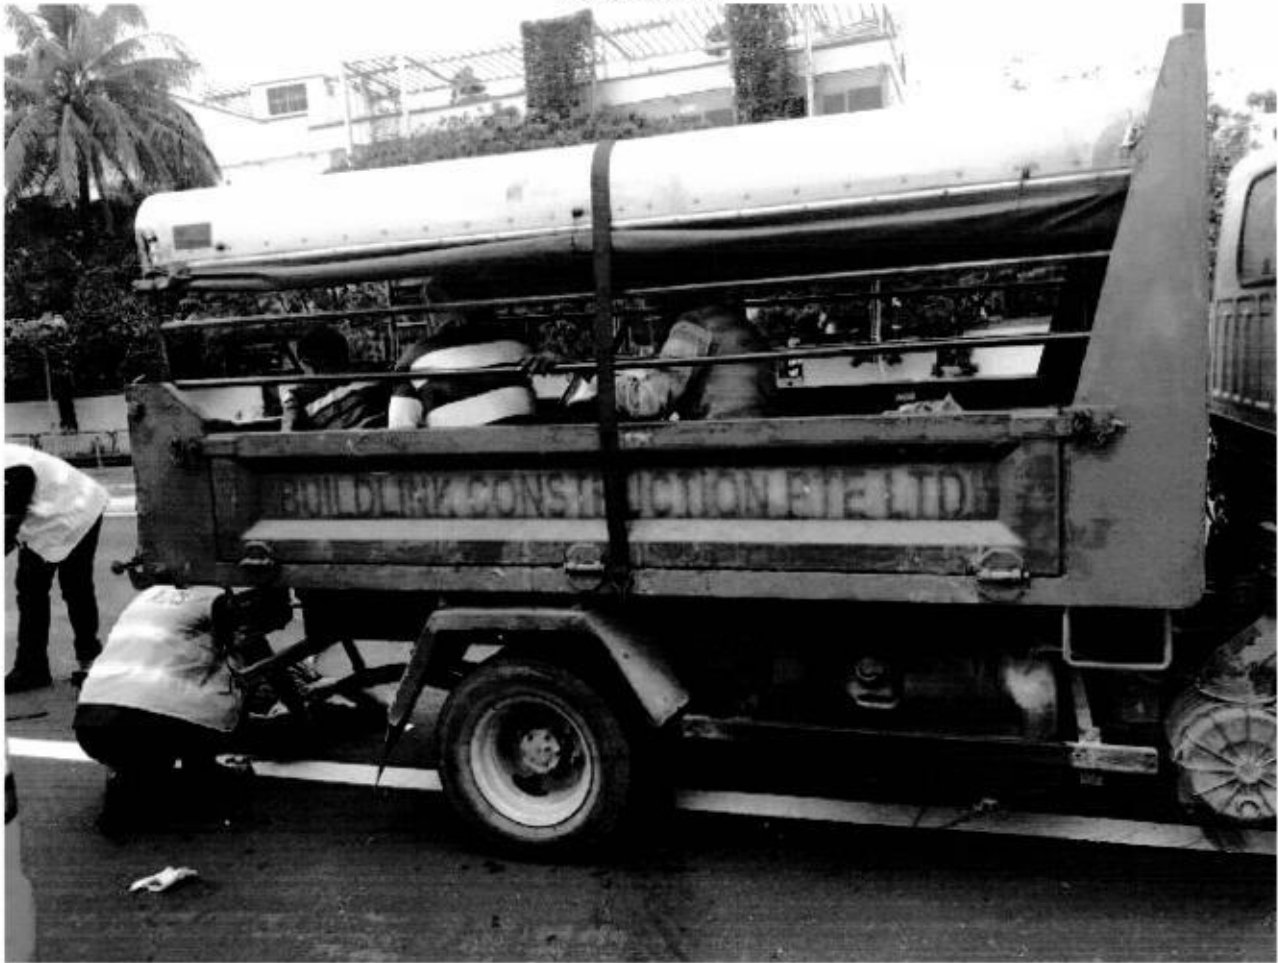
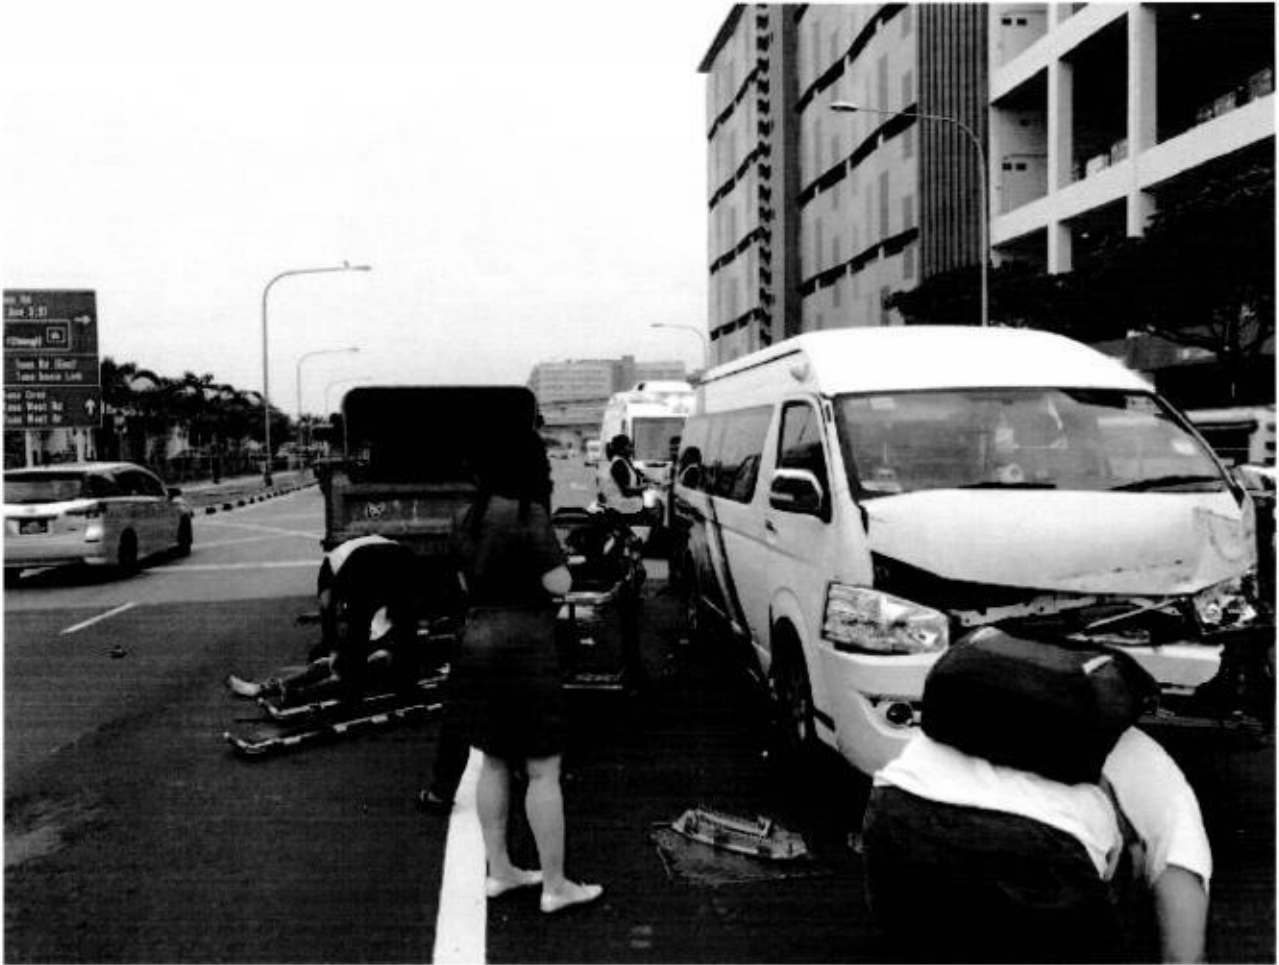
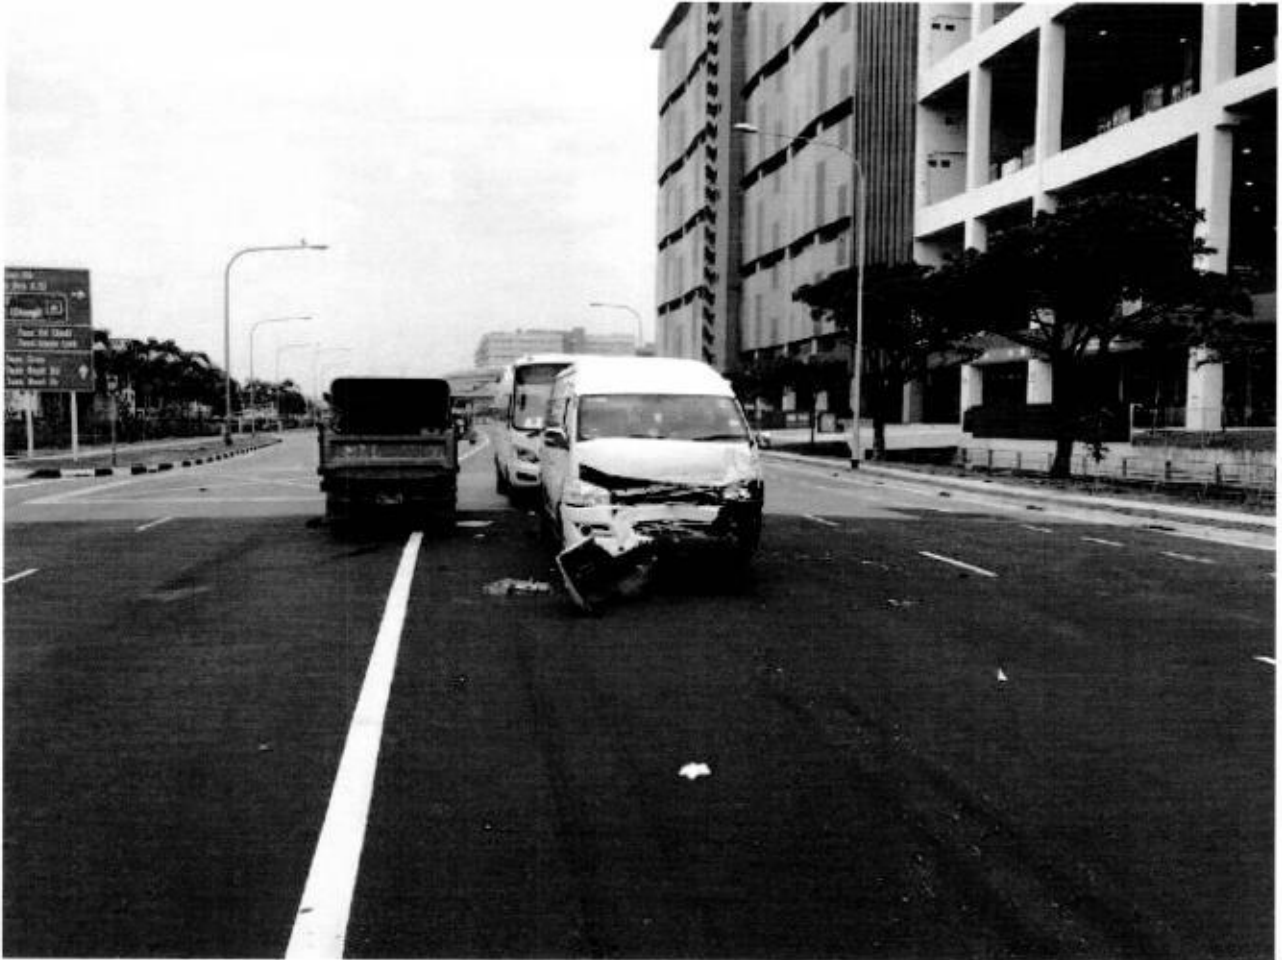
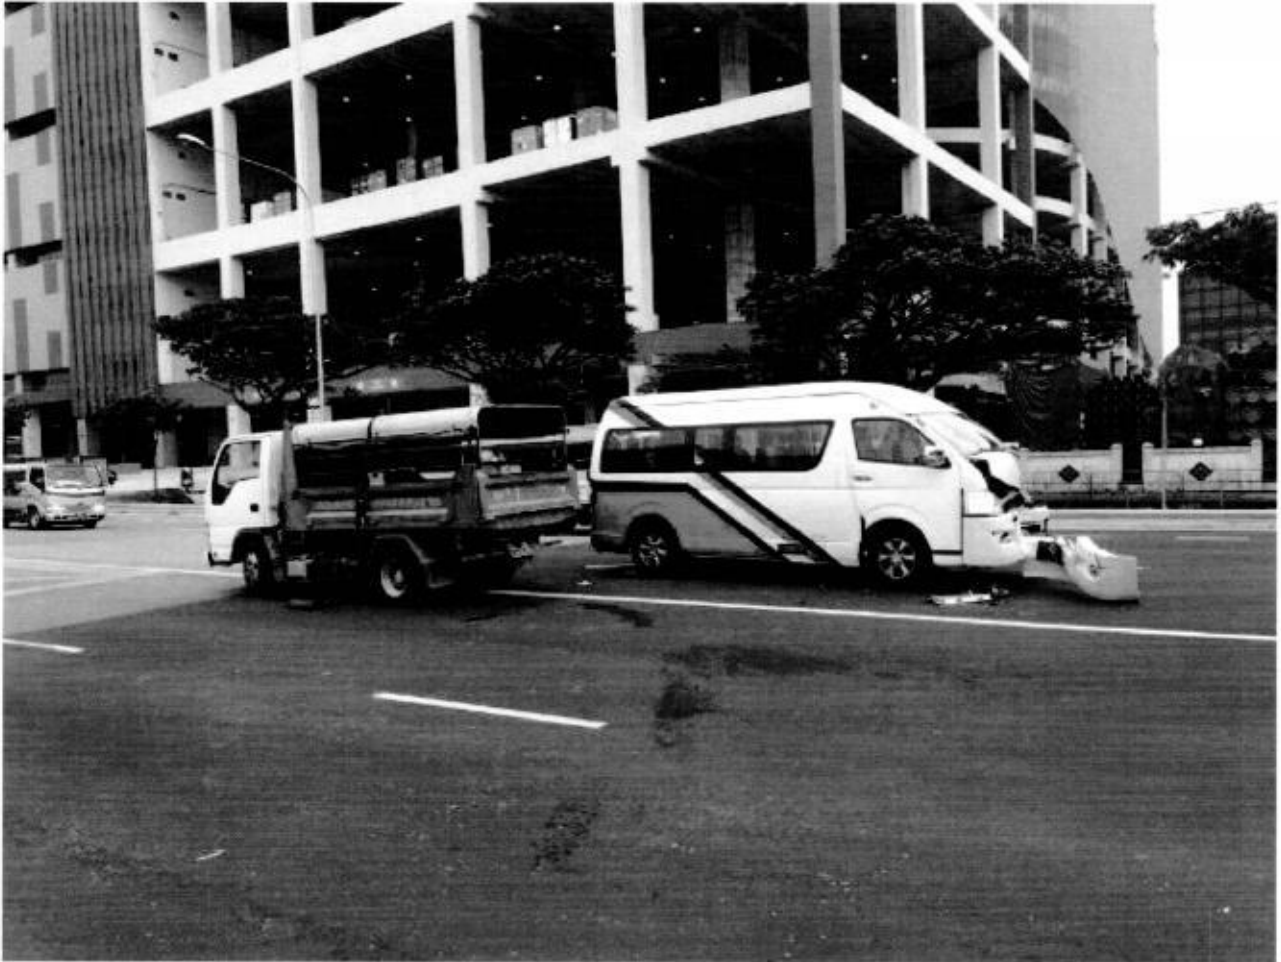
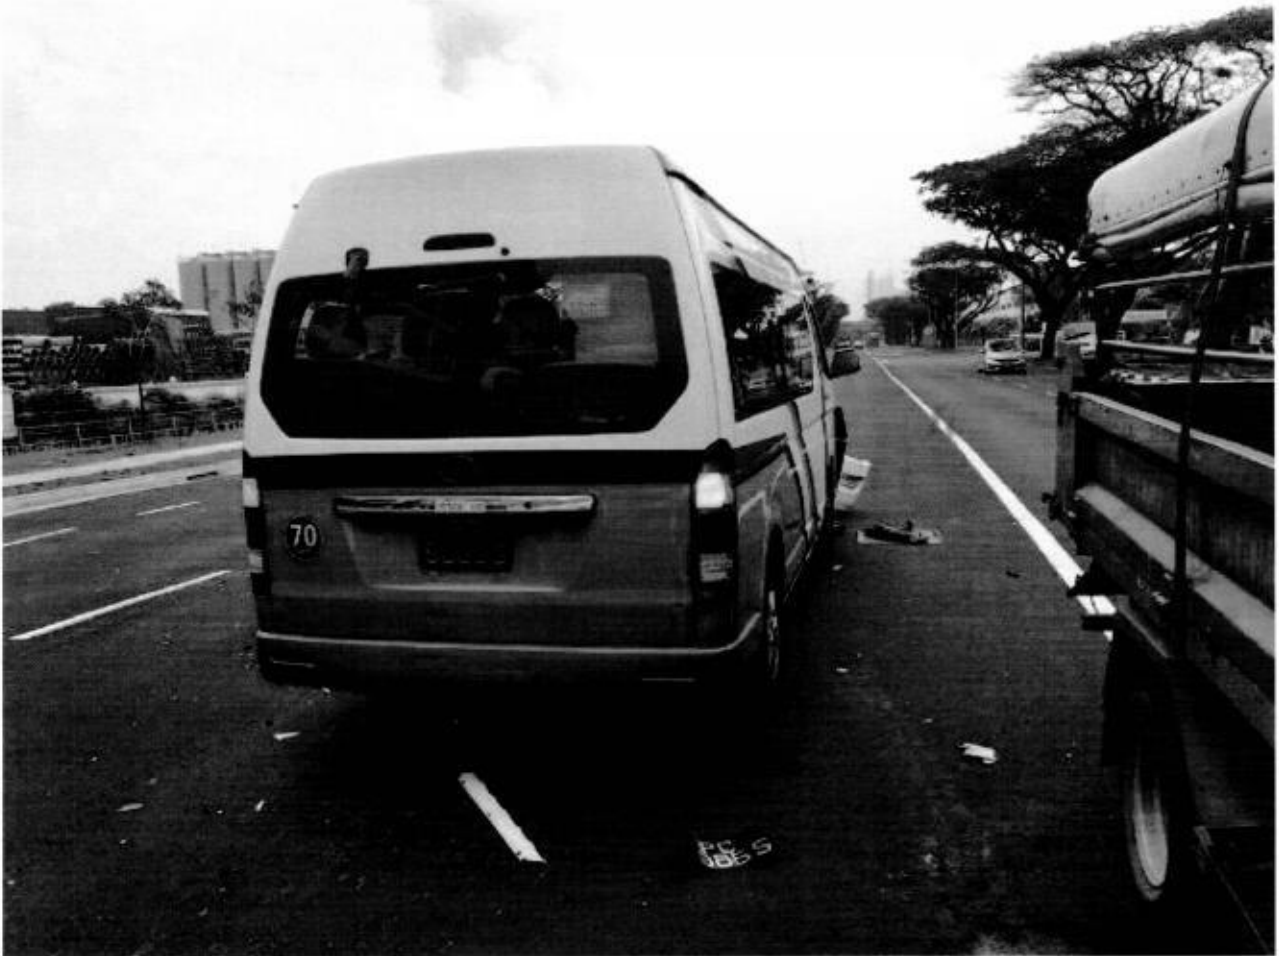
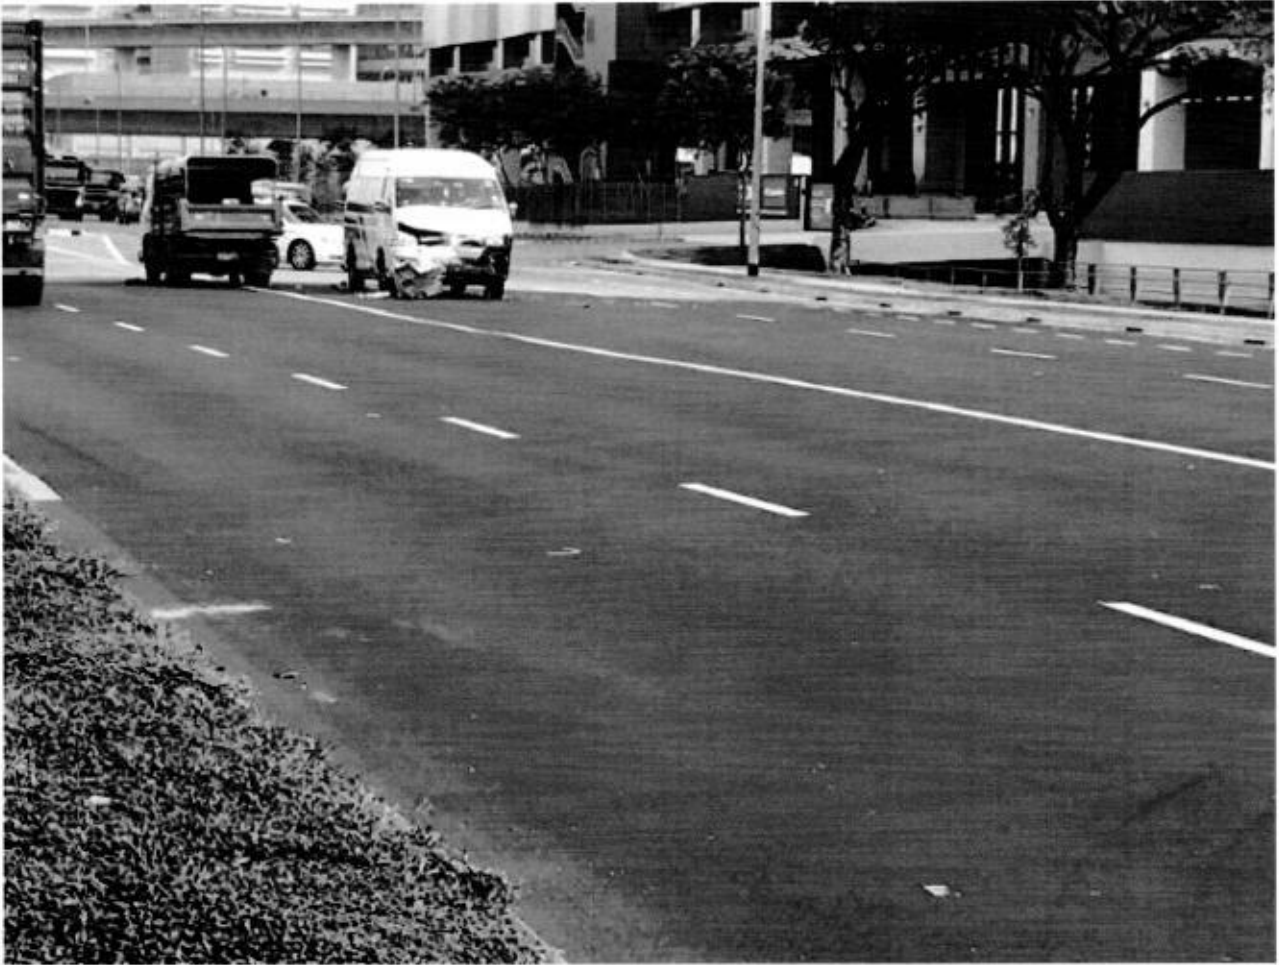
Accident Photo

Damaged at the front portion

Our visual inspection of the vehicle revealed that the damages noted are at the front portion.

We have inspected the actual damages found on the vehicle and recommend the replacement of parts and repairs accordingly. The estimated repair cost is \$35,178.90. The repairer has agreed to undertake the repairs at our adjusted lump sum amount of \$27,500.00.
