## REPAIR ESTIMATE FOR MAZDA 3 - SMG 6933 C

## VEHICLE DAMAGE INSPECTION REPORT

Our File No: CS/MSG19018607/KSF3S2  
Date: 06/11/2019

Handling Insurer:	MSIG Insurance (Singapore) Pte. Ltd.	Policy No:	29114756MKF
Claimant Vehicle No :	SMG6933C	Insured Vehicle No :	SLK3607E
Date of Loss:	21/10/2019	Nature of Claim:	TP
		Claim No:	609019

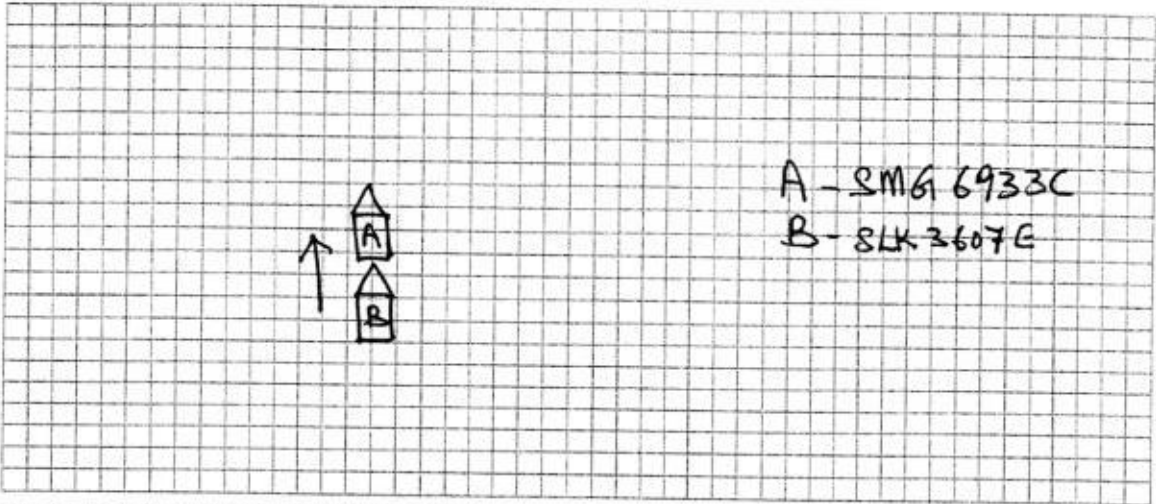
## SKETCH PLAN

On 21/10/2019 @ 07:26 am, I was driving along Yishun Ring Road towards Yishun Street 41. Vehicle in front of me stopped to give way to pedestrian, I followed and stopped my vehicle also. Vehicle behind could not on time and collided onto the rear portion of my vehicle.
