Vehicle No	: GBG5699R	Accident Date	: 18/10/2019
Make	: TOYOTA DYNA 1.5T	Policy No.	: DMCVSN3075531902
Assignment Date	: 23/10/2019	Excess	: S\$3,000.00
Date of Inspection	: 23/10/2019	Est. Duration of Repair	: 4
Inspection At	: TRIPLE-T AUTOMOBILE

The vehicle sustained impact / damages o/s front portion and parts claimed are consistent to the accident.

VEHICLE DAMAGE INSPECTION REPORT

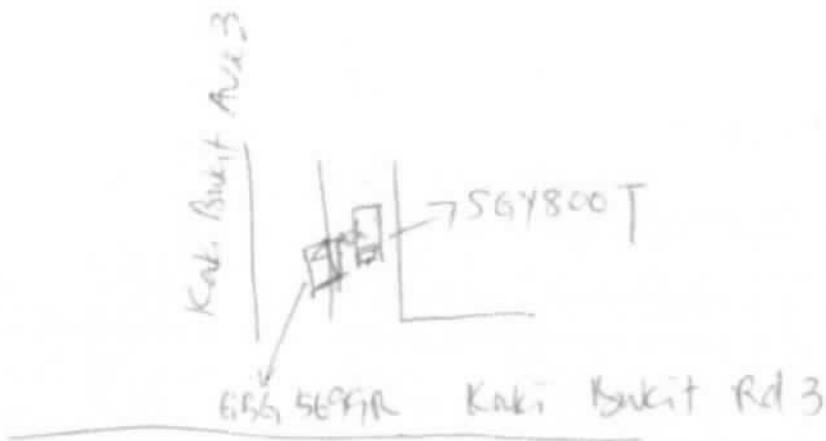
SKETCH PLAN

On mentioned date & time, I was travelling along Kaki Bukit Road 3 towards Kaki Bukit Ave 3.

When I was turning right to Kaki Bukit Ave 3, suddenly hit onto the vehicle SGY800T right position.
