To Inspect Vehicle No:

SLQ 1764R

PRE-REPAIR INSPECTION REQUEST – SLQ1764R vs SMG8833U (OI) on D.O.A.: 19/10/2019

VEHICLE DAMAGE INSPECTION REPORT

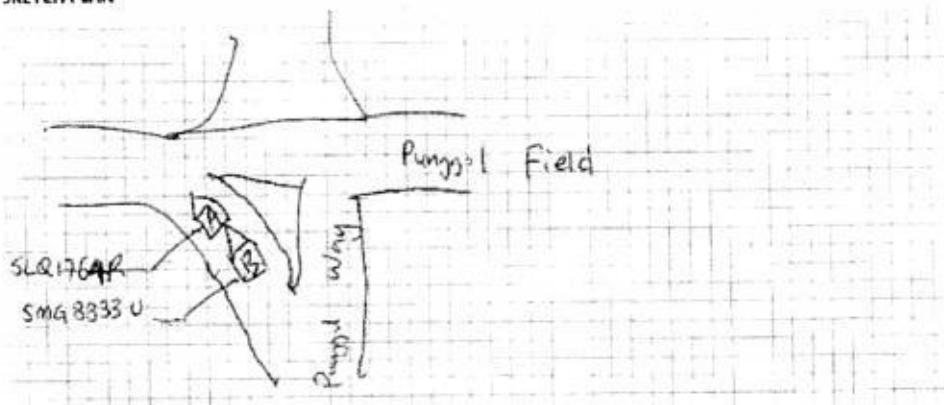
SKETCH PLAN

ON 19 October 2019 at 13:39 HRS, I WAS ON A
SLIP ROAD FROM PUNGOL WAY TOWARDS PUNGOL
FIELD WHEN SING 8833W HIT MY VEHICLE ON THE
BACK OF MY VEHICLE. AS I WAS GIVING WAY
TO THE TRAFFIC ON PUNGOL FIELD.
