## PRE-REPAIR INSPECTION REQUEST – PA7251B vs GT4998G (OI) on D.O.A.: 21/10/2019

**ACCIDENT INVOLVING MOTOR VEHICLES PA 7251B AND GT 4998G AT CHAMPIONS WAY CARPARK LOT 48/47 ON 21 OCTOBER 2019 AT 01:20.**

## VEHICLE DAMAGE INSPECTION REPORT

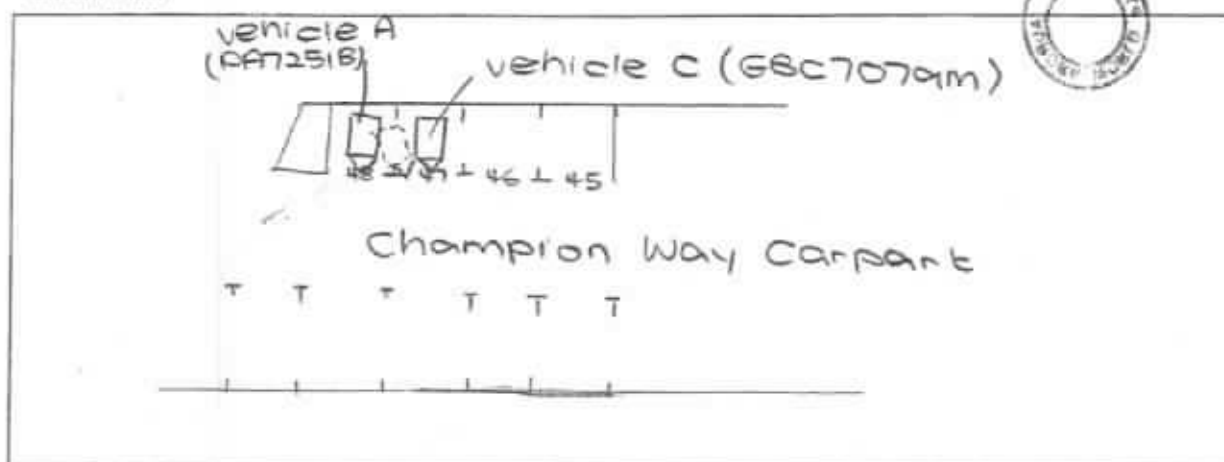
Sketch Plan #3 Pg. 1

On the 21/10/2019 at about 0520 hrs I went down back to my van and discovered it to be damaged with another lorry beside. I then called for traffic police and they came down.
