OD/TP Re-inspection / Evaluation

ACCIDENT VEHICLE SURVEY REPORT

Vehicle Reg No.:	SKX5684L	Odometer:	122665km
Make & Model:	BMW 320i	Colour:	White
Chassis number:	WBAPG56010NM91080	Date of accident:	01/08/2017
Year of Regn.:	17/06/2011	Date inspected:	02/08/2017
Repairer at:	N-51 Automotive Pte Ltd 2 Kaki Bukit Ave 2 #01-18 Kaki Bukit Auto Hub Singapore 417921

ADJUSTMENT ON REPAIR COST FOR VEHICLE NO. SKX 5684L

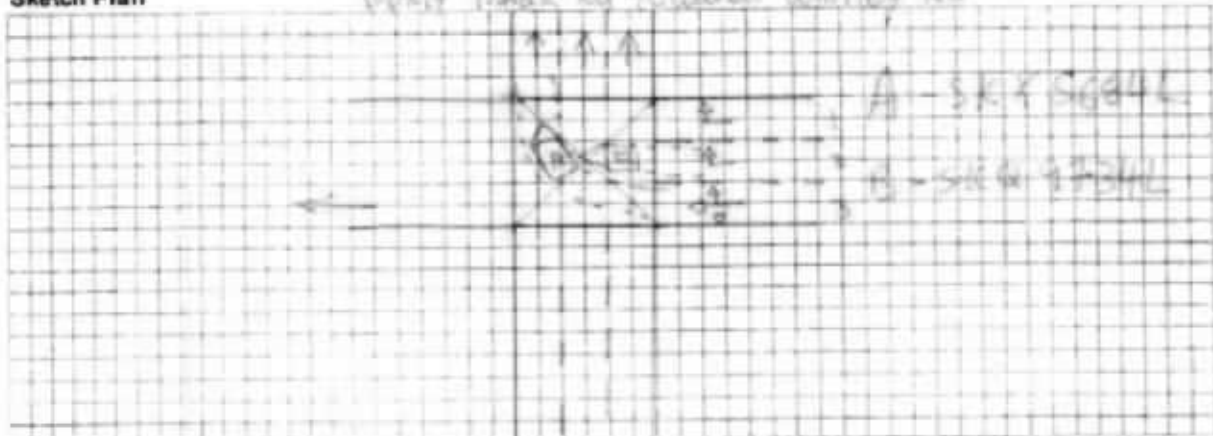
Sketch Plan #2

Bykit Timah Rd towards Whitley Rd

I was driving along Botolph Claydon rd towards Whitley rd
when I reaching the junction I making a right turn of a
(straight and turning right lane.)
suddenly a vehicle come straight and hit right side of the right
side of my vehicle. I notice the vehicle was on the (Turning Right only
lane).
I noticed from vehicle and realized a vehicle bearing (SKE 9734L)
was on the second lane which suppose to be right turn only lane,
but he drove straight ahead and cause the accident by his
front end enter the right side of my vehicle while I'm making a right
turn into Whitley Road.
Vehicle A - SKX 5689L
Vehicle B - SKE 9734L
