Insured Vehicle No	: SBD95G	Accident Date	: 08/10/2019
TP Vehicle No	: XE4518L	Assignment Date	: 25/10/2019
Make	: MERCEDES BENZ AROCS 3336K	Est. Duration of Repair	: 2
Date of Inspection	: 31/10/2019		
Inspection At	: VFIX AUTO PTE LTD

**ACCIDENT INVOLVING XE4518L AND SBD95G ON 08.10. 2019**

## VEHICLE DAMAGE INSPECTION REPORT

Our File No: CS/SMO19018958/EVF3N2

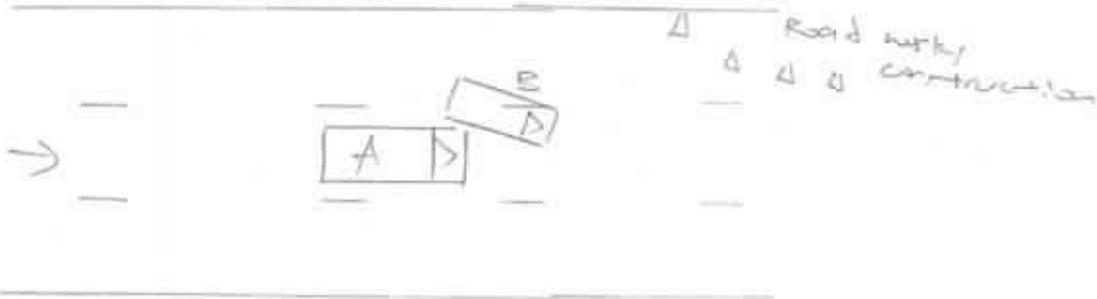
Accident Sketch Plan Pg. 1

On 8th October 2019 at 1230hrs, I was driving XE4518L along New Changi Road towards Bedok South Avenue 1 in the middle lane, suddenly a car(SBD95G) dashed out from my left and hit to my from left front portion. No one injured.

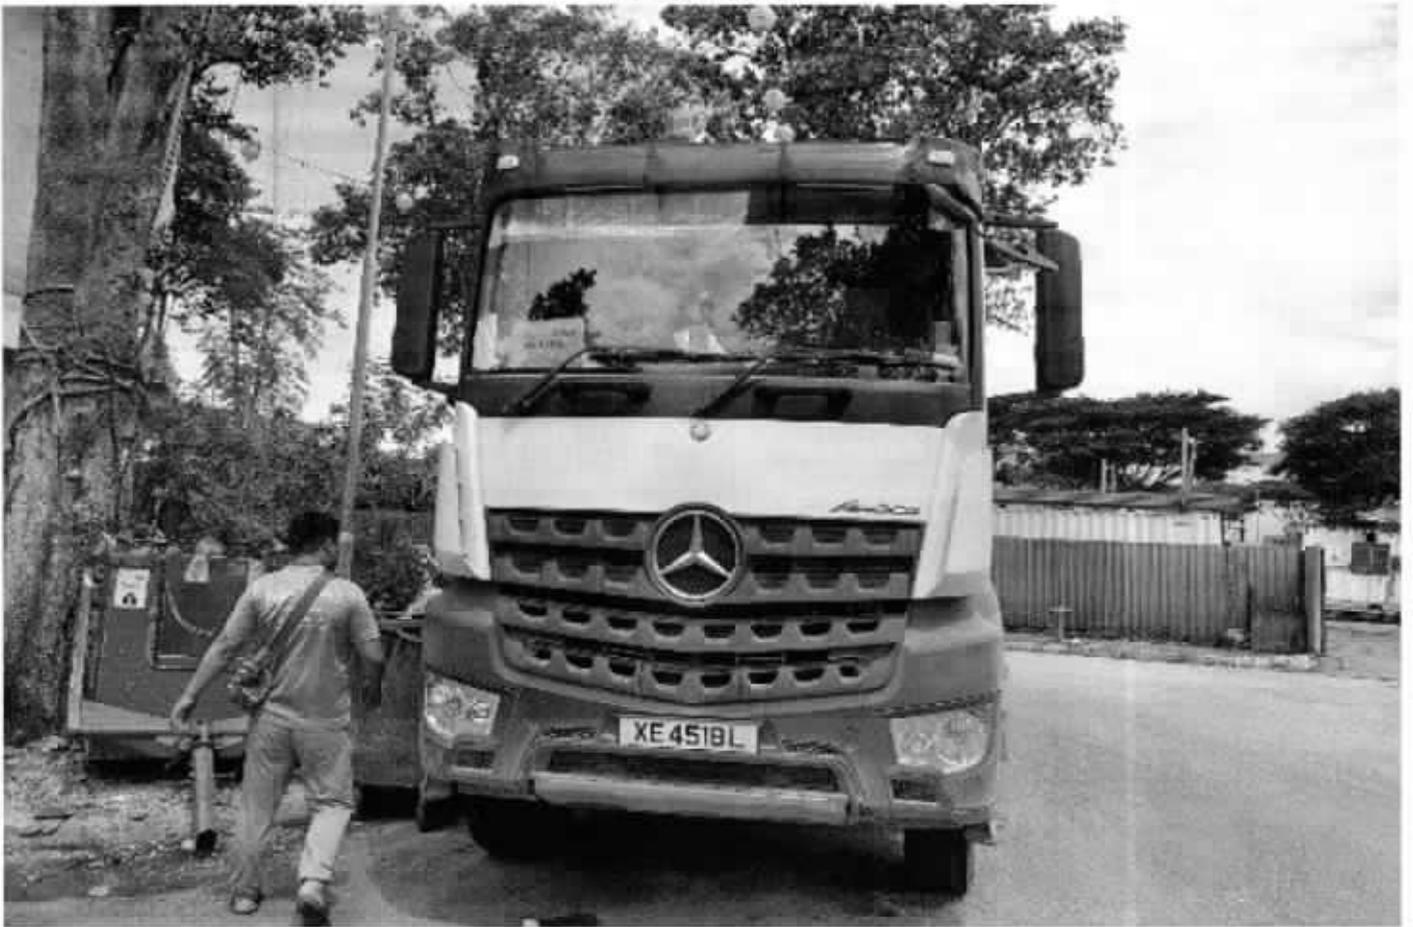
Accident Photo

The vehicle sustained impact / damages front portion and parts claimed are consistent to the accident.
