Preliminary Advice

Insured Vehicle No	: GBD9727H	Accident Date	: 21/10/2019
TP Vehicle No	: SMM3543H	Assignment Date	: 25/10/2019
Make	: HONDA SHUTTLE HYBRID	Est. Duration of Repair	: 4 days
Date of Inspection	: 25/10/2019		
Inspection At	: YEW TEE AUTOMOBILE TECH PTE LTD (KAKI BUKIT) BLK 25 KAKI BUKIT ROAD 4, #01-61 SYNERGY @ KAKI BUKIT SINGAPORE 417800

VEHICLE DAMAGE INSPECTION REPORT

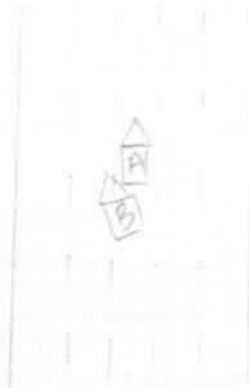
Sketch Plan #2

A = 9MM3543H

B = 9BD9727H

I was travelling straight, front car already stop and I was slowing down and stopped. After a few second, CAR B suddenly collided into my rear left portion with strong impact.
