To Inspect Vehicle No: SLW 8010E

PRE-REPAIR INSPECTION REQUEST – SLW8010E vs SLA9590G (OI) on D.O.A.: 22/10/2019

ACCIDENT INVOLVING SLW 8010 E & SLA 9590 G ON 22 OCTOBER 2019 ALONG YISHUN AVENUE 2 TOWARDS KHATIB MRT AT ABOUT 1905 HOURS
(NOTICE TO INSURER TO CONDUCT PRE-REPAIR SURVEY WITHIN 2 WORKING DAYS PURSUANT TO PARAGRAPH 6.2 OF PRE-ACTION PROTOCOL FOR NIMA CASES)

VEHICLE DAMAGE INSPECTION REPORT

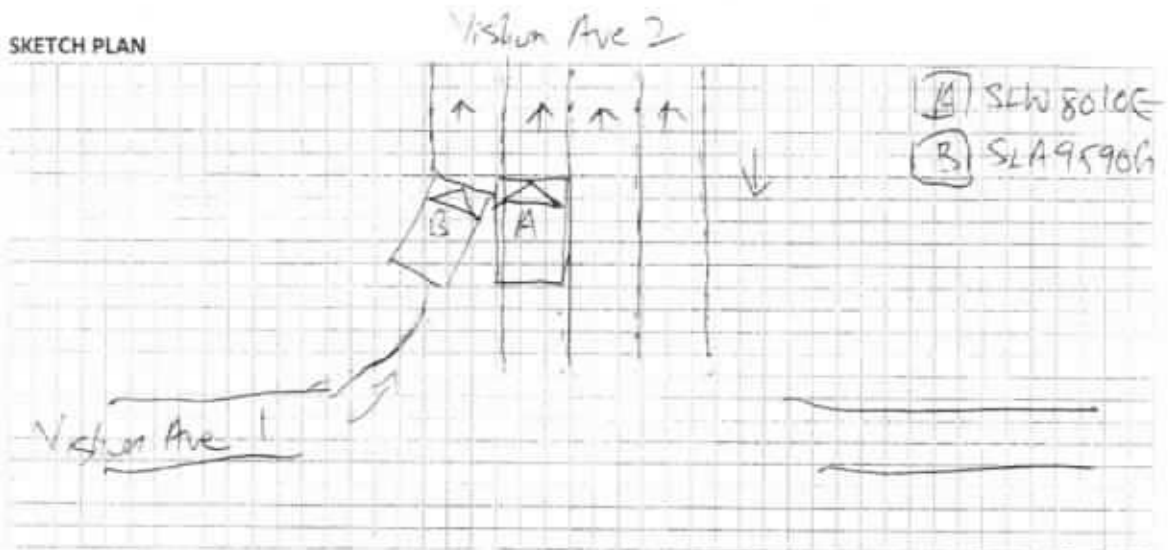
SKETCH PLAN

On 22/10/2019 @ approx 1907 hrs I was originally at Yishun Ave 2 toward Lantor @ the cross junction of Yishun Ave 1. I was making a U-turn back toward Yishun Ave 2 toward Khatib MRT station. After I made a U-turn, I maintain at lane 3 & cut off sudden vehicle SLA 9590G which was originally from Yishun Ave 1 filter to Yishun Ave 2 hit onto my motorcar left front door. After the hit the motorcar SLA 9590G continue driving without stopping. I chased after the motorcar & back at it then the motorcar SLA 9590G then proceed to stop at busstop. My motorcar suffered dents, scratches on left front of motorcar. I have a in-car camera & the video had been downloaded.
