INITIAL INSPECTION REPORT OF VEHICLE NO. SGA 7122Y.

REPAIR ESTIMATE FOR TOYOTA ALTIS - SLA 7122 Y

ADJUSTMENT ON REPAIR COST FOR VEHICLE NO. SGA 7122Y

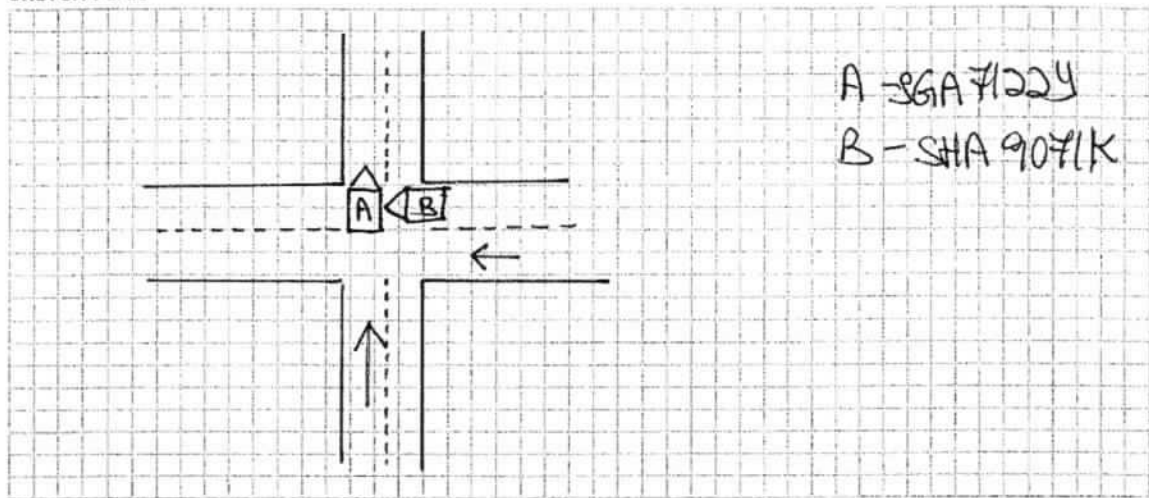
SKETCH PLAN

DESCRIBE CIRCUMSTANCES OF THE ACCIDENT

On 25/10/2019 @ 1300 hrs. I was driving along Changi TH towards T# departure. While driving straight suddenly a taxi come out from my right side beating "Red" traffic light and collided onto my vehicle right portion.
