## VEHICLE DAMAGE INSPECTION REPORT

Our File No: CS/CTI19019308/GSF3N2

| Claimant Vehicle No : | SKF5603R | Insured Vehicle No : | GY450U | |

| Make & Model: | TOYOTA COROLLA ALTIS, 1.6 (A) | Chassis No: | MR053REE104138560 |

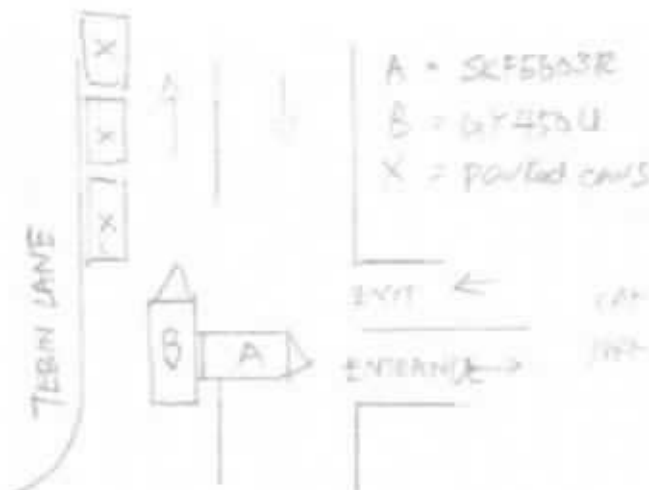
## SKETCH PLAN

ON THE 27 OCT 2019 at about 10-00pm I was travelling towards Tebin Lane as I was about to enter into the car park. Lorry (B) QY4504 came from behind me and hit my bumper.
