NTUC INCOME INSURANCE CO-OPERATIVE LTD Ref: NS/INC19019382/K1vf3n2			
73 BRAS BASAH ROAD #05-01 NTUC TRADE UNION HOUSESINGAPORE 189556		Date: 13-11-2019	 
		Code: INC4

1. Policy Particulars :- THIRD PARTY CLAIM			
Insured Veh.	GBE 7396L	Veh. Inspected	SHA 6949Z
Policy No.	5088445993-02	Coverage (\$)	0.00
Claim No.	MT/1069374-002	Excess (\$)	0.00
Assign From		Assign Date	01/11/2019

ADJUSTMENT ON REPAIR COST FOR VEHICLE NO. SHA 6949Z

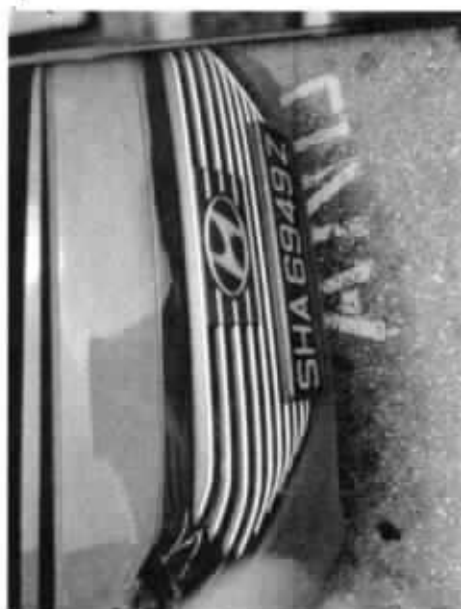
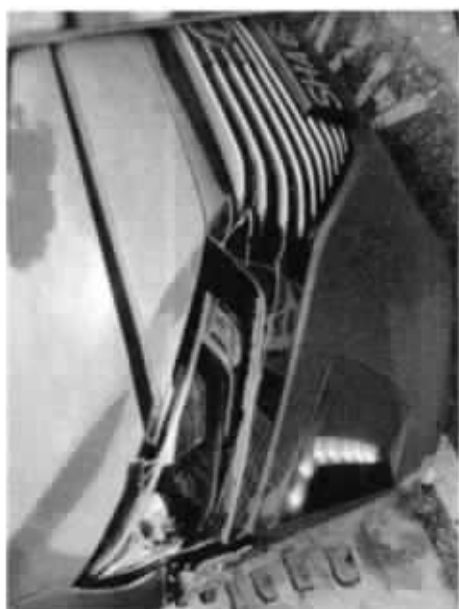
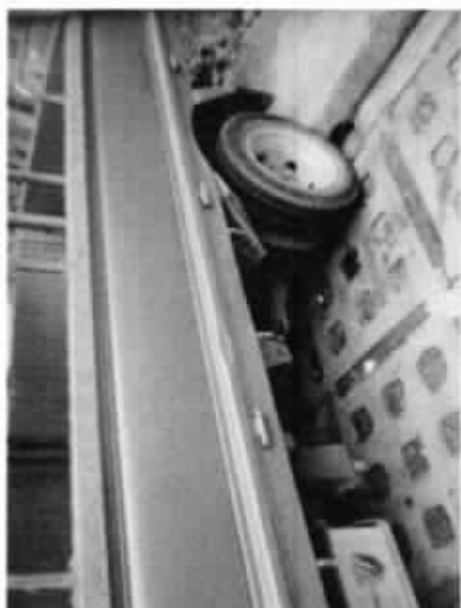
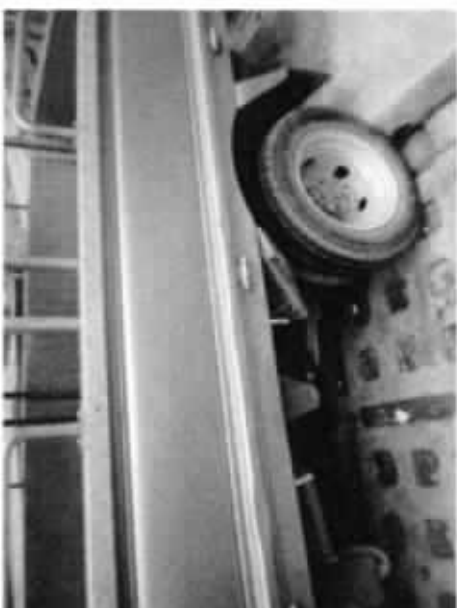
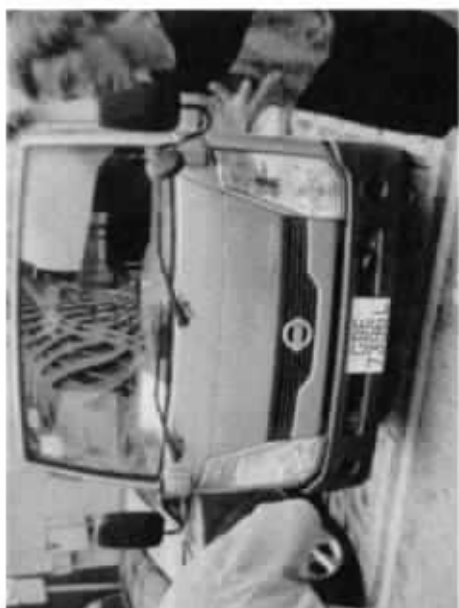
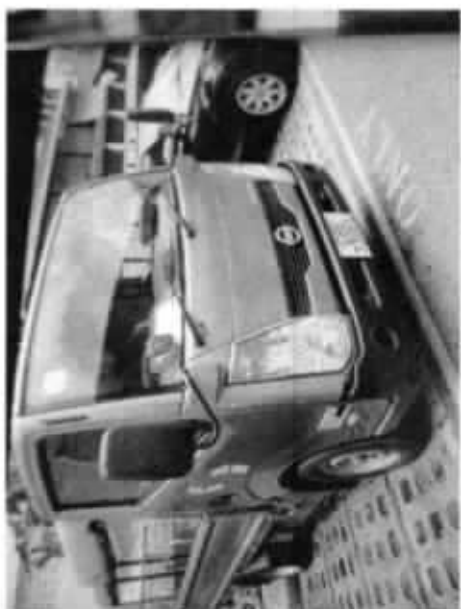
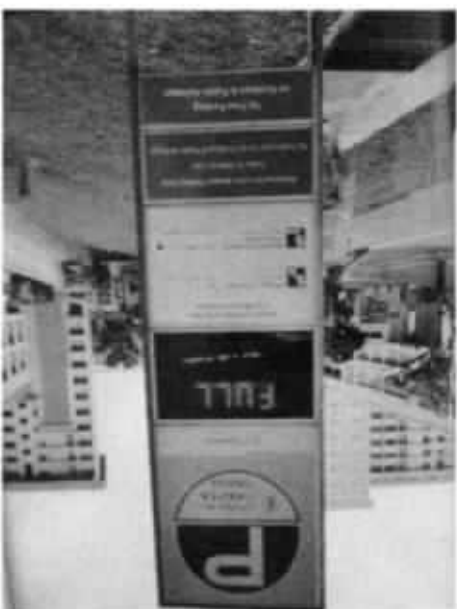
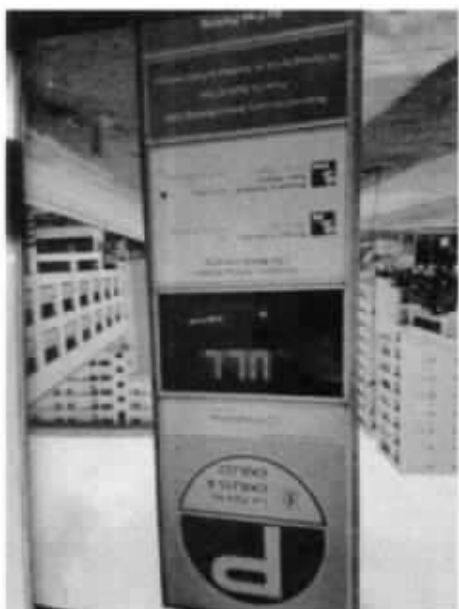
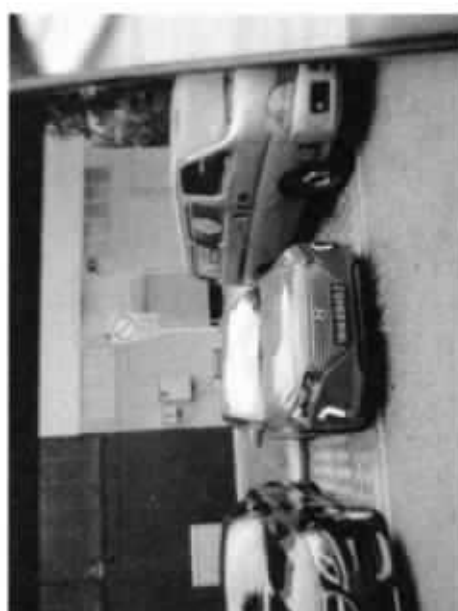
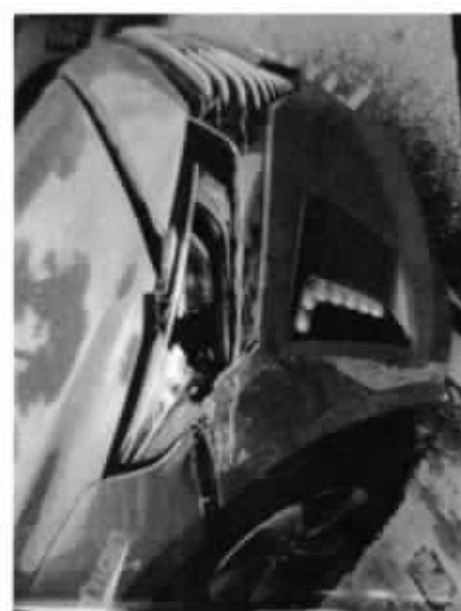
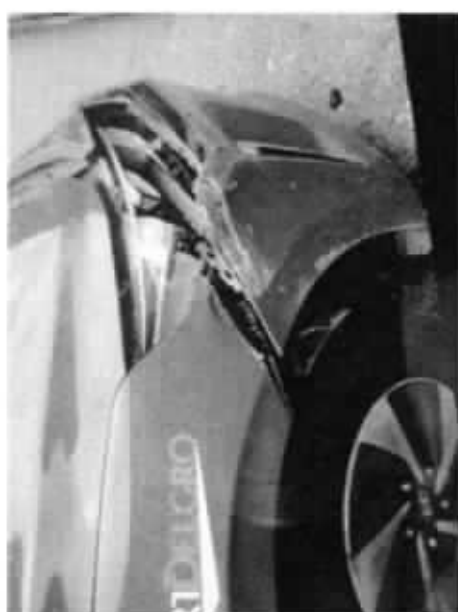
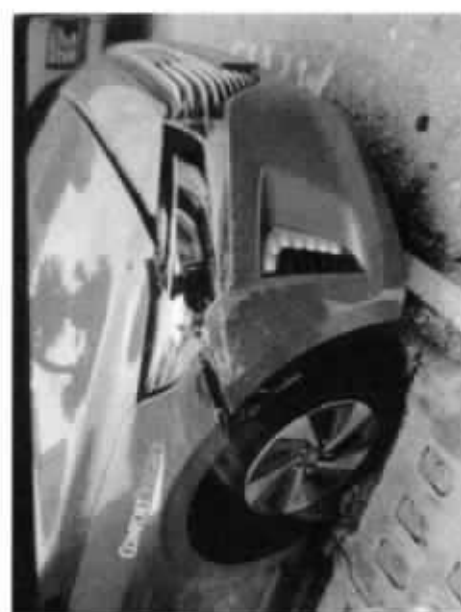
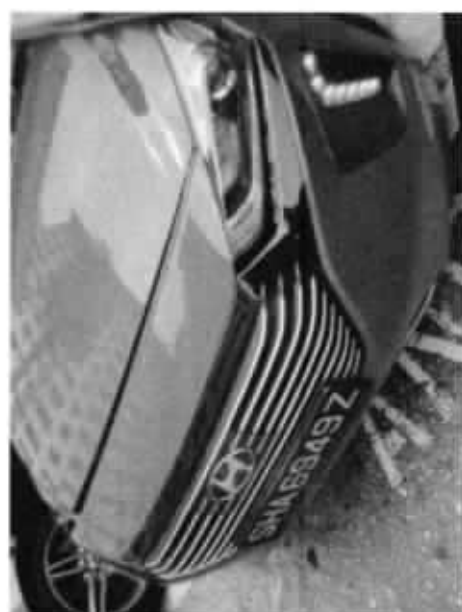
4. Description of Damages			
THE VEHICLE SUSTAINED DAMAGES AT THE O/S FRONT PORTION. DAMAGES SEE DETAILS.			
5. General Information			
Accident Date	31/10/2019	Inspection Date	01/11/2019
Survey held at	COMFORTDELGRO ENGINEERING PTE LTD 59 LOYANG DRIVE SINGAPORE 508969		
5a. Remarks			
A)THE INSPECTION WAS CONDUCTED ON A"WITHOUT PREJUDICE" BASIS. B)IN ACCORDANCE TO YOUR INSTRUCTIONS, WE HAVE NOT AUTHORISED REPAIRS.			
5b. Estimate Days of Repair			
ESTIMATED NORMAL PERIOD FOR REPAIR:		3 Working Days

Qty	Description of Parts	Condition	Estimate By Workshop (\$)	Our Adjusted (\$)
<u>REPLACEMENT OF PARTS</u>				
1	BONNET	TO REPAIR SEE LABOUR	2,253.80	-
1	BONNET LOCK	SERVICEABLE	127.30	-
1	RADIATOR GRILLE	CRACKED	1,409.10	1,409.10
1	FRONT BUMPER COVER	CRACKED	418.30	418.30
1	FRONT BUMPER GRILLE (RH)	CRACKED	186.90	186.90
1	FRONT BUMPER CENTRE MOULDING	CRACKED	188.00	188.00
2	FRONT BUMPER MOULDING @\$93.60	SERVICEABLE	187.20	-
1	FRONT BUMPER LOWER STIFFNER	SERVICEABLE	85.10	-
1	FRONT BUMPER LIP	SERVICEABLE	35.10	-
2	FRONT BUMPER BRACKET TOP (LH/RH) @\$35.00	O/S CRACKED / N/S SERVICEABLE	70.00	35.00
2	FRONT BUMPER BRACKET (LH/RH) @\$28.00	O/S CRACKED / N/S SERVICEABLE	56.00	28.00
10	FRONT BUMPER CLIPS	NOT NECESSARY	22.00	-
1	HEADLAMP SUPPORT PANEL ASSY	SERVICEABLE	949.30	-
2	HEADLAMP (LH/RH) @\$1198.80	O/S CRACKED / N/S SERVICEABLE	2,397.60	1,198.80
1	FRONT FENDER (RH)	BUCKLED	490.70	490.70
1	FRONT FENDER RETAINER	SERVICEABLE	41.40	-

1	EMBLEM-BLUE DRIVE (RH)	NECESSARY	26.60	26.60
1	WIPER CONTAINER	SERVICEABLE	61.90	-
1	WIPER CONTAINER MOTOR	SERVICEABLE	75.00	-
	LESS 20% DISCOUNT		-1,816.26	-796.28
			7,265.04	3,185.12
<u>SPECIAL NETT ITEMS</u>				
1	FRONT FENDER ADVERTISEMENT LOGO (RH)(SN)	NECESSARY	100.00	100.00

100.00	100.00
<u>LABOUR</u>				
	PANEL BEATING.INCLUSIVE OF THE REPAIR OF BONNET.		700.00	480.00

Qty	Description of Parts	Condition	Estimate By Workshop (\$)	Our Adjusted (\$)
	SPRAY PAINTING CHARGE.		700.00	600.00
	WIRING CHARGE.		50.00	20.00
	TUFF KOTE.		50.00	20.00
	TOWING CHARGE.		90.00	-
	REMOVE/REFIX AIRCON & REFILL GAS.	NOT NECESSARY	150.00	-
			1,740.00	1,120.00
GRAND TOTAL			9,105.04	4,405.12

RECOMMENDED COST OF REPAIRS (CONFIRMED)				4,405.12
---	--	--	--	----------
