To Inspect Vehicle No: SLA 347R

The UIC / Chassis frame / Body Structure affected due to collision.

VEHICLE DAMAGE INSPECTION REPORT

Date Inspected: 05/11/2019 Inspected At: 27A Tanjong Penjuru
Singapore 609042
Repairer: Trans Eurokars Pte Ltd

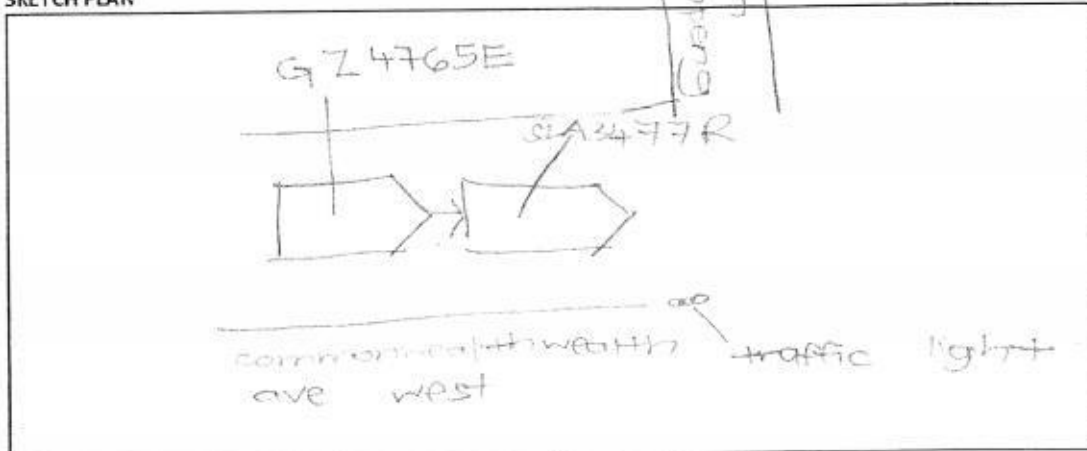
Sketch Plan #2 Pg. 1

I was driving along commonwealth ave east on 25/10/19 at 7:05pm and the traffic light changed colour. I slowed down and came to a stop. When I looked into my rear view mirror and noticed the vehicle GZ4765E was still approaching quickly. I released my brake to move forward a little but GZ4765E still collided into my car SLA3477R.

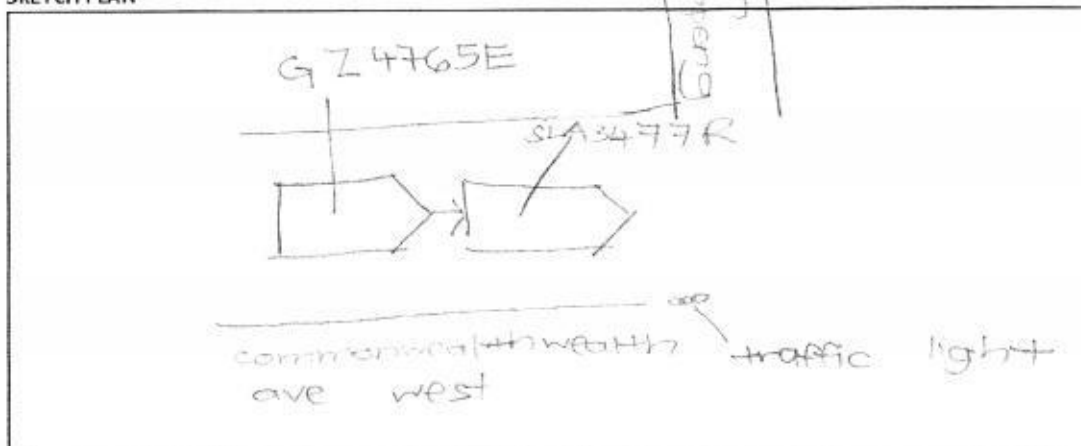
Accident Sketch Plan Pg. 1

I was driving along commonwealth ave east on 25/10/19 at 7:05pm and the traffic light changed colour from green to amber. I slowed down and came to a stop. When I looked into my rear view mirror and noticed the vehicle GZ4765E was still approaching quickly. I released my brake to move forward a little but GZ4765E still collided into my car SLA3477R.
