## VEHICLE DAMAGE INSPECTION REPORT

Our File No: CS/TMI19019499/FSF3E2

Claimant Vehicle No : SHA3745P

Make &amp; Model: HYUNDAI I40, 1.7 D CRDi (A)

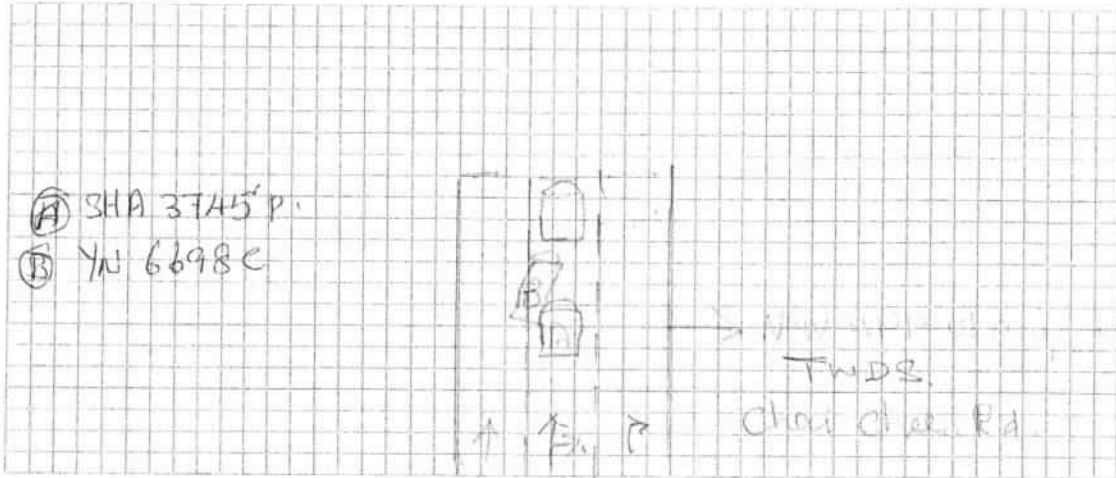
## SKETCH PLAN

On 2/11/2019 at about 1550 hrs, I vehicle A were queue up at traffic light junction. There was few car ahead of me. When traffic green the road started to move, there was a big space ahead of me. Suddenly vehicle B Cuts in sharply and brush against my left front bumper and it drop.
