VEHICLE DAMAGE INSPECTION REPORT

Handling Insurer:	China Taiping Insurance (Singapore) Pte. Ltd.	Policy No:	DMCVSN30159119000
Claimant Vehicle No :	GBE3782G	Insured Vehicle No :	GT9750X
Date of Loss:	01/11/2019	Nature of Claim:	TP
		Claim No:	SNM19D205209C02

Reg No:	GBE3782G	Engine No:	D4CBF874720
Make & Model:	HYUNDAI H-1 STAREX, 2.5 D CRDi (A)	Chassis No:	KMFWBX7KMGU786396
Reg. Date:	20/11/2015 (Man. Year: 2015)	Odometer:	169142 km
Colour:	White		
Engine Capacity:	2497 cc		
Market Value/New Car Price:	N/A		
Sum Insured (\$\$):	Market Value/New Car Price

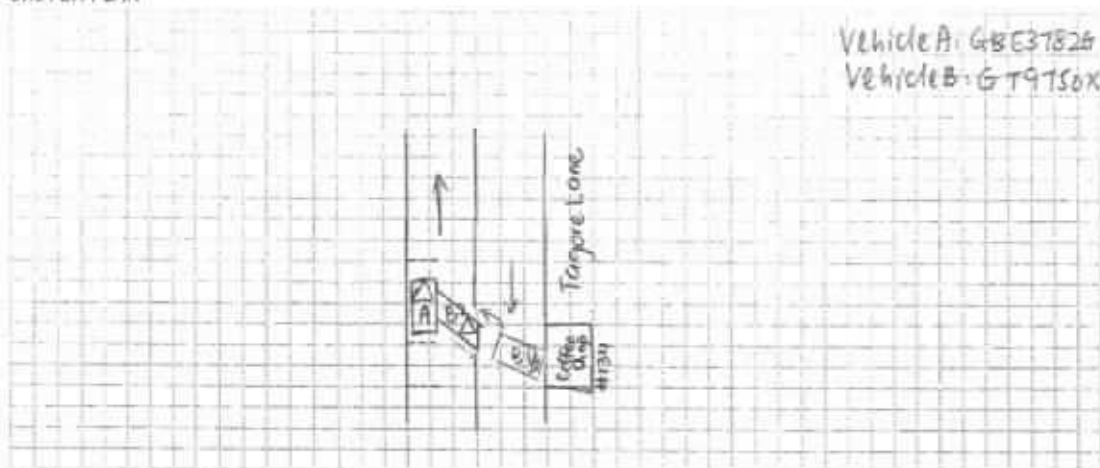
SKETCH PLAN

On 01-11-2019 at about 17:45hrs, I parked my vehicle at Tagore Lane 158. I went to a nearby coffeeshop after parking.

After about 5 minutes, I went over to pick up my vehicle. I realised that vehicle B: GT9750X had collided onto my front right portion of my stationary vehicle while he was reversing. The driver of vehicle B, wrote a statement admitting his fault. I have attached the statement together with this report.
