**Preliminary Advice**

| Vehicle No | : SML3282R | Accident Date | : 06/11/2019 |
| Make | : BMW 523I | Policy No. | : DMPCSN3041191900 |

## VEHICLE DAMAGE INSPECTION REPORT

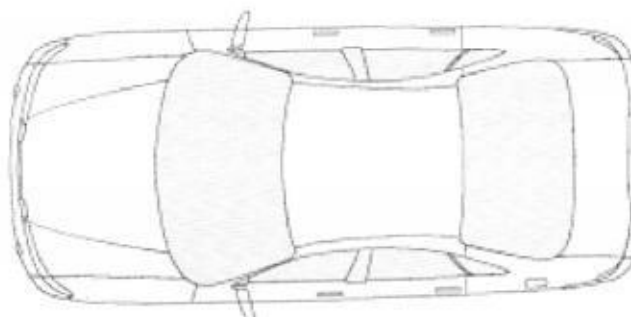
### Damage Areas

The vehicle sustained impact / damages front o/s portion and parts claimed are consistent to the accident.
