VEHICLE DAMAGE INSPECTION REPORT

Our File No: CS/EGI19019968/USD3N2
Date: 20/01/2020

Handling Insurer:	ERGO Insurance Pte. Ltd.	Policy No:	
Claimant Vehicle No :	GBB9075R	Insured Vehicle No :	GBC5952E
Date of Loss:	04/11/2019	Nature of Claim:	TP
		Claim No:	CDMCG19002079

Reg No:	GBB9075R		
Make & Model:	NISSAN CABSTAR, 3.0 5M/T ABS 2DR 2WD Turbo (A)	Engine No:	ZD30257184K
Reg. Date:	13/09/2010 (Man. Year: 2010)	Chassis No:	JN1SC2F24Z0801512
Colour:	Silver	Odometer:	392048 km
Engine Capacity:	2953 cc		
Market Value/New Car Price:	N/A		
Sum Insured (S\$):	Market Value/New Car Price

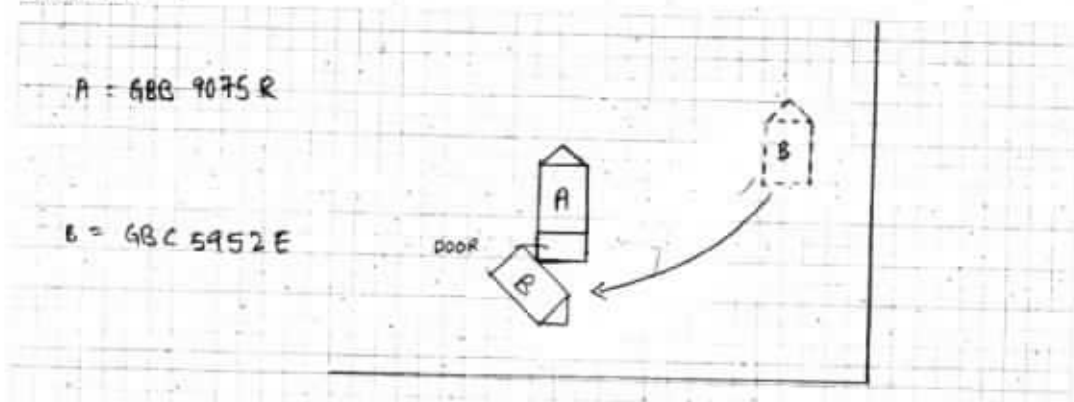
SKETCH PLAN

I was stationary at the above-mention location, unloading stocks with my colleague, vehicle B reversed & collided into the Rear (RH) portion of my door.

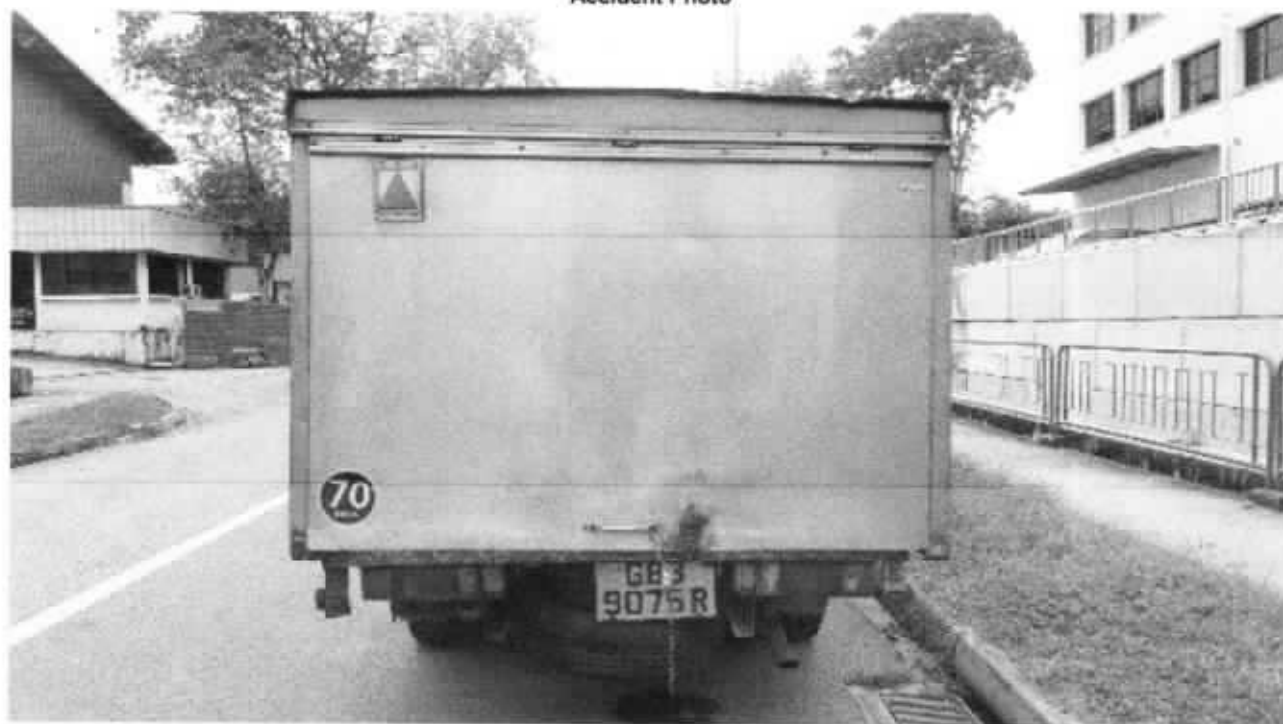
Accident Photo

The U/C / Chassis frame / Body Structure affected due to collision.

No	Particulars	Lab.Type	Repairer's	Amount
Labour Items				
1	TO REPAIR REAR ALUMINIUM CANOPY BOX DOOR } (\$300)(50%)	New	1,800.00	150.00
2	TO JACK & DISMANTLE ALUMINIUM CANOPY FRAME STRUCTURE }	New	800.00	0.00
3	TO SPRAY & PAINTING WHOLE REAR BOX DOOR (\$300)(50%)	New	800.00	150.00
Gross Labour Cost (\$\$)			3,400.00	300.00
