## ASSIGNMENT

To inspect Vehicle No:

SHC 4377B

THE VEHICLE SUSTAINED DAMAGES AT THE N/S BODY.
DAMAGES SEE DETAILS.

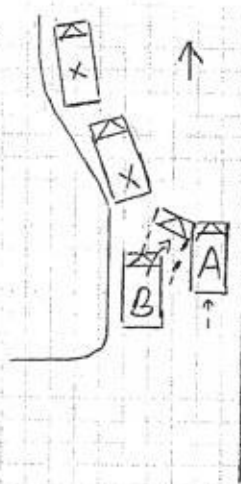
### SKETCH PLAN

I WAS DRIVING STRAIGHT ALONG THE DRIVE WAY OF BUKIT TIMAH ROAD NEAR THE TAXI STAND. SUDDENLY THE VEHICLE SLG8633S WHICH WAS QUEUING TO THE TAXI STAND CUT OUT ABRUPTLY INTO MY TRAVEL PATH AND COLLIDED ONTO THE LEFT FRONT PORTION OF MY TAXI. NO PAX

A-SHC 4377B  
B-SLG 8632S
