**PRE-REPAIR INSPECTION REQUEST – SKT9450P vs SMG5631E (OI) on D.O.A.: 18/11/2019**

## VEHICLE DAMAGE INSPECTION REPORT

Our File No: CS/AIG19020474/KTD3

Handling Insurer: AIG Asia Pacific Insurance Pte. Ltd. Policy No:  
 Claimant: SKT9450P Insured Vehicle No: SMG5631E  
 Vehicle No: SKT9450P Nature of Claim: TP Claim No: 9445820870SG  
 Date of Loss: 18/11/2019

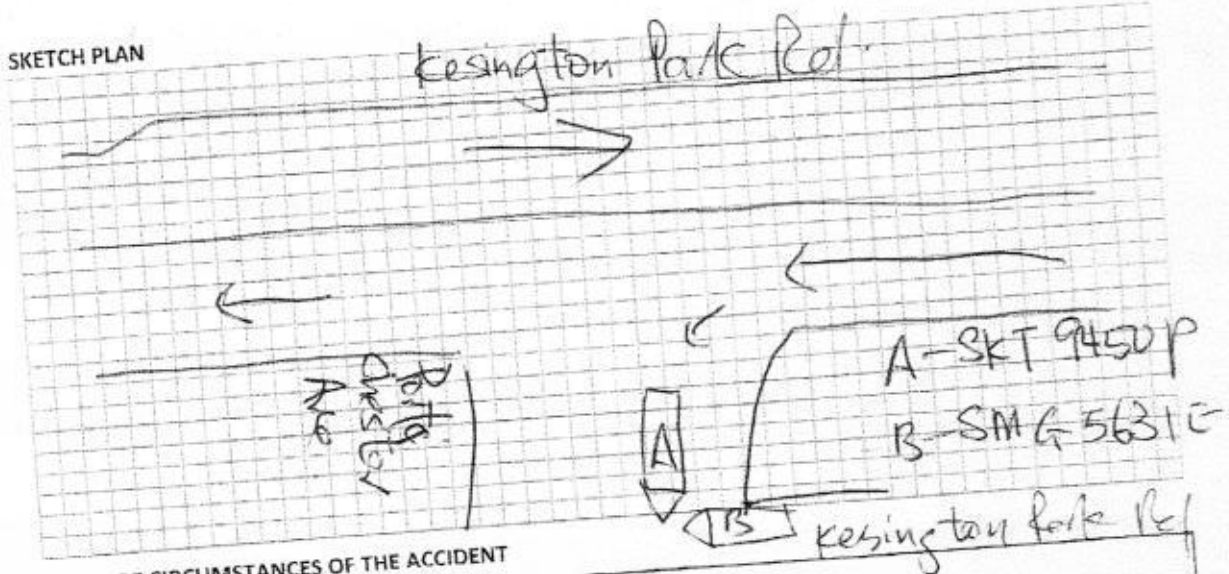
SKETCH PLAN

As I was driving along Portchester Ave, a car from the slip Rd (Kensington Park Rd) suddenly came out and hit me on my left.
