## LKK Auto Consultants Pte Ltd

Vehicle No. SHB 8437R  
Insured Veh. GBH 8329J  
Claim No. SNM19D205654  
Policy No. DMCVSN1832611901  
Accident Date 25/11/2019  
Inspection Date 25/11/2019

### ADJUSTMENT ON REPAIR COST FOR VEHICLE NO. SHB 8437R

PHOTOGRAPHS FOR VEHICLE NO. SHB 8437R

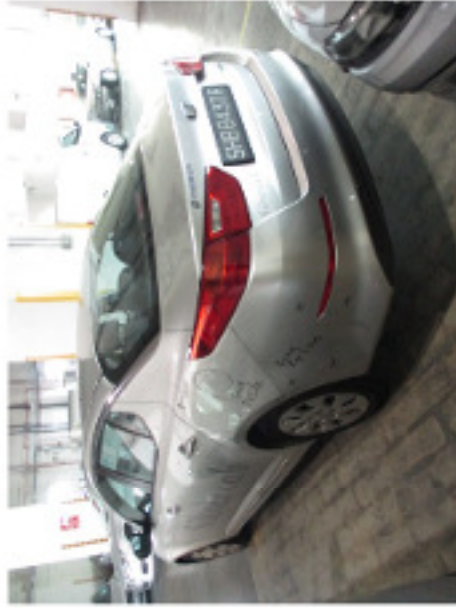
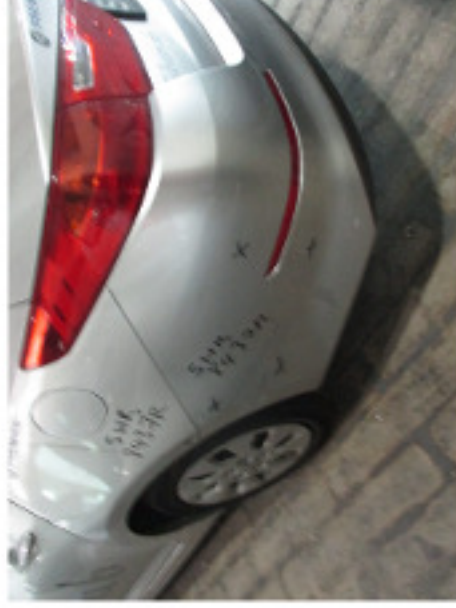
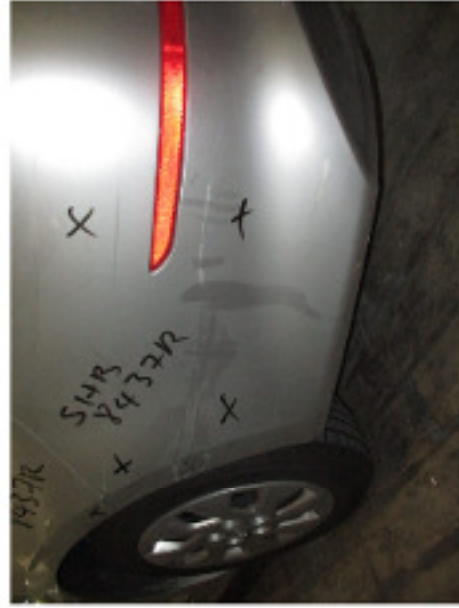
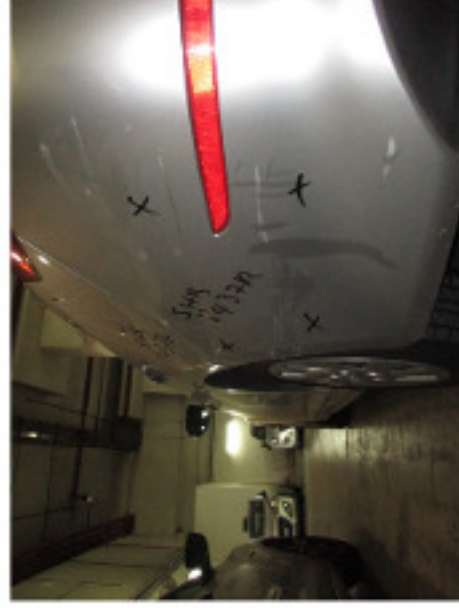
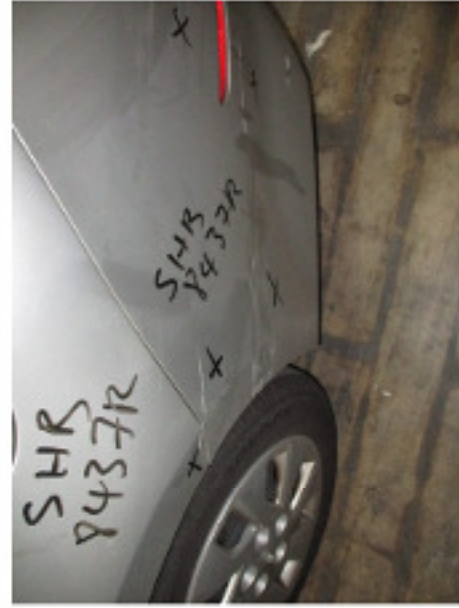
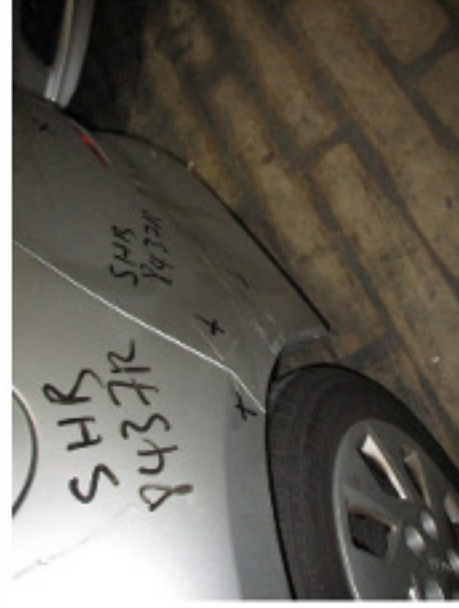
<b>4. Description of Damages</b>				
THE VEHICLE SUSTAINED DAMAGES AT THE REAR & N/S REAR PORTION. DAMAGES SEE DETAILS.				
<b>5. General Information</b>				
Accident Date	25/11/2019	Inspection Date	25/11/2019	
Survey held at	PREMIER AUTOMOTIVE SERVICES PTE LTD 23 CHANGI SOUTH AVENUE 2 #01-02 SINGAPORE 486443			
<b>5a. Remarks</b>				
A)THE INSPECTION WAS CONDUCTED ON A"WITHOUT PREJUDICE" BASIS. B)IN ACCORDANCE TO YOUR INSTRUCTIONS, WE HAVE NOT AUTHORISED REPAIRS.				
<b>5b. Estimate Days of Repair</b>				
ESTIMATED NORMAL PERIOD FOR REPAIR:		<b>3 Working Days</b>

Qty	Description of Parts	Condition	Estimate By Workshop (\$)	Our Adjusted (\$)
	<b><u>REPLACEMENT OF PARTS</u></b>			
1	WHEEL COVER	NOT NECESSARY	116.00	-
1	REAR LH FENDER (NPA)	TO REPAIR SEE LABOUR	-	-
1	REAR BUMPER (NPA)	TO REPAIR SEE LABOUR	-	-
	LESS 10% DISCOUNT		-11.60	-

104.40	-
	<b><u>SPECIAL NETT ITEMS</u></b>			
1	REAR N/S FENDER STICKER (SN)	NECESSARY	60.00	60.00
1	SUNDRY (SN)	NECESSARY	50.00	30.00
			110.00	90.00
	<b><u>LABOUR</u></b>			
	TO CHECK REAR N/S WHEEL ALIGNMENT.	NOT NECESSARY	60.00	-
	TO DISMANTLE /REFIT THE INNER GARNISHES ,INNER LININGS ,INNER TRIMS ,CUSHION SEAT, CARPET ,ETC TO FACILITATE REPAIRS.		180.00	50.00
	TO LABOUR CHARGE FOR DISMANTLE AND RENEW THE ACCIDENT DAMAGED PARTS.INCLUDING TO KNOCK - OUT ,STRAIGHTEN ,REPAIR ,RESHAPE OF THE REAR N/S FENDER ,REAR BUMPER ETC.		550.00	360.00
	TO PUTTY AND SPRAY PAINTING ON THE REAR BUMPER ,REAR N/S FENDER .		400.00	400.00
	TO APPLY RUSTPROOFING ON THE REPAIRED AND REPLACED PANELS.		80.00	30.00
			1,270.00	840.00
	<b>GRAND TOTAL</b>		<b>1,484.40</b>	<b>930.00</b>
	<b>RECOMMENDED COST OF REPAIRS</b>			<b>930.00</b>
