Vehicle No. GZ 2918U
Insured Veh. SKG 3427R
Claim No. VC013211
Policy No. 8-V0023551-MVA
Accident Date 20/11/2019
Inspection Date 25/11/2019

2. Vehicle Particulars & Condition				
Make & Model	SSANGYONG MUSSO	c.c	2874	
Engine No.	HIDDEN	Year of Reg.	2006	
Chassis No.	KPAWA2EDS6P414056	Colour	BLACK	
Odometer	351026	Steering	IN ORDER	
Brakes	IN ORDER	Modification	SPORTS RIM	
General	GOOD

ADJUSTMENT ON REPAIR COST FOR VEHICLE NO. GZ 2918U

PHOTOGRAPHS FOR VEHICLE NO. GZ 2918U

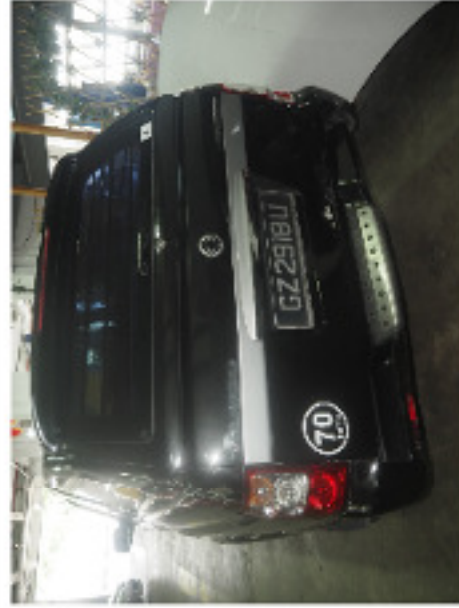
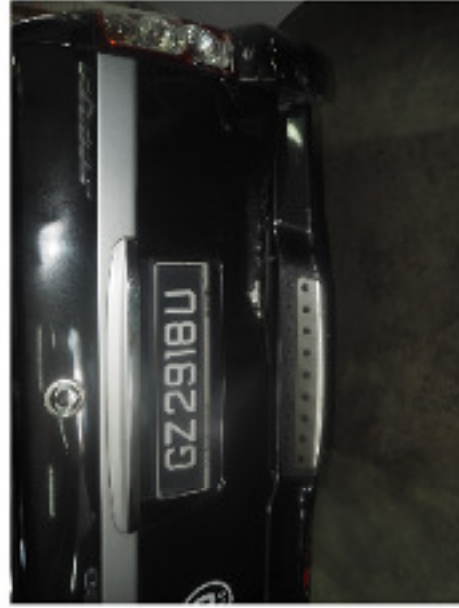
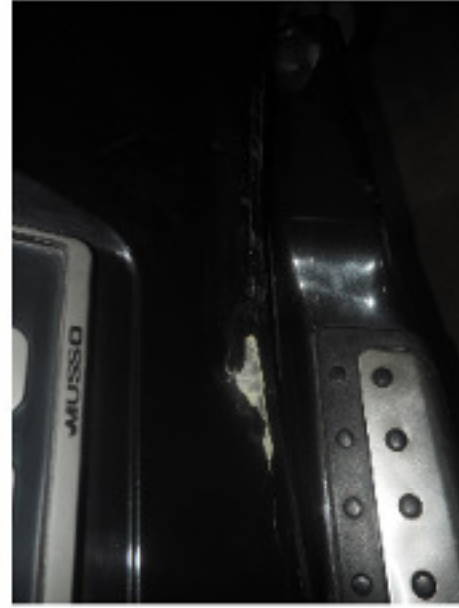
4. Description of Damages				
THE VEHICLE SUSTAINED DAMAGES AT THE REAR PORTION.				
DAMAGES SEE DETAILS.				
5. General Information				
Accident Date	20/11/2019	Inspection Date	25/11/2019	
Survey held at	MG SOLUTION PTE LTD 23 KAKI BUKIT AVE 4 (SOUTH WING) #02-03B VICOM INSPECTION CENTRE, SINGAPORE 415933			
5a. Remarks				
A)THE INSPECTION WAS CONDUCTED ON A"WITHOUT PREJUDICE" BASIS. B)IN ACCORDANCE TO YOUR INSTRUCTIONS, WE HAVE NOT AUTHORISED REPAIRS.				
5b. Estimate Days of Repair				
ESTIMATED NORMAL PERIOD FOR REPAIR:		5 Working Days

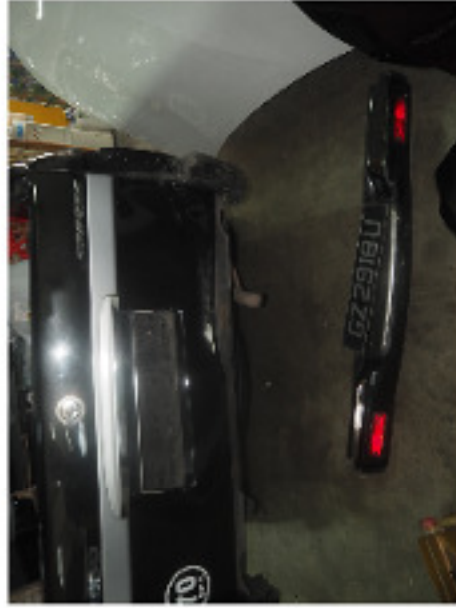
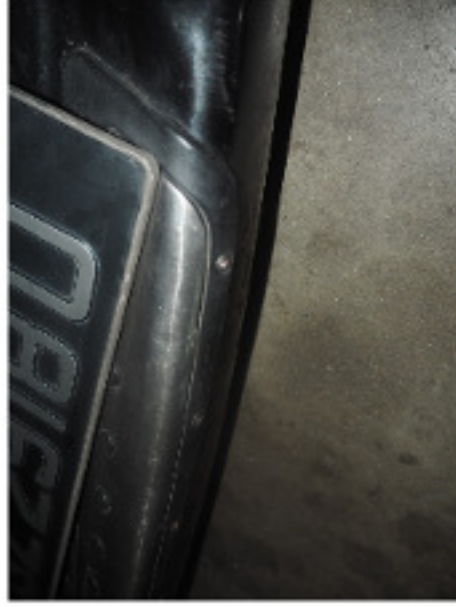
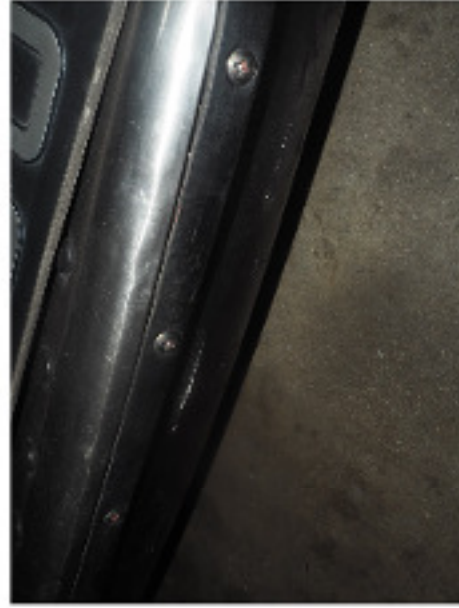
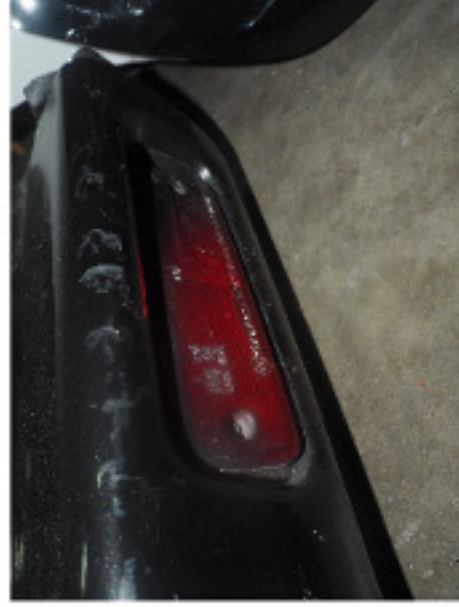
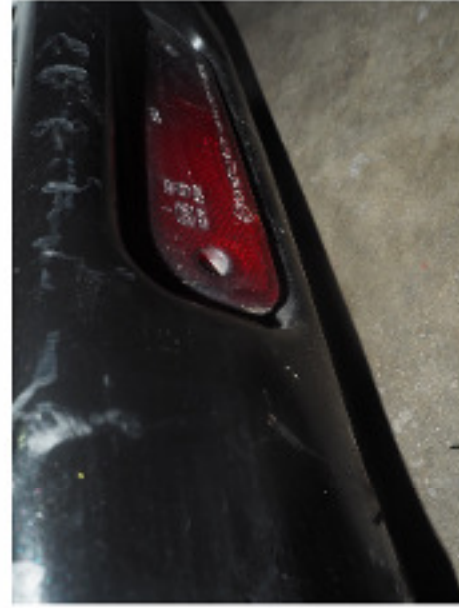
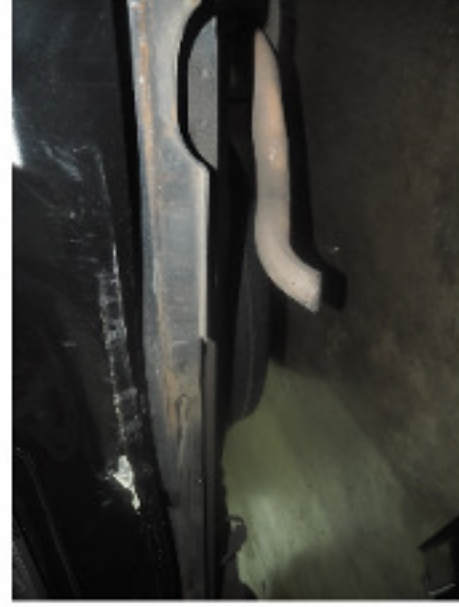
PHOTOGRAPHS FOR VEHICLE NO. GZ 2918U

RE-INSPECTION
