To Inspect Vehicle No: XD 4770D

**Preliminary Advice**

The vehicle sustained impact / damages n/s front portion and parts claimed are consistent to the accident.

## VEHICLE DAMAGE INSPECTION REPORT

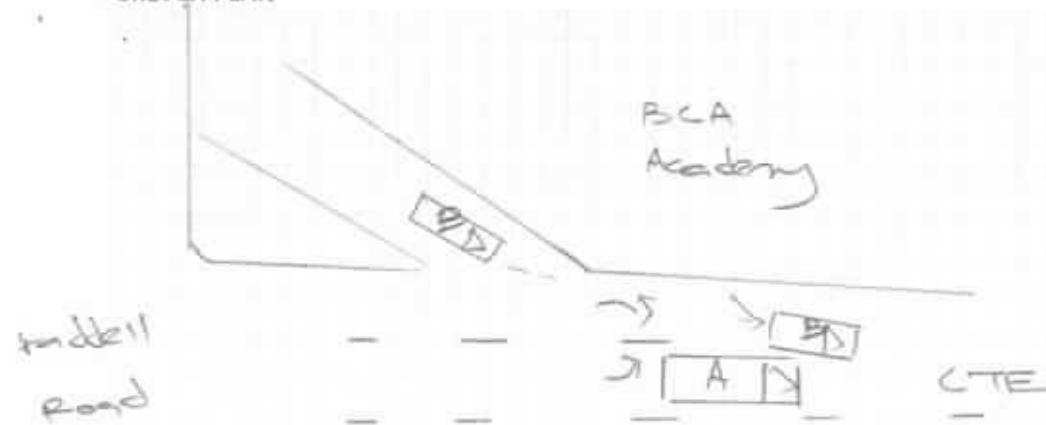
# SKETCH PLAN

A: XD 4770D

B: SJR 717C

On 27/11/2019 at around 10:30hr, I drove my lorry XD4770D from Buddell road turning to cte. Upon reaching at the merging lane, car SJR717C came out from side road squeeze through on my left & resulting her car hit my left hand glazed against my lorry front left portion. Nobody was injured.
