Preliminary Advice

Vehicle No	: SLH8399M	Accident Date	: 29/11/2019
Make	: MAZDA 3	Policy No.	:
Assignment Date	: 04/12/2019	Excess	: S\$0.00
Date of Inspection	: 05/12/2019	Est. Duration of Repair	: 3.00
Inspection At	: TRANS EUROKARS PTE LTD (UBI) 5 UBI CLOSE SINGAPORE 408605

VEHICLE DAMAGE INSPECTION REPORT

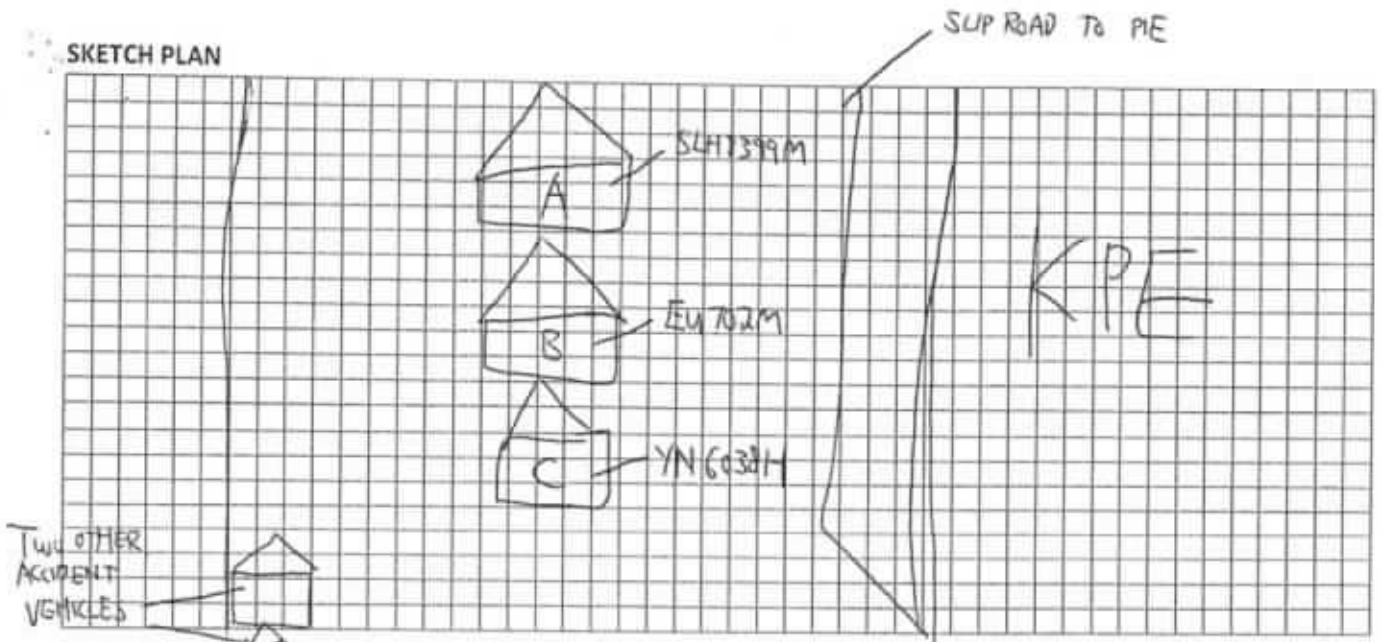
SKETCH PLAN

LOCATION: I was travelling on the KPE ~~road~~ towards the City. When taking the slip road leading to the PIE, I noticed that there were two vehicles involved in an accident on the slip road. I ~~to~~ moved right to give some space for the accident vehicles and turned back into the line on the slip road after I was clear of them. I came to a complete stop behind a car as I waited in line on the slip road. A few seconds later, my car was hit from behind, ~~and~~ another impact was felt a few seconds after the first. Upon alighting from my car, I observed that ~~that~~ ~~the~~ car EU 702M ~~was~~ was almost bumper-to-bumper with me, and that lorry YN 6038H had also appeared to have hit EU 702M as well.
