1.	1. Policy Particulars :- THIRD PARTY CLAIM							
	Insured Veh.	SJW 5044B	Veh. Inspected	SJC 1218Z				
	Policy No.		Coverage (\$)	0.00				
	Claim No.	M19HO03177/JT	Excess (\$)	0.00				
	Assign From	JAIME TAY	Assign Date	04/12/2019

2.		Vehicle Partic	culars & Condition					
	Make & Model	B.M.W. 216D G.T	c.c	1496				
	Engine No.	HIDDEN	Year of Reg.	2017				
	Chassis No.	WBA2E320705H46232	Colour	BROWN				
	Odometer	65663	Steering	IN ORDER				
	Brakes	IN ORDER	Modification	SPORTS RIM				
	General	FAIR

ADJUSTMENT ON REPAIR COST FOR VEHICLE NO. SJC 1218Z

PHOTOGRAPHS FOR VEHICLE NO. SJC 1218Z

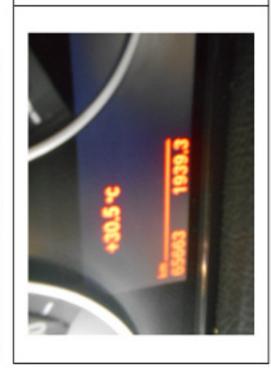
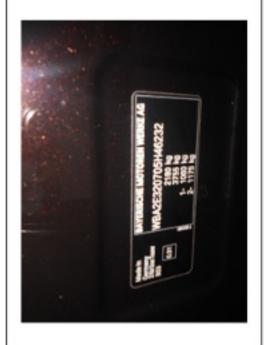
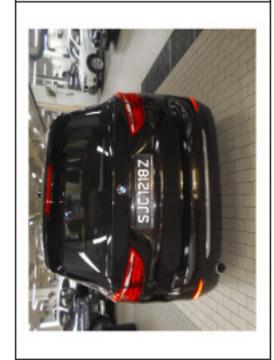
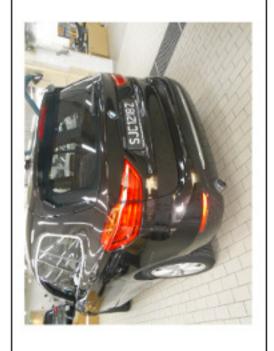
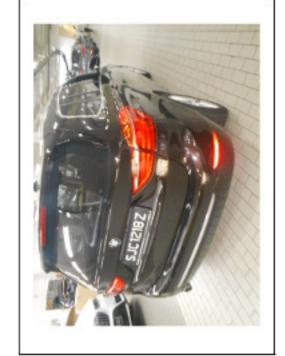
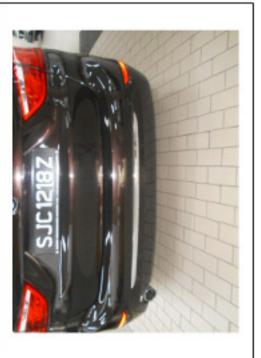
4.		Description	on of Damages					
	THE VEHICLE SU	STAINED DAMAGES AT THE REA	AR PORTION.					
	DAMAGES SEE D	ETAILS.						
5.		General	Information					
	Accident Date	26/11/2019	Inspection Date	04/12/2019				
	Survey held at	PERFORMANCE MOTORS LTD						
		303 ALEXANDRA ROAD SINGAPORE 159941						
5a.		Re	emarks					
	A)THE INSPECTION WAS CONDUCTED ON A"WITHOUT PREJUDICE" BASIS. B)IN ACCORDANCE TO YOUR INSTRUCTIONS, WE HAVE NOT AUTHORISED REPAIRS.							
5b.	5b. Estimate Days of Repair							
	ESTIMATED NOR	MAL PERIOD FOR REPAIR:	3 Working Days

Qty	Description of Parts	Condition	Estimate By Workshop (\$))	Our Adjusted (\$)
	REPLACEMENT OF PARTS			
1	REAR BUMPER CARRIER (SN)	* CHECK	460.40	-
1	SUPPORT (SN)	* CHECK	45.55	-
1	REAR BUMPER TRIM STRIP (CHROM)(SN)	SCRATCHED	110.55	110.55
1	REAR BUMPER PANEL PRIMED (LINES PDC)(SN)	CUT	1,045.45	1,045.45
1	SUNDRIES (SN)	* CHECK	80.00	-
			1,741.95	1,156.00
	LABOUR			
	TO REPLACE REAR BUMPER AND ATTACHMENTS.		1,275.00	850.00
	PAINTING REAR BUMPER.		1,038.00	934.00
	TO CHECK ELECTRICAL WIRING SYSTEMS AND LIGHTINGS AT THE REAR SECTION FOR PROPER FUNCTION.		177.00	150.00
	TO REMOVE OLD PDC ASSEMBLY,REPLACE DAMAGED PARTS AND RECONNECT TO NEW BUMPER INCLUDING CONDUCT CHECKS FOR PROPER FUNCTION.		177.00	150.00
			2,667.00	2,084.00
	GRAND TOTAL		4,408.95	3,240.00
