Preliminary Advice

Vehicle No	: GBG7993C	Accident Date	: 29/11/2019
Make	: TOYOTA DYNA 150	Policy No.	: 29099690
Assignment Date	: 04/12/2019	Excess	: S\$500.00
Date of Inspection	: 04/12/2019	Est. Duration of Repair	: 6 days
Inspection At	: Systematic Airconditioning Pte Ltd (HQ) 29 Senoko Way Singapore 758059

VEHICLE DAMAGE INSPECTION REPORT

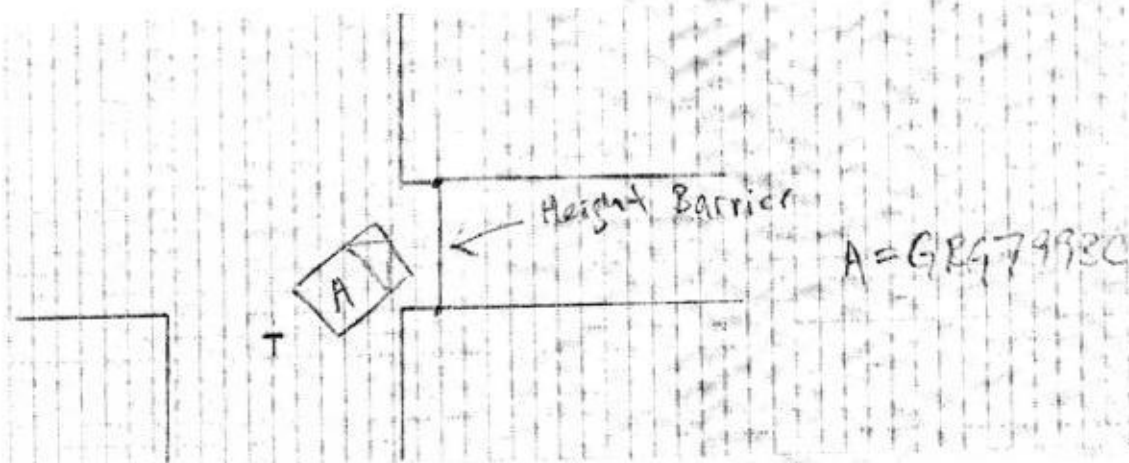
SKETCH PLAN

✓ At about 3.30 pm, it was raining heavily. I was about to exit the car park, as I was driving out turning right I step on my brake but it was too late as the top of the vehicle has hit the metal gantry.
