## SINGAPORE ACCIDENT STATEMENT

**REPORT OF A TRAFFIC ACCIDENT**

NTUC INCOME INSURANCE CO-OPERATIVE LTD Ref: NS/INC19021418/Gvf3e2	
73 BRAS BASAH ROAD #05-01 NTUC TRADE UNION HOUSESINGAPORE 189556	Date: 19-12-2019
Code: INC4	
<b>1. Policy Particulars :- THIRD PARTY CLAIM</b>	
Insured Veh. FBQ 2598R	Veh. Inspected SHA 4779K
Policy No. 5112087425	Coverage (\$) 0.00
Claim No. MT/1074122-002	Excess (\$) 0.00
Assign From	Assign Date 03/12/2019
<b>2. Vehicle Particulars &amp; Condition</b>	
Make & Model HYUNDAI SONATA	c.c 1991
Engine No. HIDDEN	Year of Reg. 2012
Chassis No. KMHET41VMCA822903	Colour BLUE
Odometer 625253	Steering IN ORDER
Brakes IN ORDER	Modification NIL
General GOOD	
<b>3. Conditions of Tyres</b>	
	Size Make Balance
R/H Front Tyre	215/60 R16 HANKOOK 5 mm
L/H Front Tyre	215/60 R16 HANKOOK 5 mm
R/H Rear Tyre	215/60 R16 HANKOOK 5 mm
L/H Rear Tyre	215/60 R16 HANKOOK 5 mm
<b>4. Description of Damages</b>	
THE VEHICLE SUSTAINED DAMAGES AT THE REAR N/S PORTION. DAMAGES SEE DETAILS.

## ADJUSTMENT ON REPAIR COST FOR VEHICLE NO. SHA 4779K

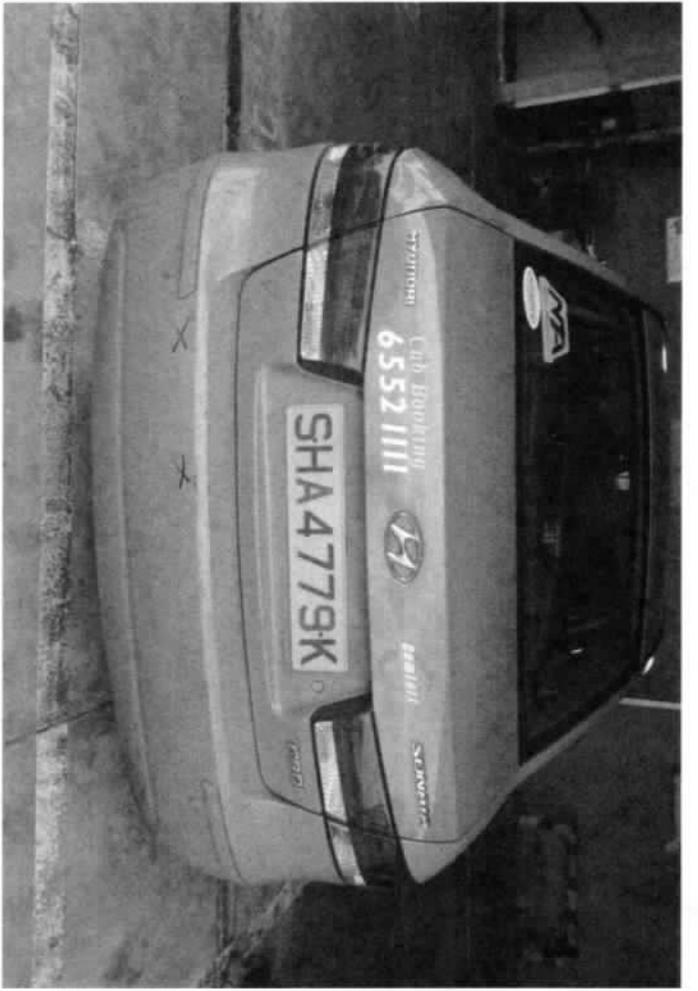
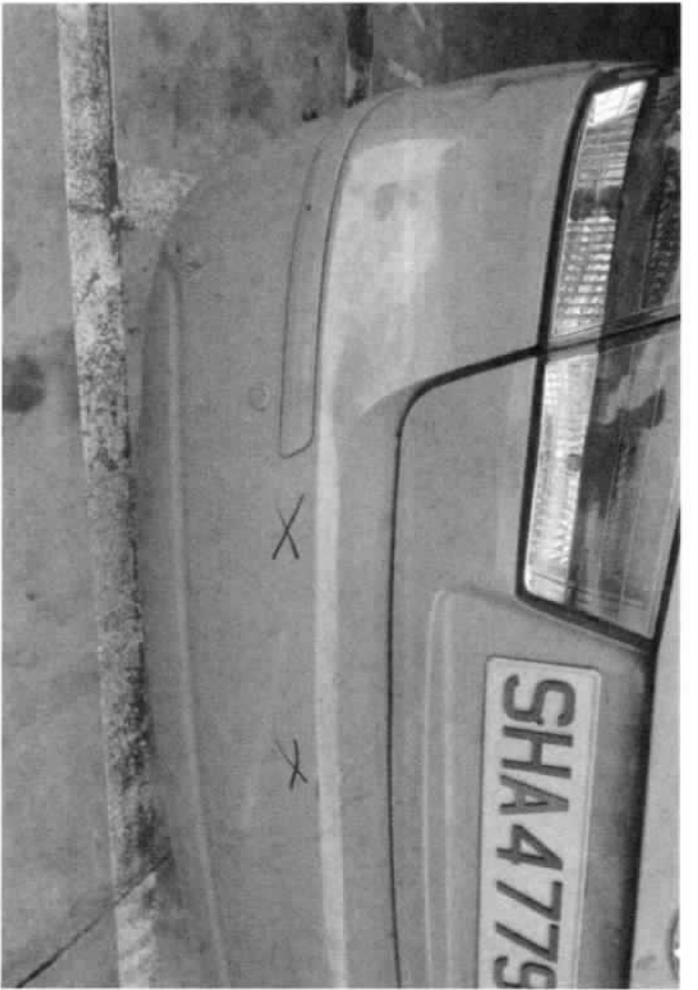
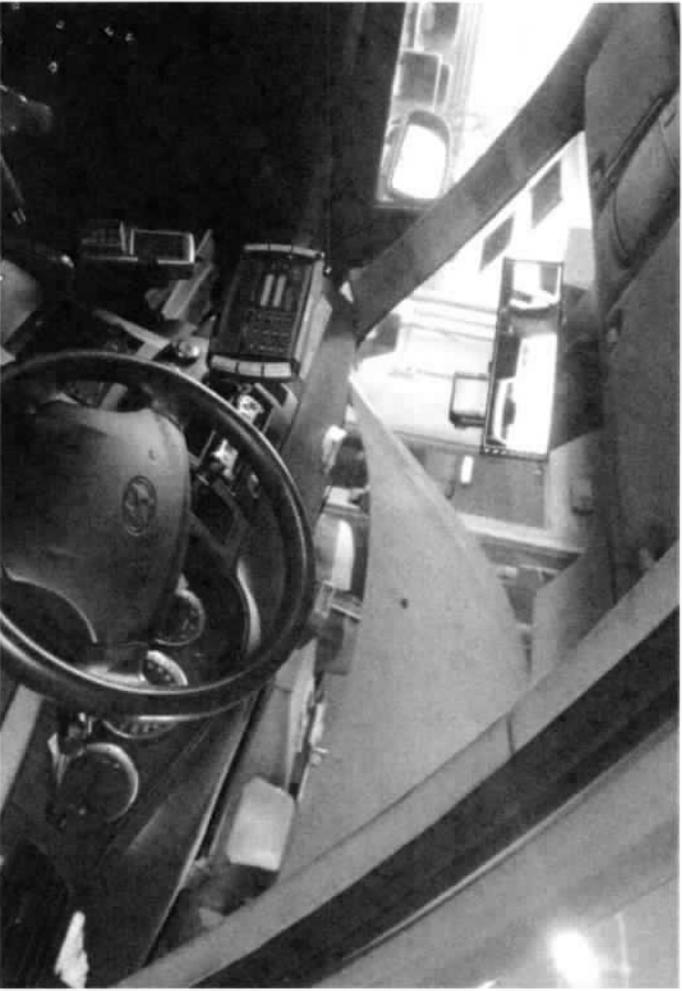
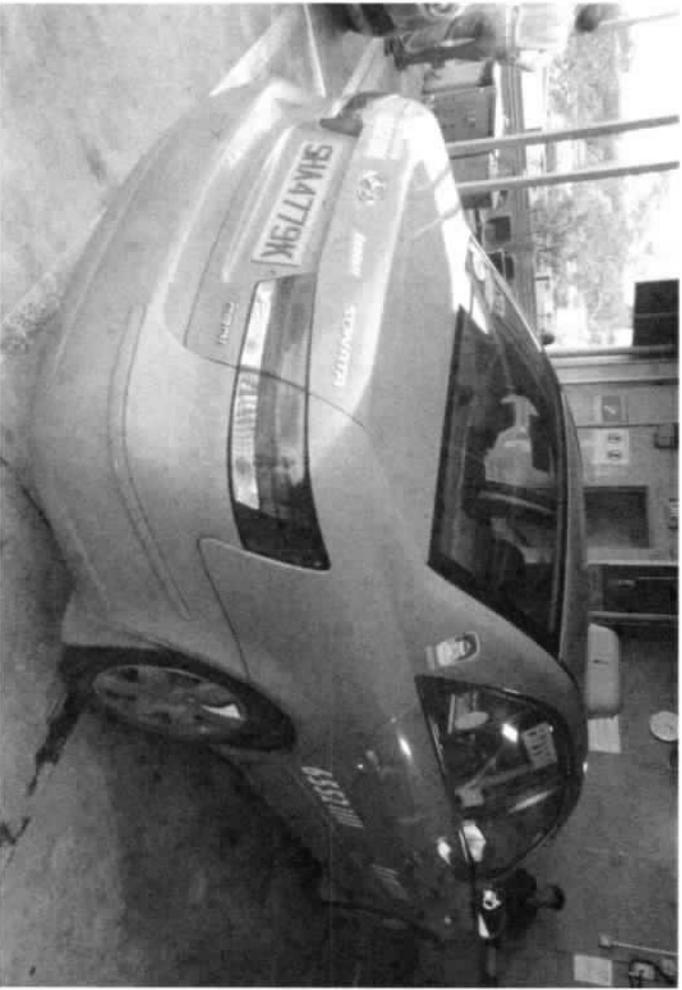
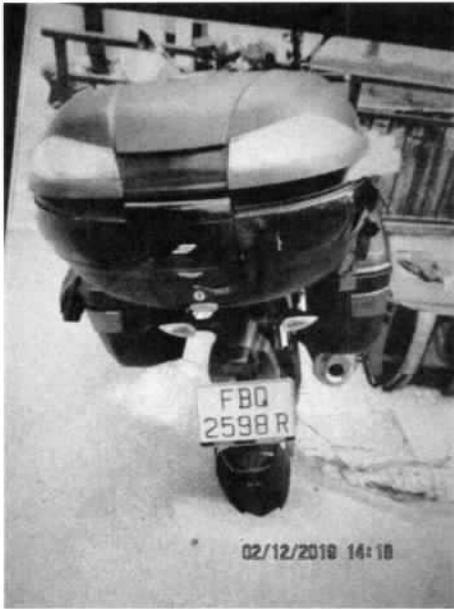
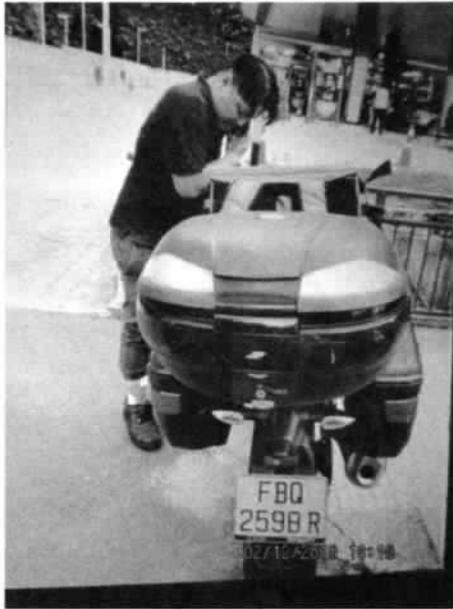
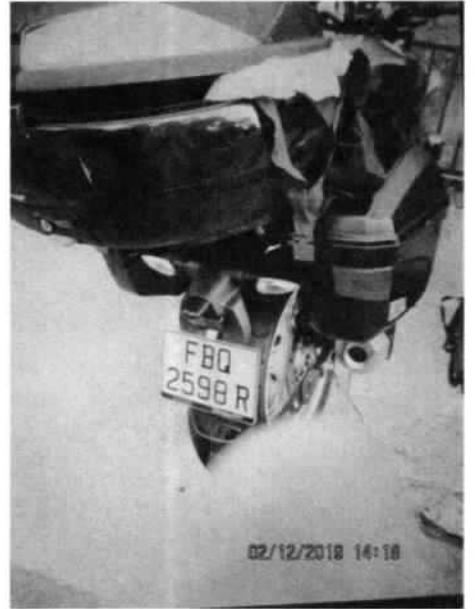
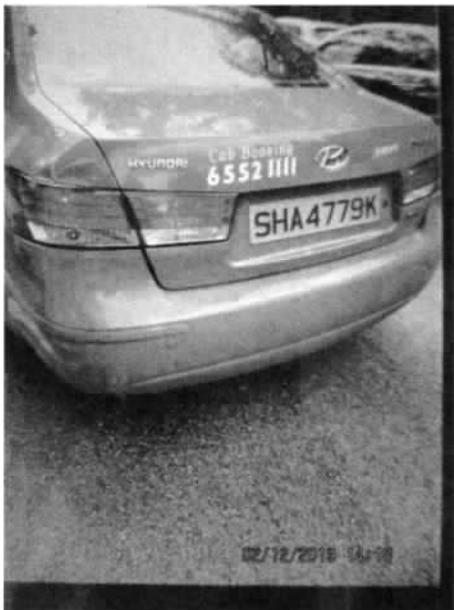
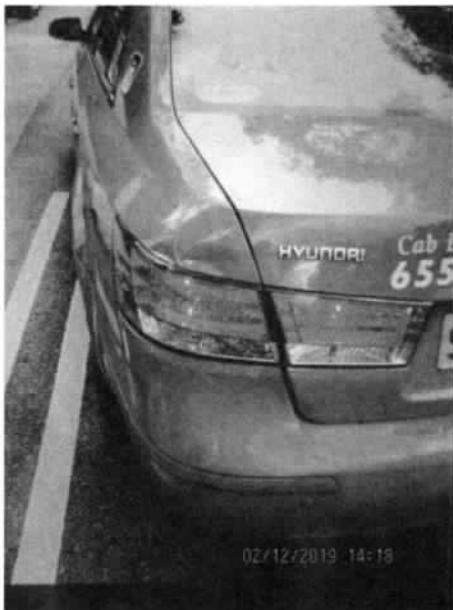
Qty	Description of Parts	Condition	Estimate By Workshop (\$)	Our Adjusted (\$)
<b>REPLACEMENT OF PARTS</b>				
1	REAR BUMPER	TORN	578.40	578.40
10	REAR BUMPER CLIP	NECESSARY	22.00	22.00
1	REAR BUMPER PROTECTOR (LH)	SCRATCHED	38.00	38.00
1	TAIL LAMP (RH)	CUT	344.00	344.00
1	REAR FENDER (RH)	TO REPAIR SEE LABOUR	1,935.90	-
1	REAR FENDER INNER LINING (RH)	NOT NECESSARY	74.10	-
1	REAR WINDSCREEN MOULDING	NOT NECESSARY	60.00	-
	LESS 20% DISCOUNT		-610.48	-196.48
			2,441.92	785.92
<b>SPECIAL NETT ITEMS</b>				
1	REAR WINDSCREEN SEALANT (SN)	NOT NECESSARY	46.00	-

46.00	-
<b>LABOUR</b>				
	PANEL BEATING. INCLUSIVE OF THE REPAIR OF REAR FENDER (RH).		560.00	480.00
	SPRAY PAINTING CHARGE.		500.00	400.00
	WIRING CHARGE.		50.00	20.00
	TUFF KOTE.	NOT NECESSARY	50.00	-
	REMOVE / REFIX CUSHION & UPHOLSTERY REAR.		150.00	60.00
	REMOVE / REFIX REAR WINDSCREEN GLASS.	NOT NECESSARY	120.00	-
	REMOVE / REFIX REVERSE SENSOR.		120.00	40.00
			1,550.00	1,000.00
<b>GRAND TOTAL</b>			<b>4,037.92</b>	<b>1,785.92</b>
<b>RECOMMENDED COST OF LUMP SUM REPAIRS (TO ITS PRE-ACCIDENT CONDITION) (CONFIRMED)</b>				<b>1,400.00</b>
